SALAMANDER INSPECTIONS LTD

Mechanical Insulation Energy Audits

Energy Audit

University of the Fraser Valley

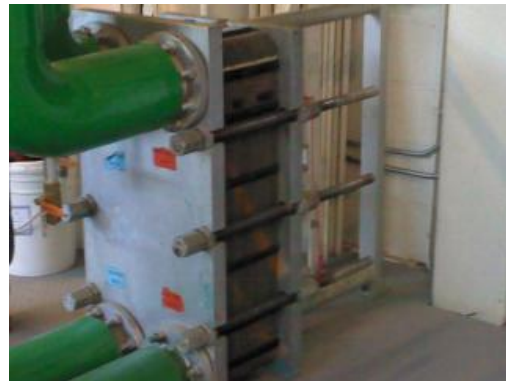
Figure 2 This photo shows the same plate heat exchanger.

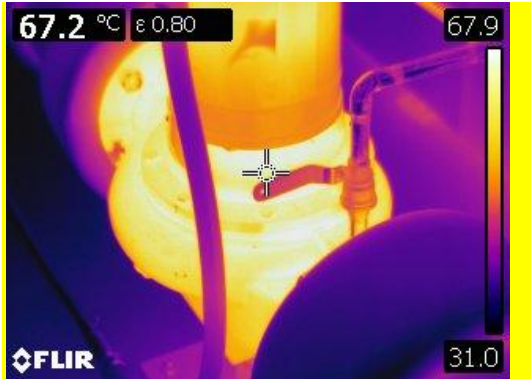
Figure 3 This thermographic image of a vertical pump within the mechanical room.

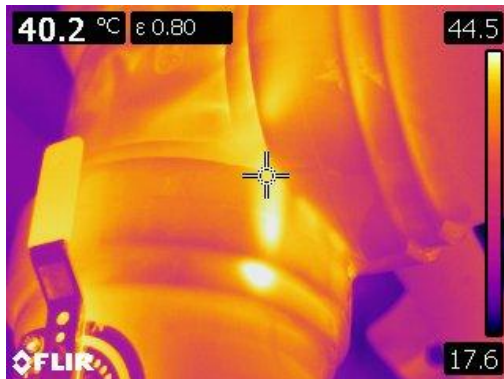
Figure 5 This Thermographic image of a Victaulic Tee which has been insulated with flex wrap. Note the high rate of heat loss as indicated by the bright color.

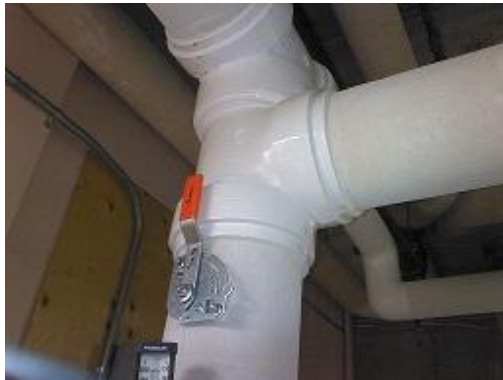
Figure 6 This conventional photo shows the PVC fitting applied to the Victaulic Tee. The fitting looks great but the thermographic image shows a high rate of heat loss.

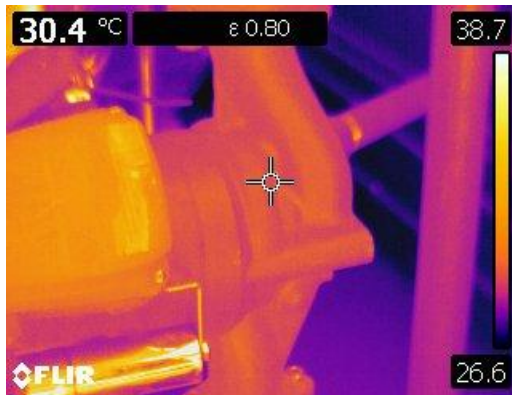
Figure 7 This is a thermographic image of a circulation pump adjacent to the boiler.

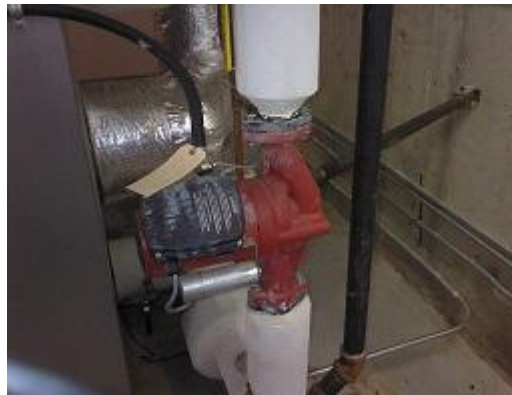
Figure 8 This is a conventional photo of the same pump.

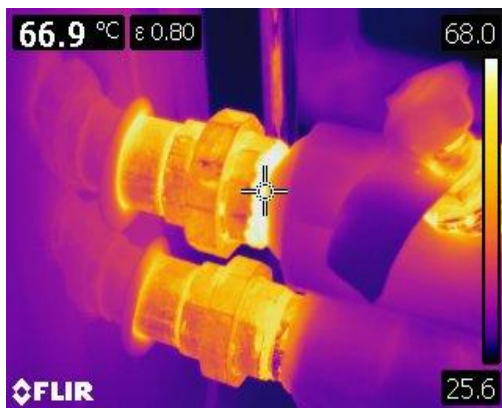
Figure 9 This is a thermographic image of the supply and return lines at the back of the boiler. These two lines are operating at a high temperature and pose a personal protection hazard.

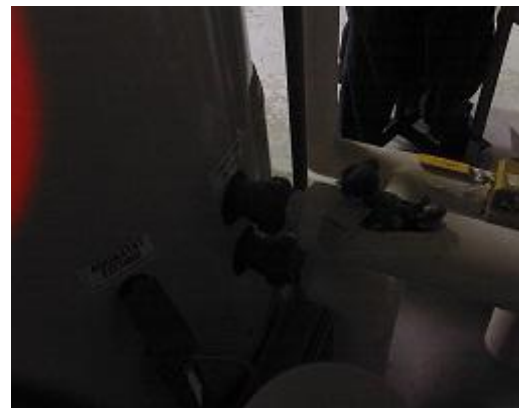
Figure 10 This is the conventional image of the supply and return lines at the back of the boiler.

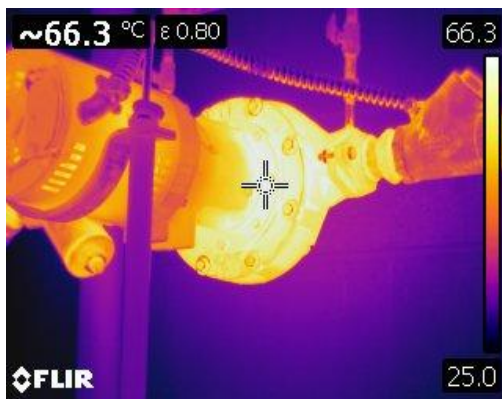
Figure 11 This thermographic image is of a small motorized pump.

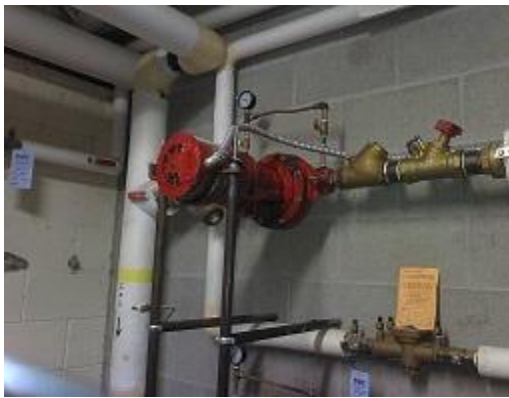
Figure 12 This is a conventional image of the same pump.

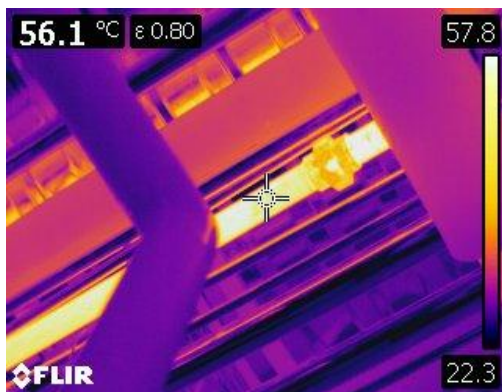
Figure 13 This thermographic image is of a bare 1.25 inch pipe 21 feet in length against the ceiling of the room.

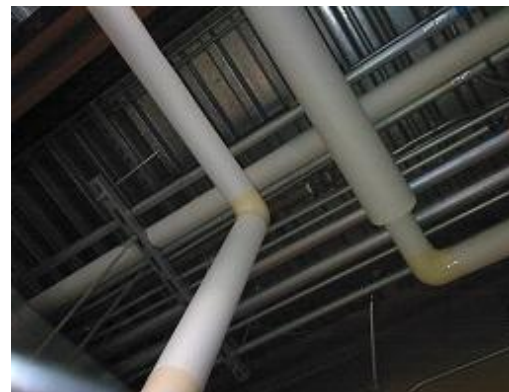
Figure 14 This is a conventional image of the same pipe.

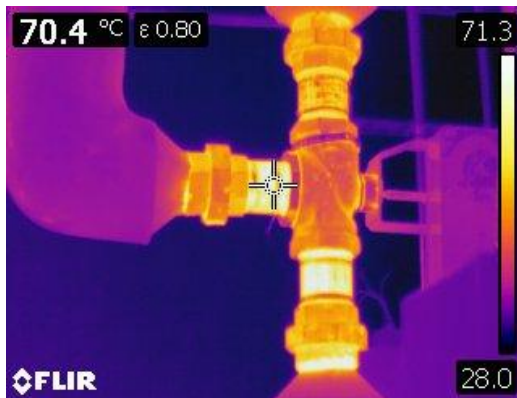
Figure 15 This thermographic image is of a bare three way valve operating at a high temperature.

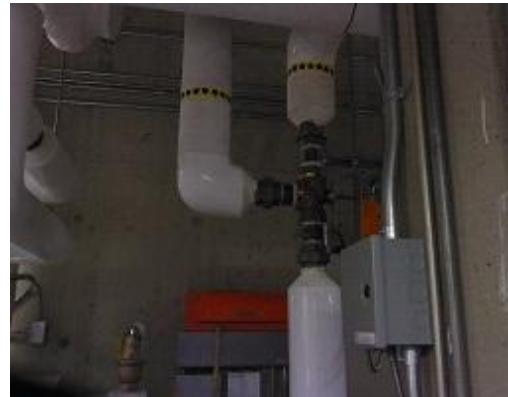
Figure 16 This conventional image is of the same three way valve.

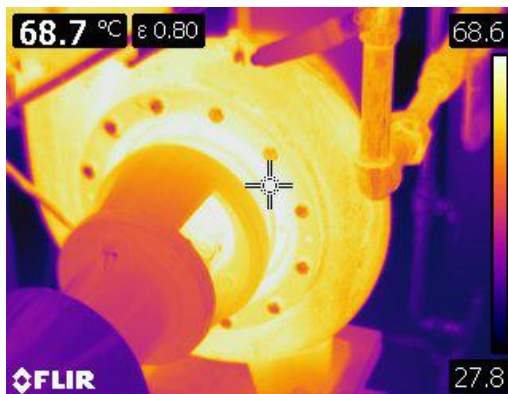
It is also important to recognize the hazards that hot exposed surfaces present to personnel. The boiler rooms and fan rooms generally are tightly packed with equipment and piping systems operating at temperatures of nearly 77°C. (People experience burns at temperatures above 65°C). Un-insulated or exposed surfaces at these high temperatures are to be considered a serious risk for staff and personnel. Properly insulated systems and equipment eliminate the possibility of individuals coming into contact with these hot surfaces and will prevent accidental burns. This is an important life safety and financial consideration.

Figure 17 Thermographic image of a Personnel protection hazard at floor level

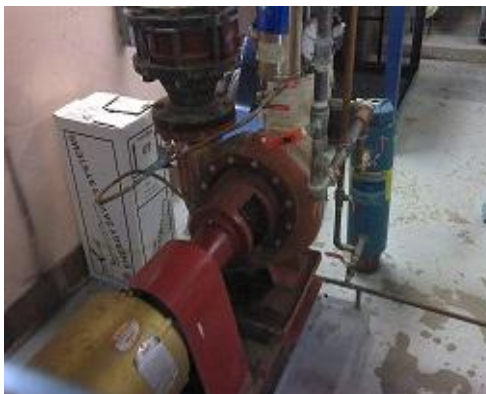
Figure 18 conventional image of the same pump.

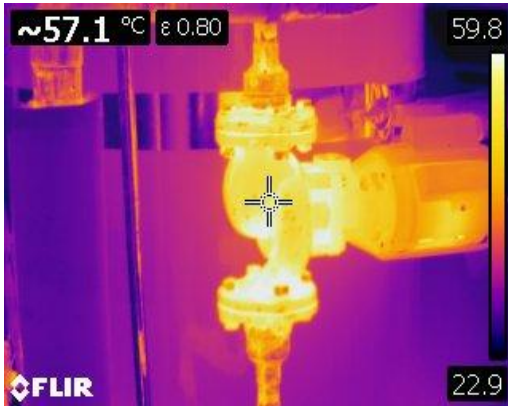
Figure 19 Thermographic image of a pump adjacent to the domestic hot water tank.

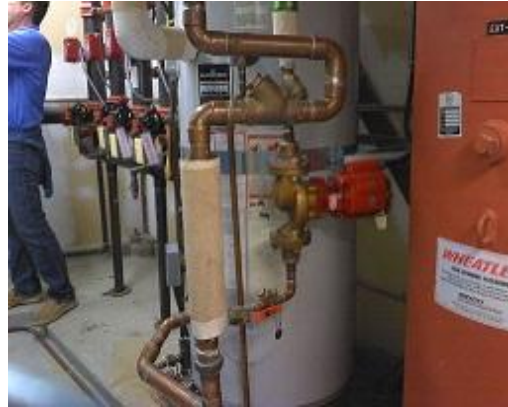
Figure 20 Conventional image of the pump adjacent to the domestic hot water tank.

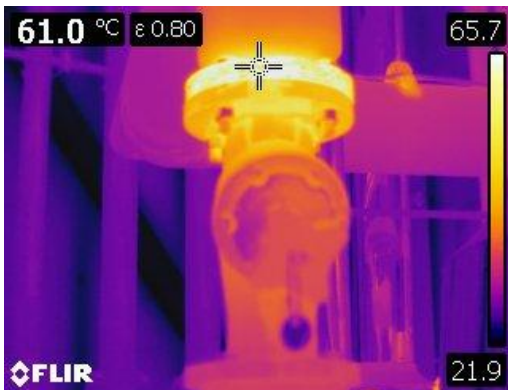
Figure 21 Thermographic image of a control valve adjacent to boiler.

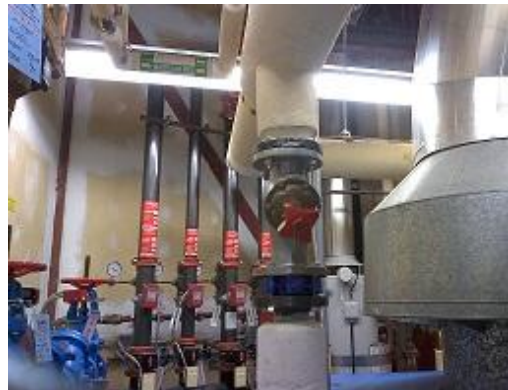
Figure 22 Conventional image of the same control valve.

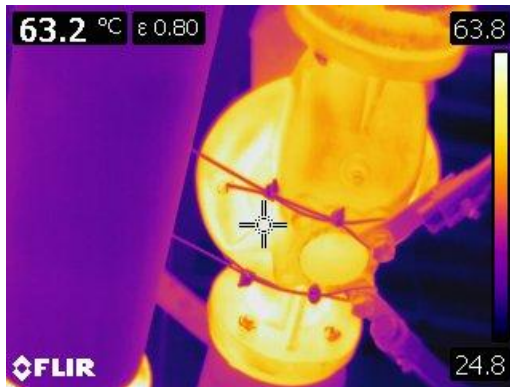
Figure 23 Thermographic image of motorized pump on heating system.

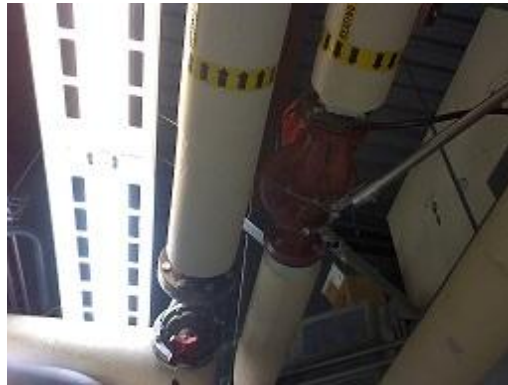
Figure 24 Conventional image of the same pump and associated flanges requiring

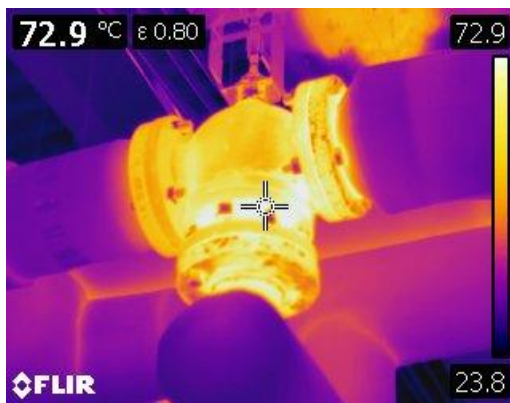
Figure 25 Thermographic image of three way valve requiring insulation.

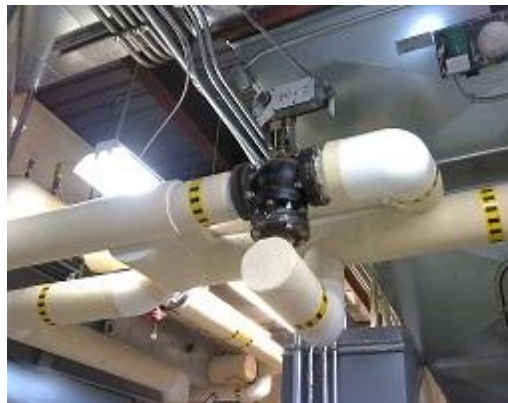
Figure 26 Conventional image of the same valve and flanges requiring insulation.

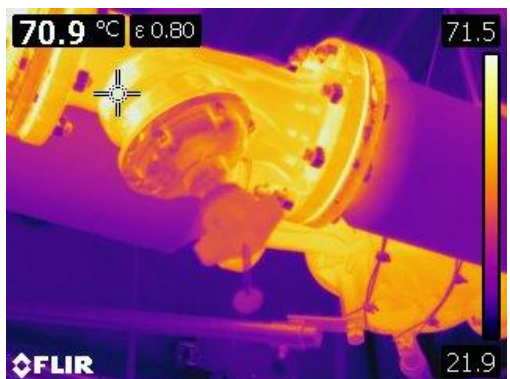
Figure 27 Thermographic image of control valve.

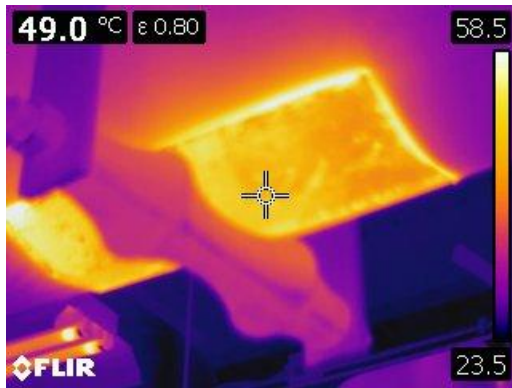
Figure 29 Thermographic image of hanger supports without insulation behind plates.

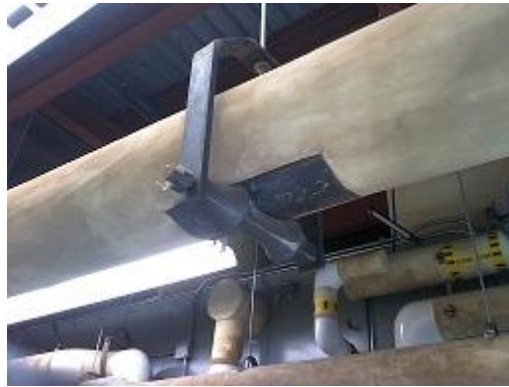
Figure 30 Conventional picture of hanger support.

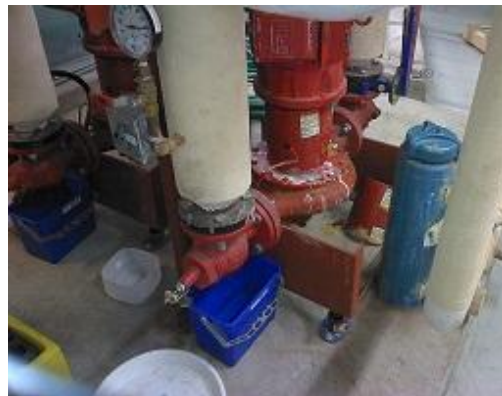
Figure 32 Conventional image of the same heating pumps.

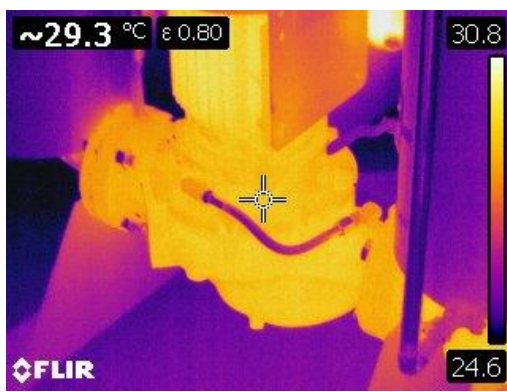
Figure 33 Thermographic image of the P6-B motorized pump.

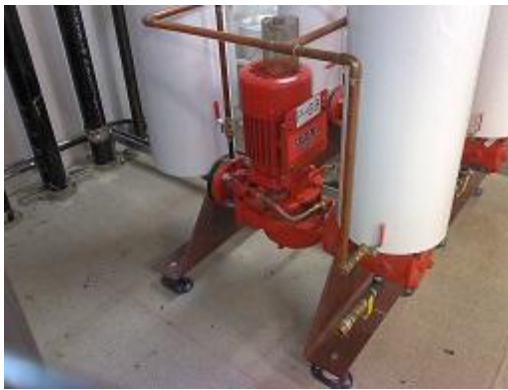
Figure 34 Conventional image of the same pump.

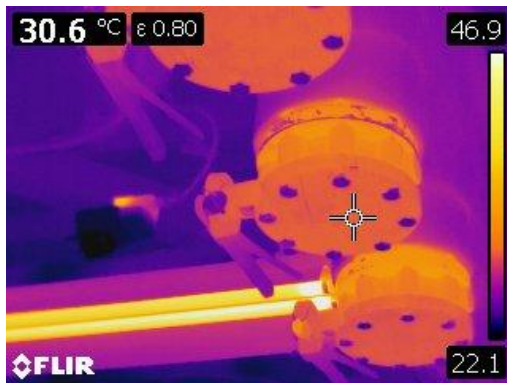
Figure 35 Thermographic image of the exposed gate valves on the Thermonex header.

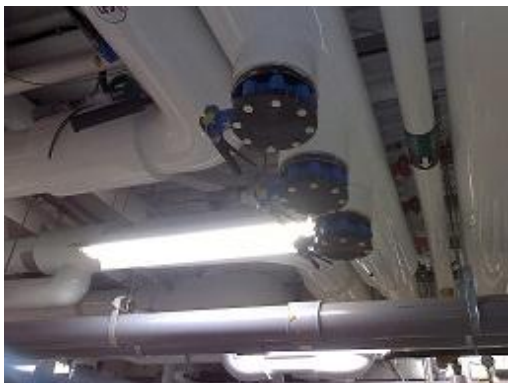
Figure 36 Conventional image of the same header.

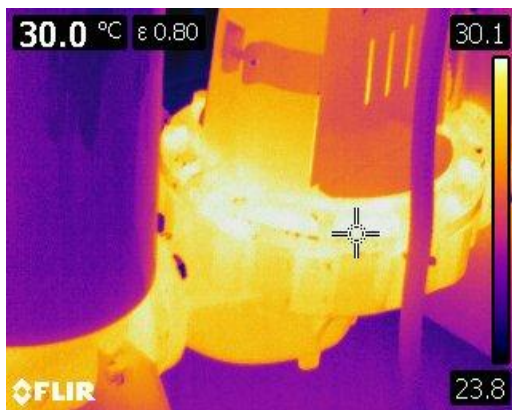
Figure 37 Thermographic image of a motorized heating pump.

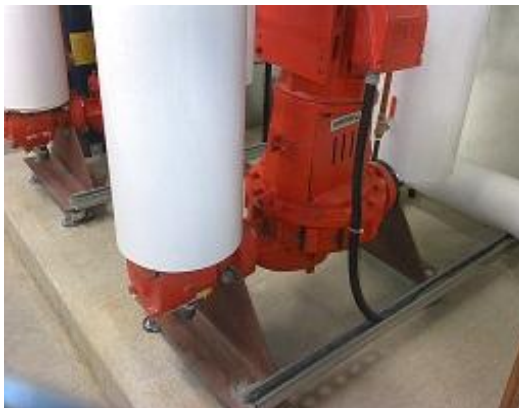
Figure 38 Conventional image of the same pump.

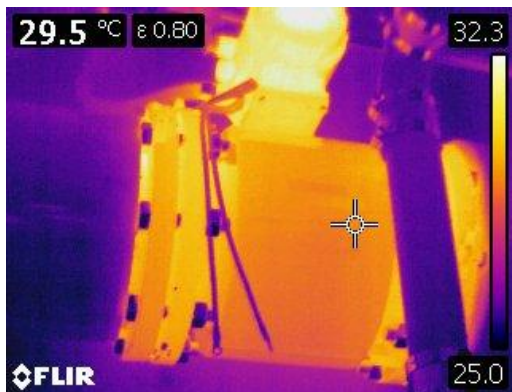
Figure 39 Thermographic image of a flow meter on the heating side.

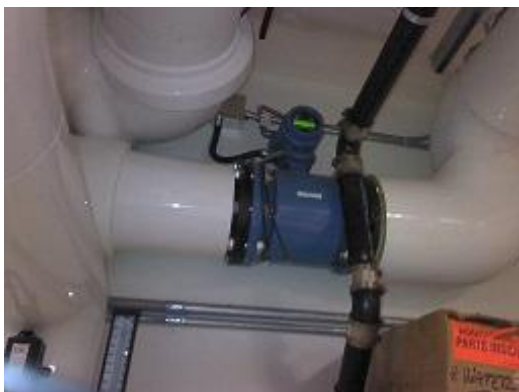
Figure 40 Conventional image of the flow meter.

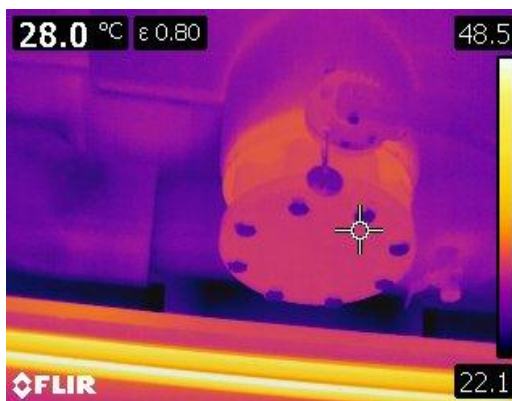
Figure 41 Thermographic image of exposed gate valves.

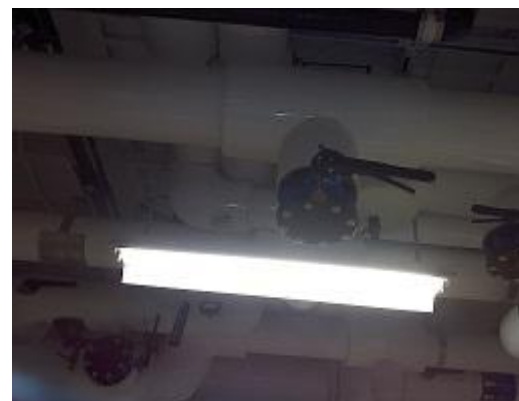
Figure 42 Conventional image of the same gate valves.

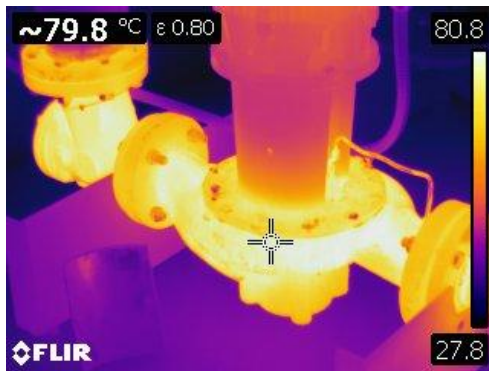
Figure 43 Thermographic image of exposed heating pump.

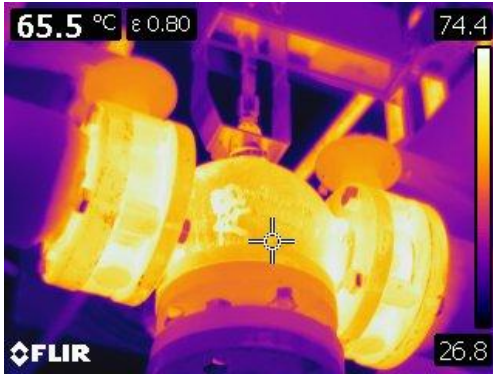
Figure 57 Thermographic image of exposed three way valve.

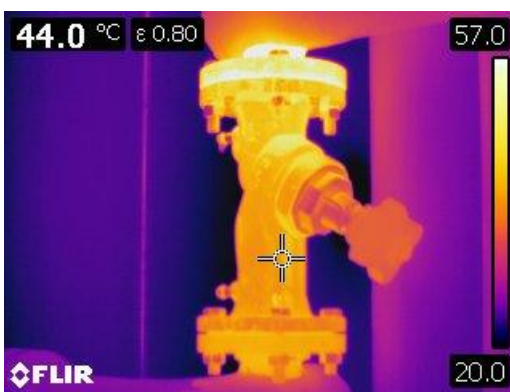
Figure 57 Thermographic image of exposed control valve.

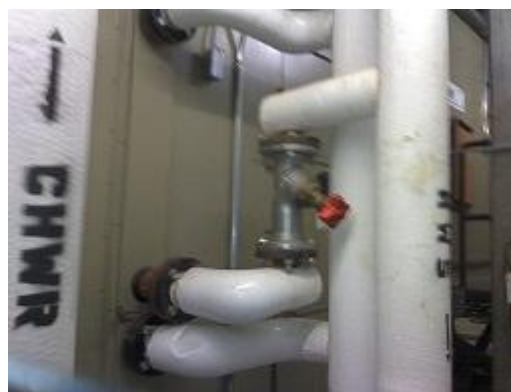
Figure 58 Conventional picture of exposed control valve and flanges to unit.

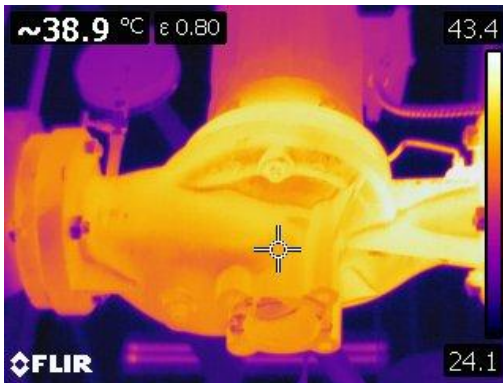
Figure 59 Thermographic image of exposed motorized heating pump.

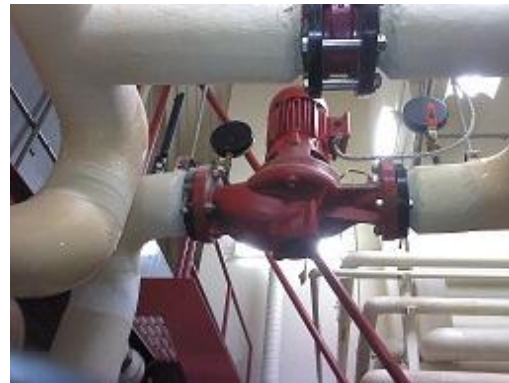
Figure 60 Conventional picture of exposed heating pump.

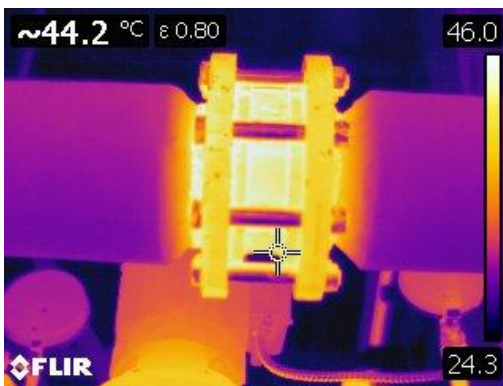
Figure 59 Thermographic image of exposed valve and flanges.

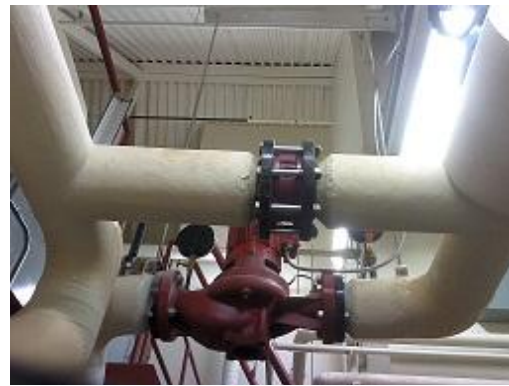
Figure 60 Conventional picture of same valve and flanges.

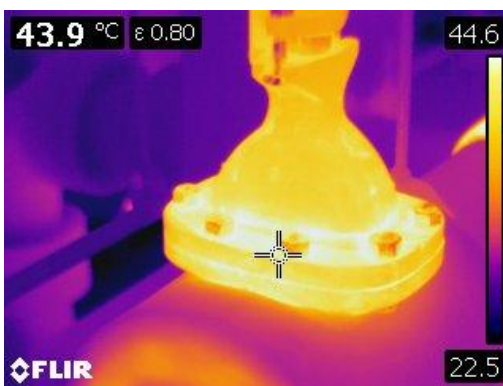
Figure 61 Thermographic image exposed valve bonnet.

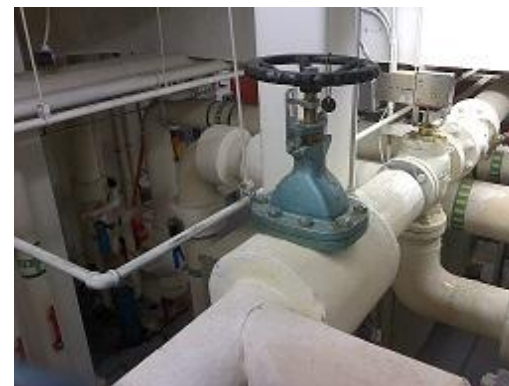
Figure 62 Conventional image of exposed valve bonnet and other exposed valves and flanges.

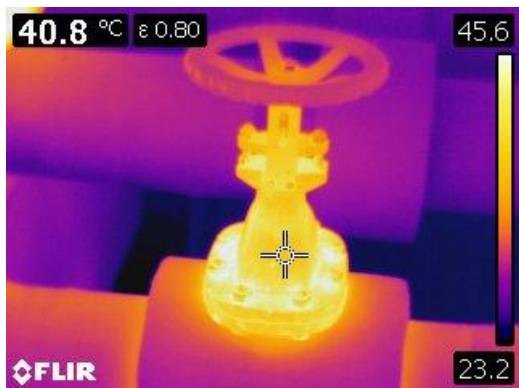
Figure 63 Thermographic image of exposed valve bonnet.

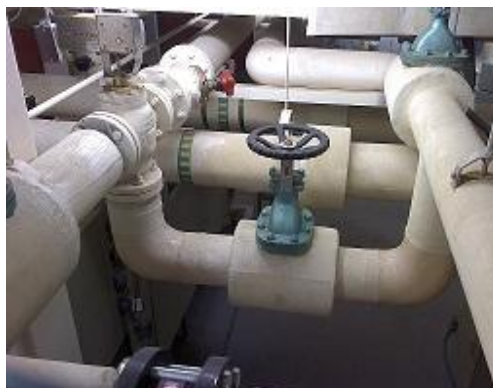
Figure 64 Conventional image of exposed valve bonnet and other exposed valves and flanges.

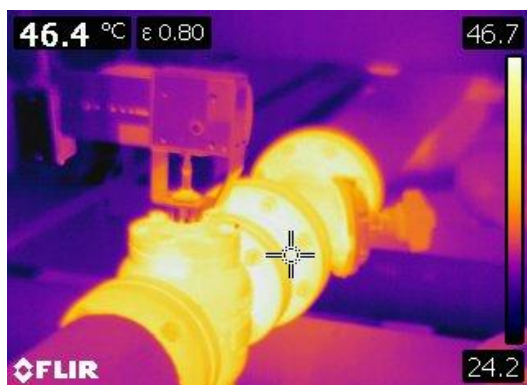
Figure 65 Thermographic image exposed motorized three way valve.

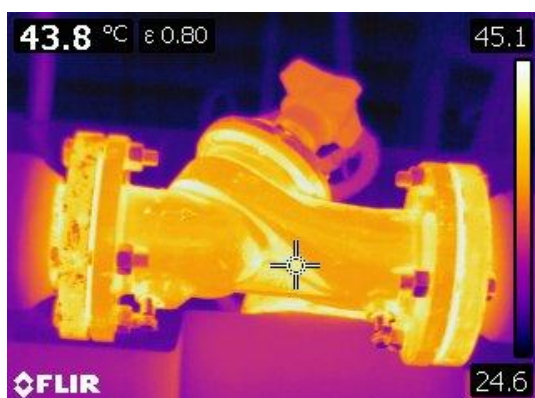
Figure 67 Thermographic image of bare control valve

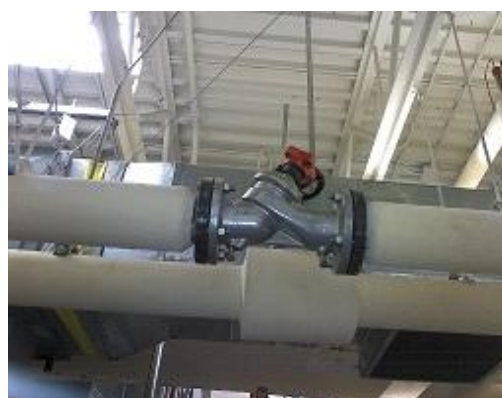
Figure 68 Conventional picture of the same control valve.

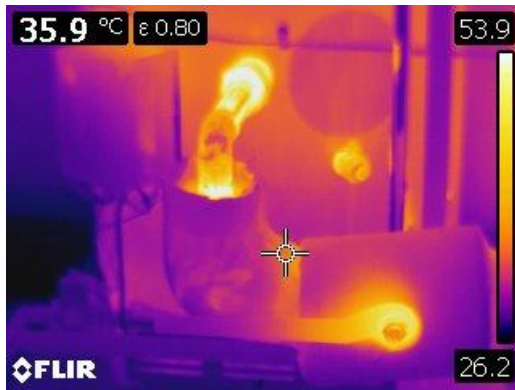
Figure 69 Thermographic image of damaged piping from hot water tank.

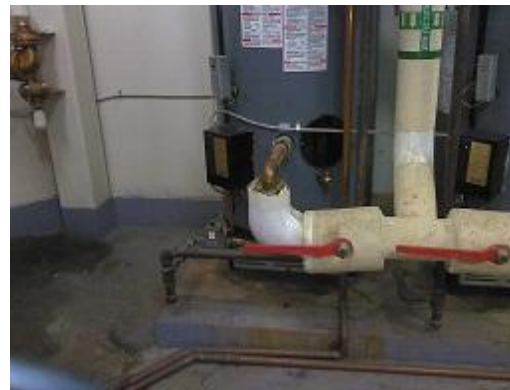
Figure 70 Conventional image of the same pipes to and from hot water tank.

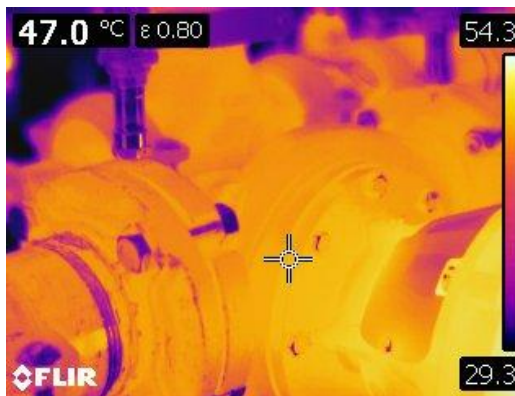
Figure 71 Thermographic image of motorized circulation pump.

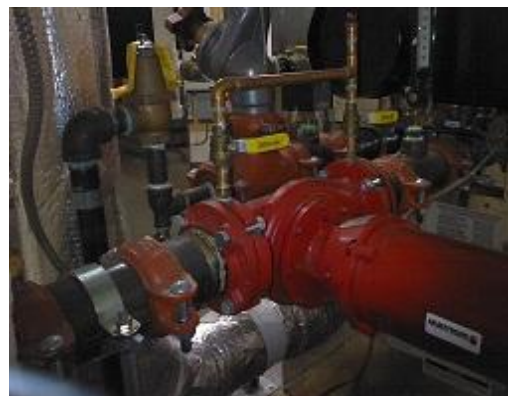
Figure 72 Conventional picture of the same pump and associated piping.

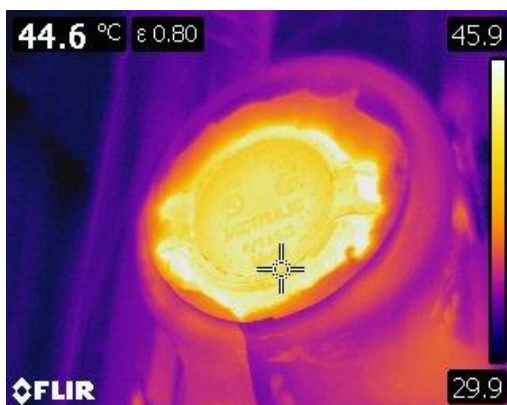
Figure 73 Thermographic image of bare Victaulic cap and clamp.

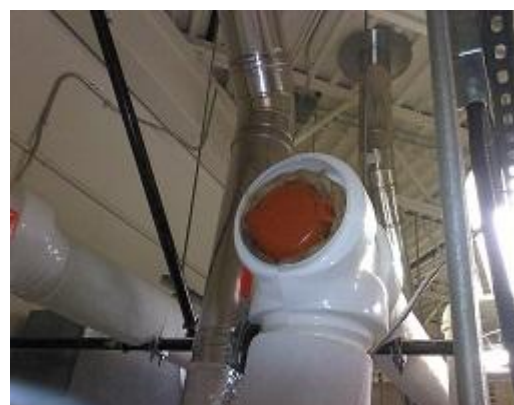
Figure 74 Conventional picture of the same un- finished fitting.

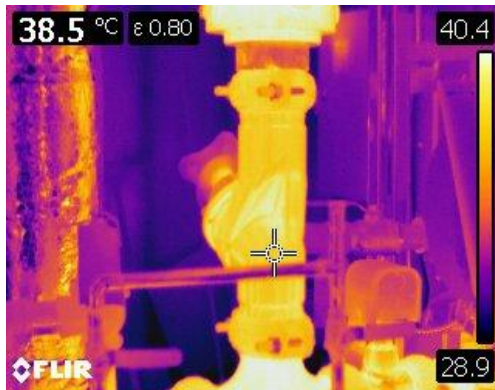
Figure 75 Thermographic image of control valve and piping at boiler.

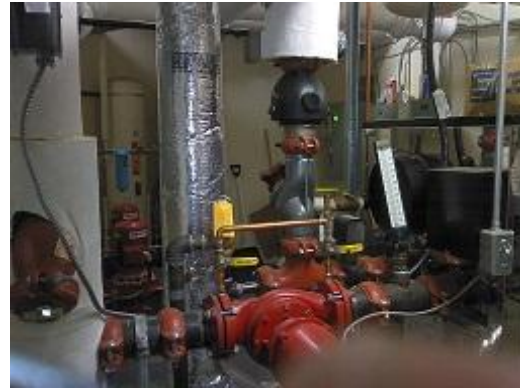
Figure 76 Conventional picture of bare valves, pumps and piping.

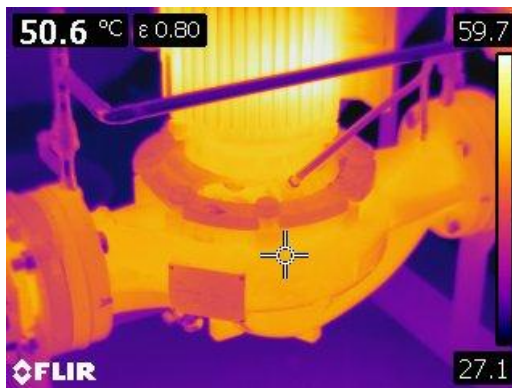
Figure 77 Thermographic image of heating pump and associated piping.

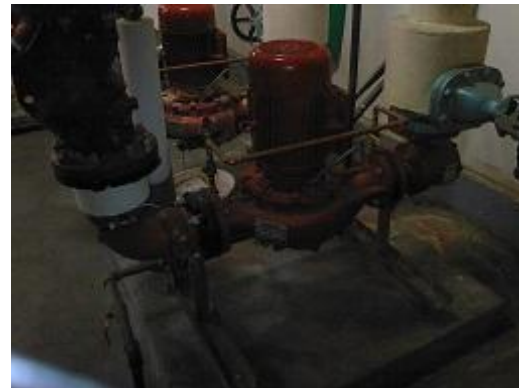
Figure 78 Conventional picture of the same pump and piping.

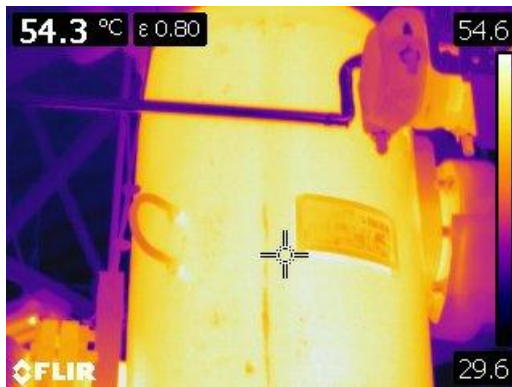
Figure 79 thermographic image of a receiver tank.

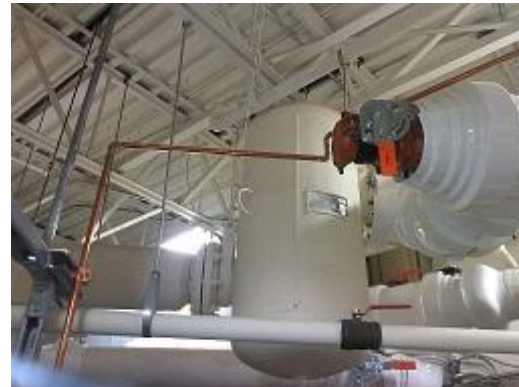
Figure 80 Conventional image of the same tank.

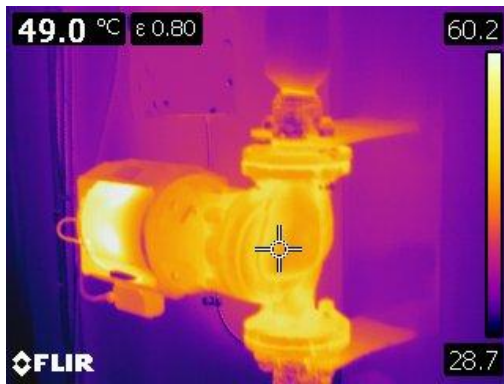
Figure 81 Thermo graphic image of heating pump and associated piping.

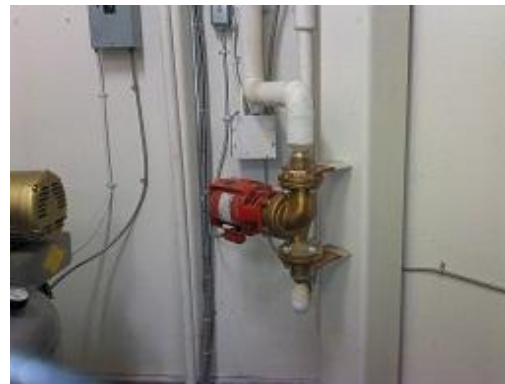
Figure 82 Conventional picture of heating pump and associated piping.

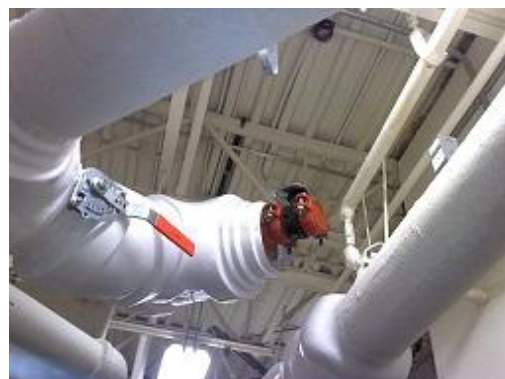
Figure 84 conventional image of the same heating piping.
