SALAMANDER INSPECTIONS LTD

Mechanical Insulation Energy Audits

Energy Audit

For the Food Processing
Development Center
6309 – 45 Street Leduc, Alberta

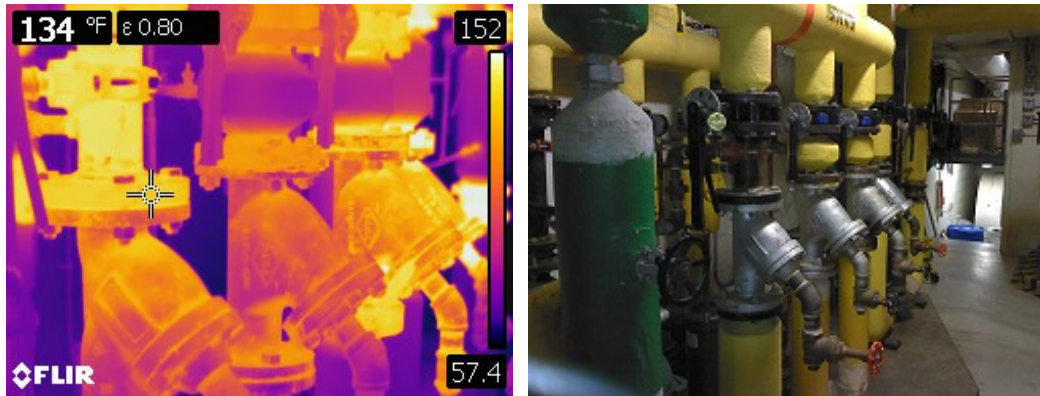
A row of uninsulated valves and strainers in the Leduc Food Processing Center boiler room as seen by the thermographic camera.

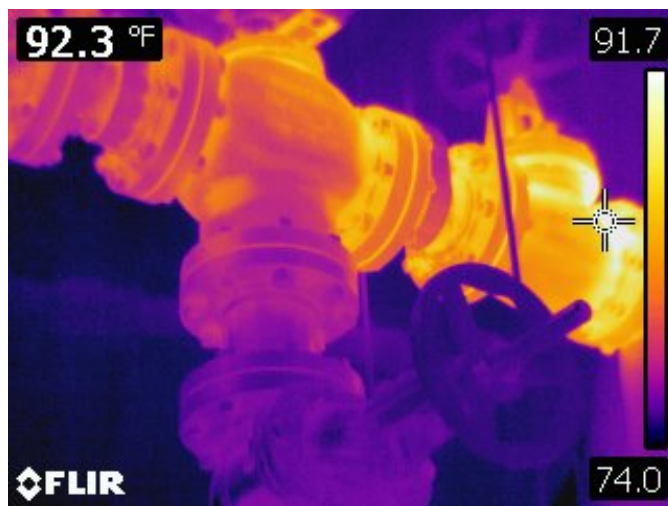
There are some areas where pumps, valves and piping remain without insulation applied.

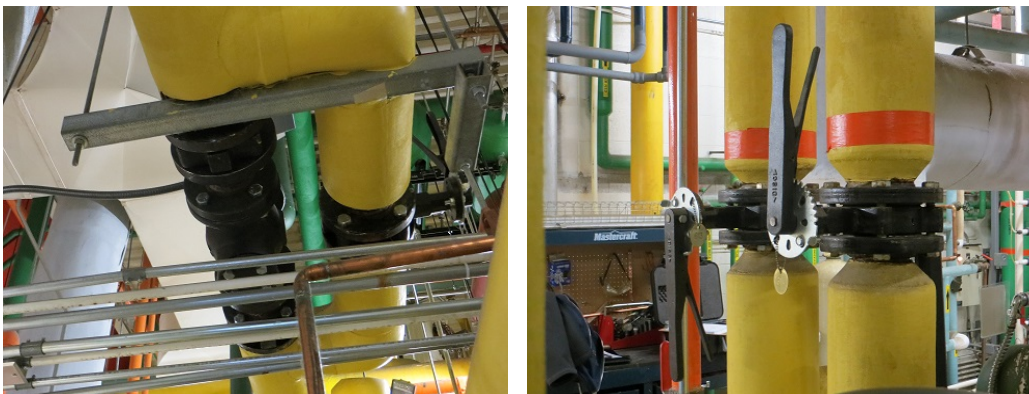
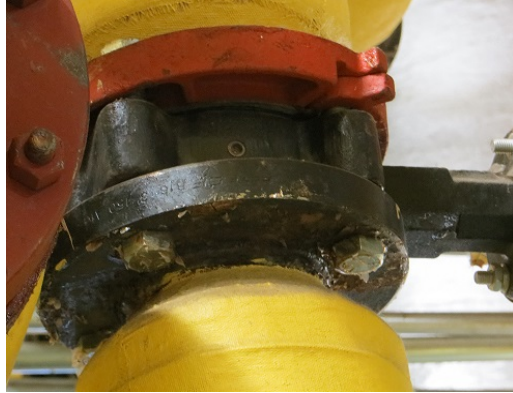
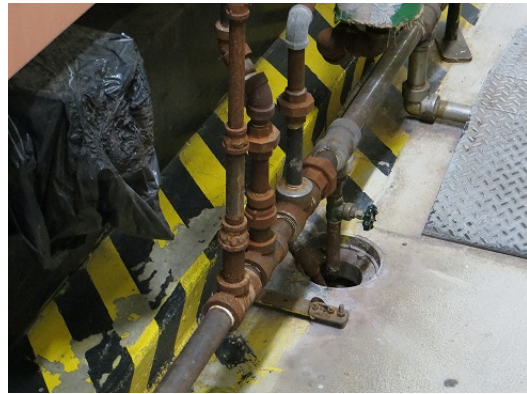
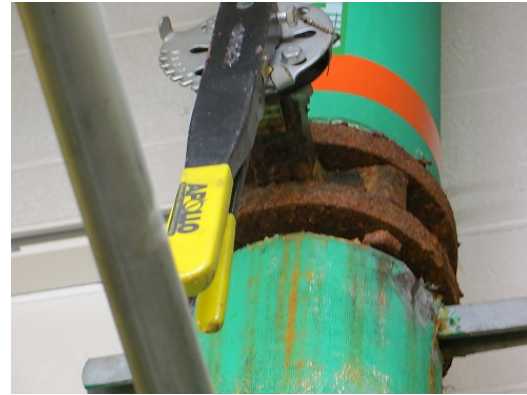
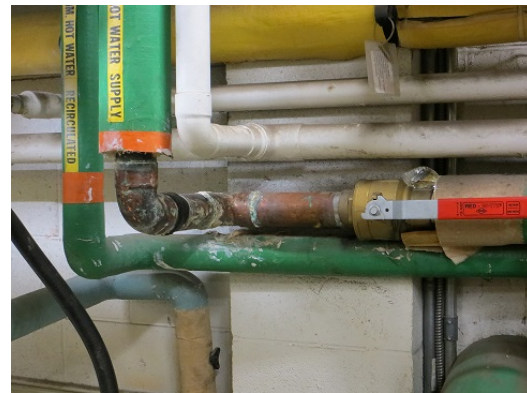
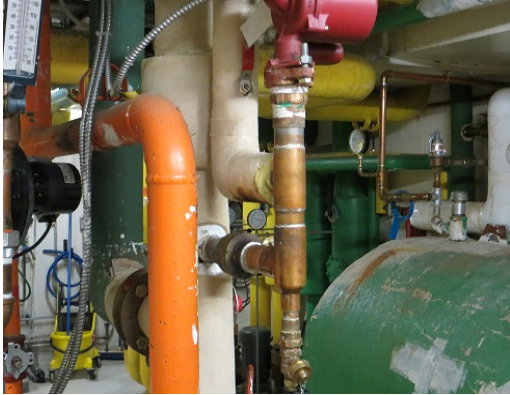
Boiler Room

We have assessed the boiler room and found that the insulation applied to the mechanical systems is in fair to good condition. However, there are some instances where pumps, valves and piping have no insulation applied and therefore, an opportunity to receive some savings is available.

The workmanship of the existing insulation is in fair to good condition but some bad practices were followed when these materials were installed. During the course of this inspection we counted at least (30+) valves, (6+) strainers, (30) pumps and a number of flanges and couplings as well as and other areas which have not been insulated. We also found areas where the mechanical insulation is damaged, missing and worn out from mechanical abuse. There isn't a good reason to not insulate valves, piping and or fittings but to achieve cost savings at the time of construction or a specification which allowed these practices to take place. We can now show that not insulating pipes hot or cold will cost money for the operation of the building and or repairs to equipment or piping. The report contains visual inspection of these systems utilizing thermographic analysis and conventional digital photographs for reference.

The energy wasted in the boiler room in the Leduc facility as a result of the poor performance of the insulation systems is approximately 1,242 GJ per year.

Looking at the work done in the boiler room, the existing work was well done judging by the condition of the materials applied. However, there are many areas that will need to be insulated to ensure that each type of system is covered appropriately. The heating and steam system is missing substantial amounts of insulation from the valves, strainers, pumps and equipment. This is typically throughout the plant and will provide the most savings when insulated. The domestic hot and cold are missing insulation materials also due mostly to maintenance work at which time reapplication never happened.

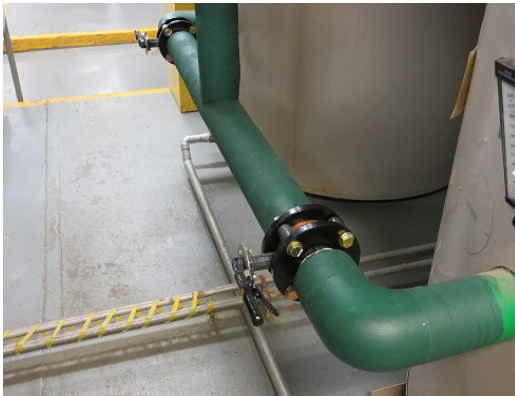
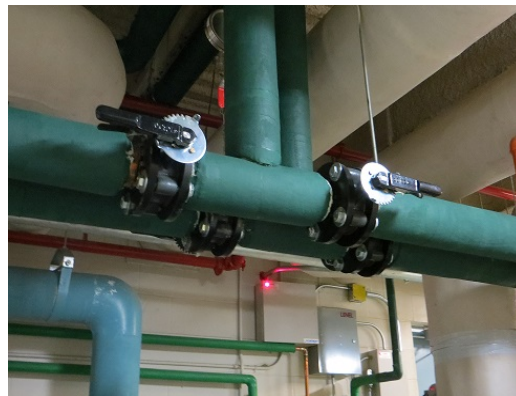
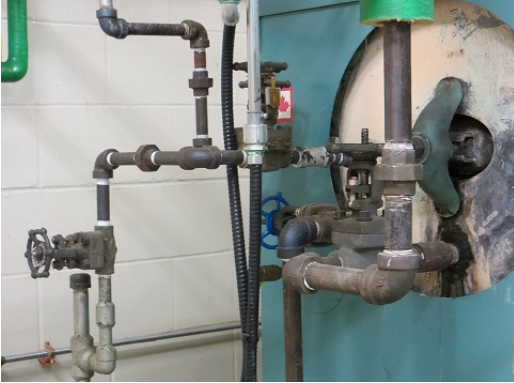
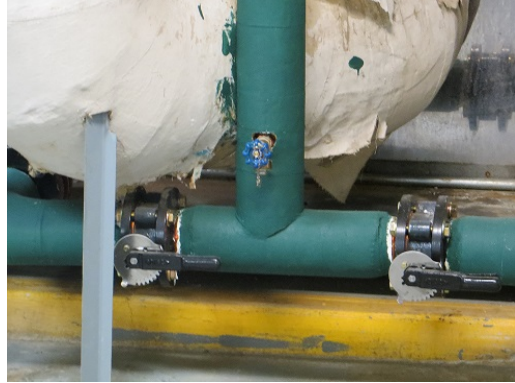
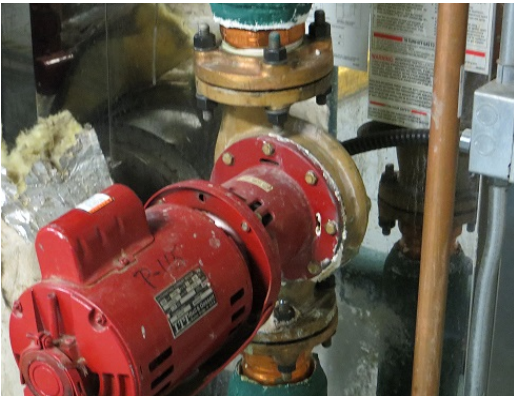
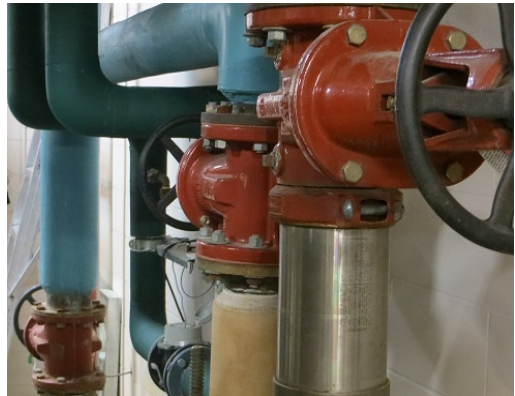
Mechanical Room 2nd floor

We have walked through and inspected the mechanical room on the second floor and found numerous areas which will require insulation to be applied to achieve thermal efficiency. The overall workmanship is good but as seen in other areas insulation has not been applied to any valves, strainers, pumps or heat exchangers. There are areas where pipe covering has been removed for maintenance work, this material should have been replaced at the time when work was done. There are many areas which have no insulation applied which is the main reason why this area is so warm at 30C.

Deficiencies in the insulation systems for the mechanical room on the 2nd floor result in a loss of approximately 1,217 GJ per year.

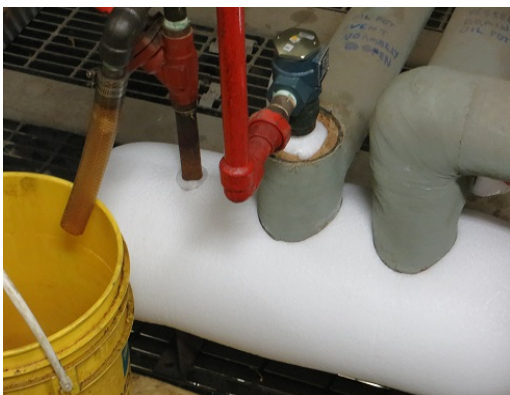
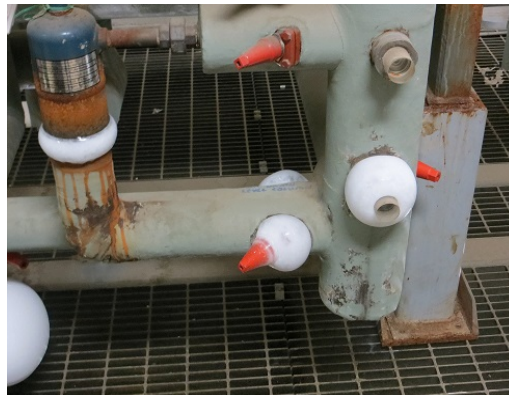
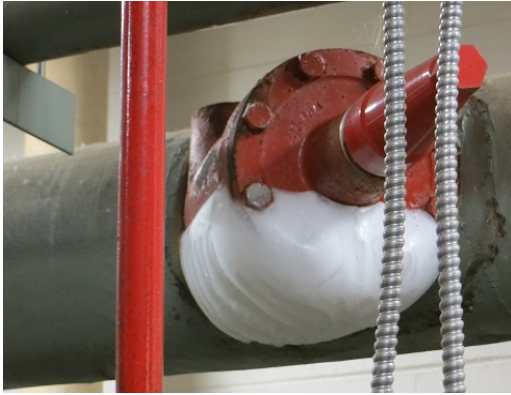
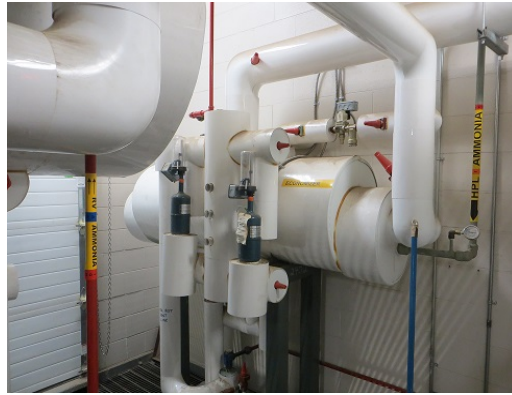
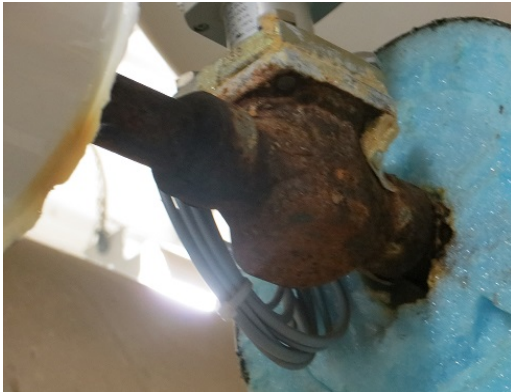
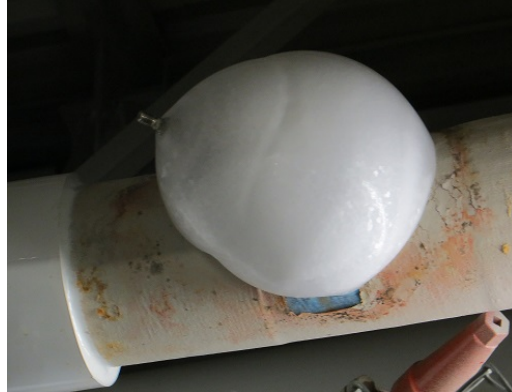
2nd Floor Mechanical Room Ammonia System

We have inspected the ammonia system piping in the 2nd floor mechanical room and found that the work and the condition of materials is excellent. We found a few minor areas where materials had been removed and the ice that has formed in those areas is the evidence that the vapor barrier was compromised. We observed a few areas where there was what appeared to be black mold formed on the canvas jacketing this is probably because of a failure of the vapor barrier.

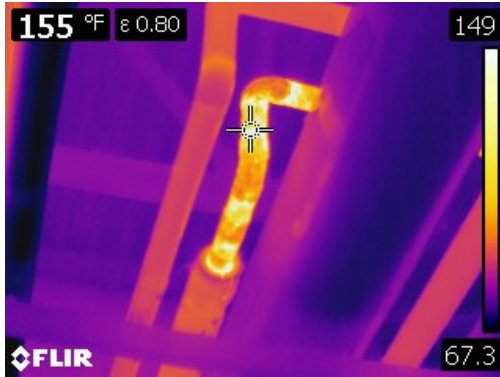
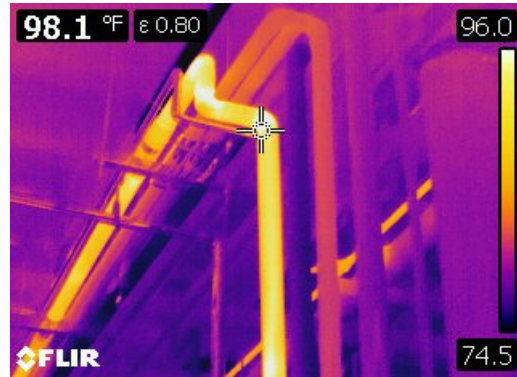
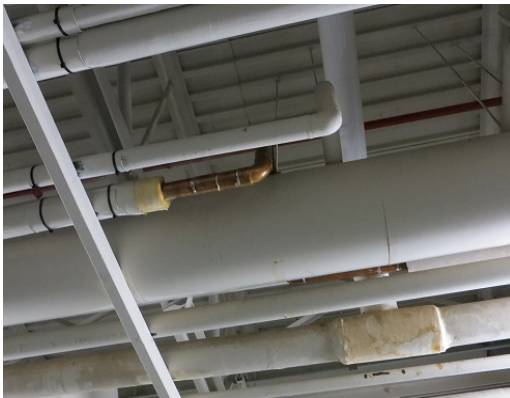
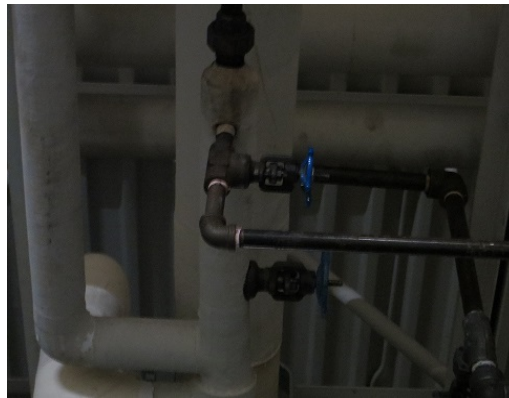
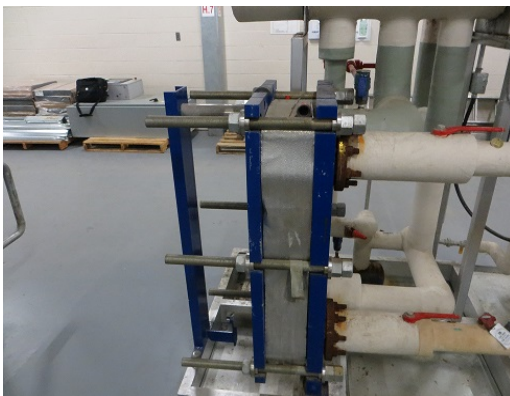
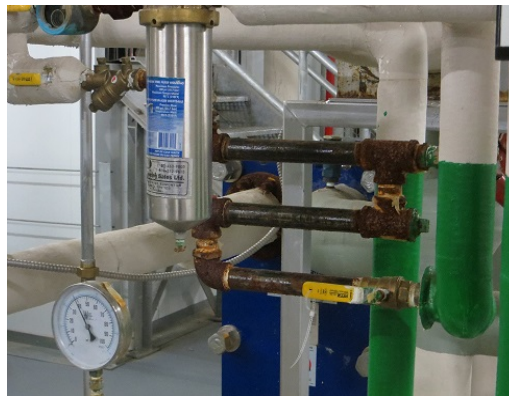
2nd Floor Mechanical Space

The insulation materials applied to the piping in the mechanical space adjacent to the 2nd floor mechanical room were found to be in good condition with some amounts of material missing due to maintenance of systems supplying the lower process floor.

We took pictures of the overhead runs of pipe which were insulated and found one particular pipe which had a higher than desired surface temperature. We have included thermal photos to show the 98.1 surface temperature of the pipe. There is also a heat exchanger that should be insulated as well.

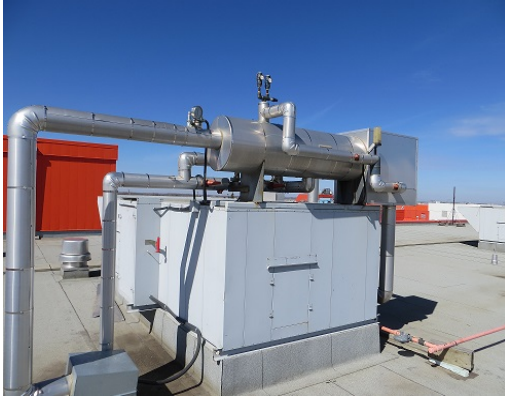
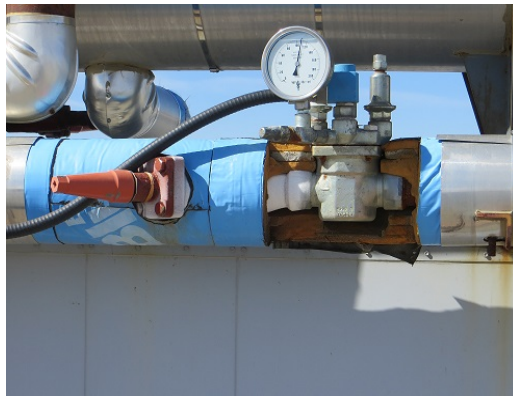
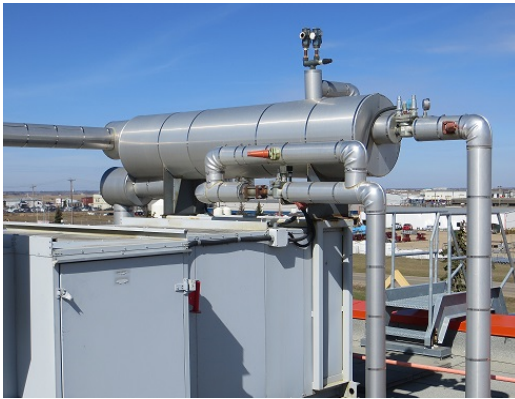
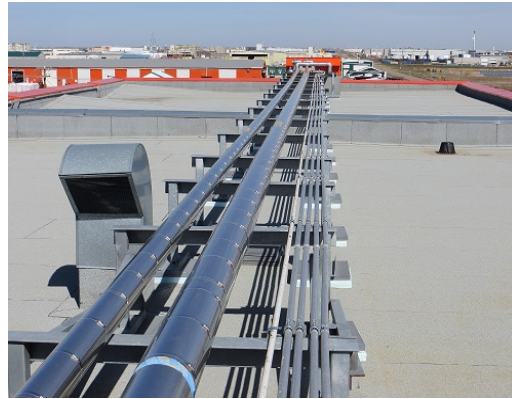
Roof Top Units

We have inspected the piping on the roof of the production facility and found all but one area where the piping and cladding in great overall condition.

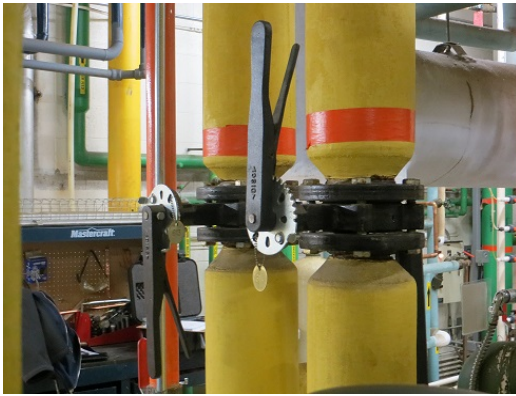
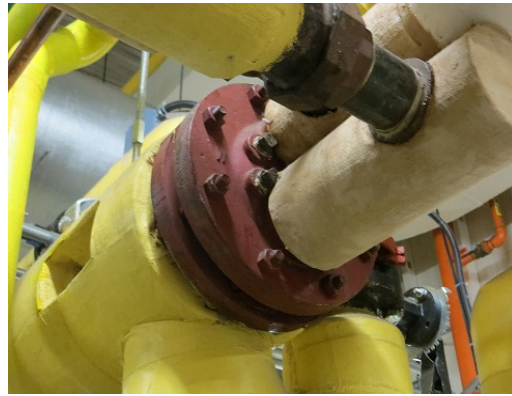
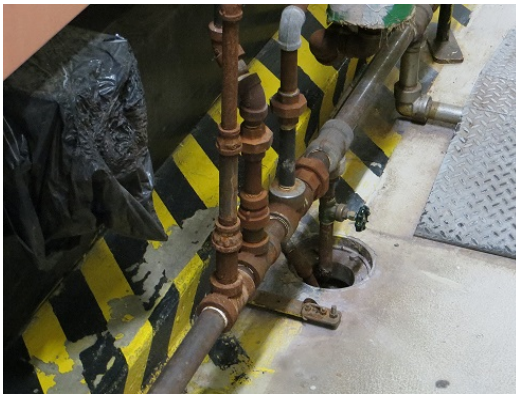
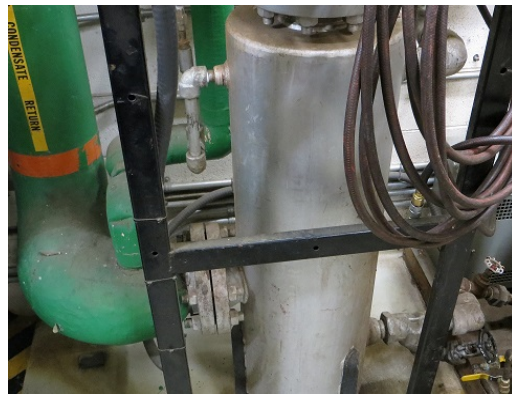
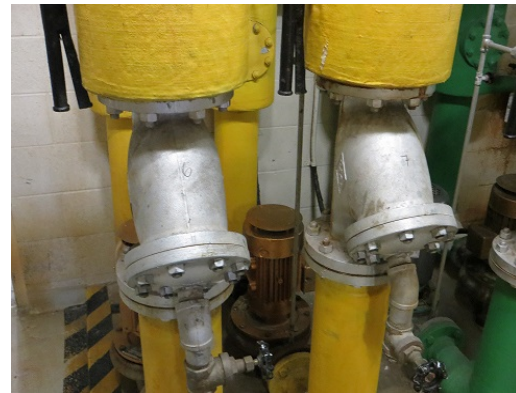
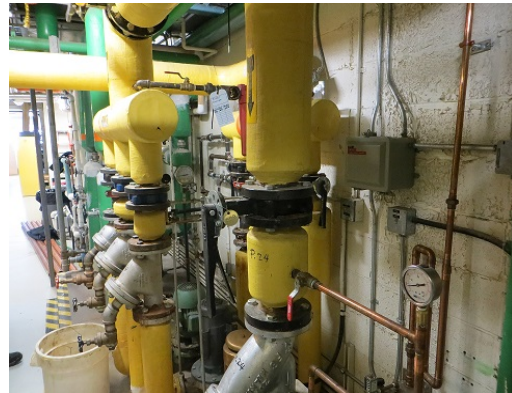
Personnel Protection

We also would like to address the hazards that the hot exposed items present to personnel. The boiler rooms and fan rooms generally are tightly packed with equipment and piping systems operating up to 121°C, the systems and equipment which are not insulated leave many opportunities for employees and maintenance personnel to come in contact with these surfaces which can burn skin. Properly insulated systems and equipment eliminate the possibility of individuals coming into contact with these hot surfaces and will prevent accidental burns which will add value by individuals not having claims and or lost time incidents.
