SALAMANDER INSPECTIONS LTD

Mechanical Insulation Energy Audits

Energy Audit

Eagle Park

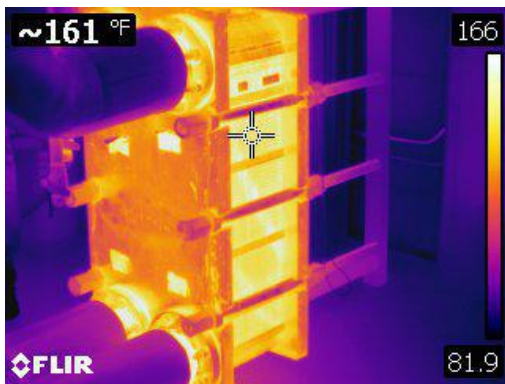
Figure 1 This is an infrared photo of the heat exchanger showing the areas with where large temperature differences create high rates of heat transfer.

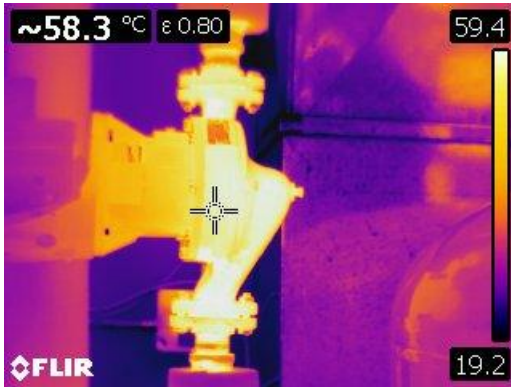
Figure 3 This thermographic image of an exposed motorized heating pump at 58° C or 136° F.

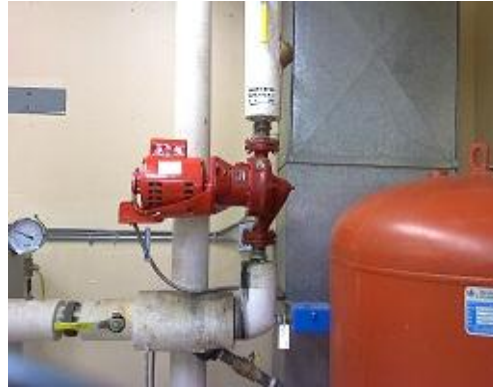
Figure 4 This is a conventional photo of the same pump. There is also an exposed strainer and union.

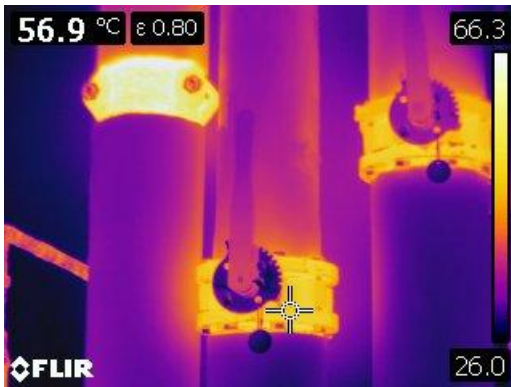
Figure 5 This Thermographic image of HWR supply and return with exposed valves and Victaulic fittings.

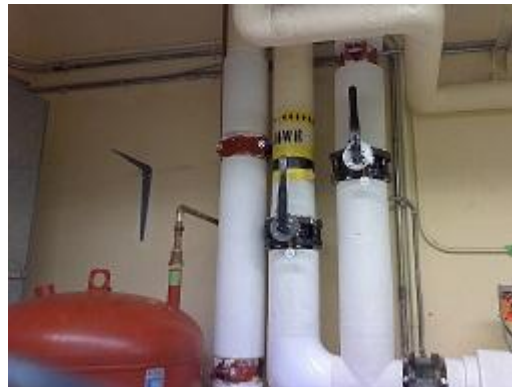
Figure 6 This conventional photo shows the same valves and exposed Victaulic fittings. This work has been recently done and these valves and fittings should have been insulated.

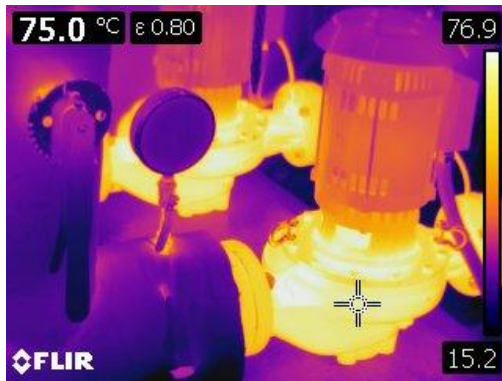
Figure 7 This is a thermographic image of two motorized heating pumps at 75° C or 167° F.

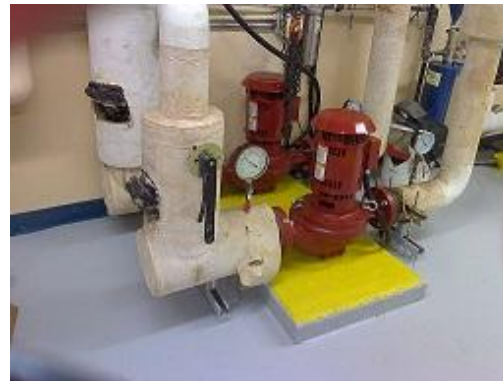
Figure 8 This is a conventional photo of the two heating pumps. These pumps could have removable pads made and installed. The pads are re-useable for maintenance purposes.

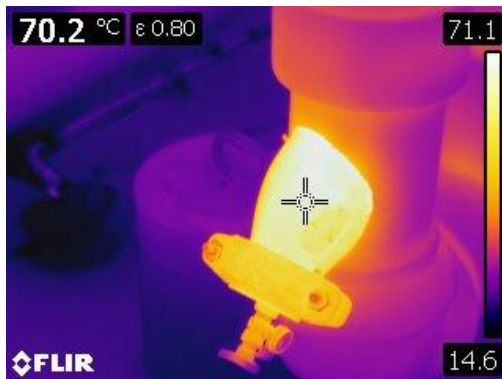
Figure 9 This is a thermographic image of a Victaulic strainer/drain at 70.2° C or 158°F. There is a risk to personnel where temperatures exceed 65 ° C.

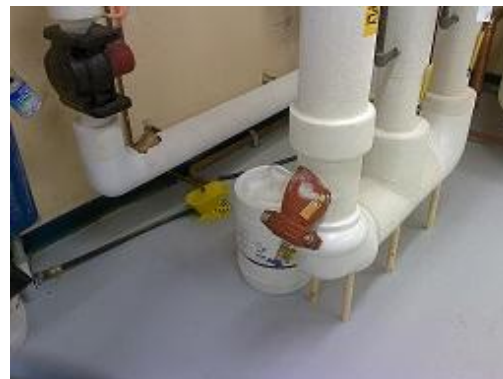
Figure 10 This is the conventional image of the same bare strainer/drain in the boiler room. Of note is the motorized pump with the Styrofoam packing around it acting as insulation. Maintenance personnel recognize the importance of the pump being insulated.

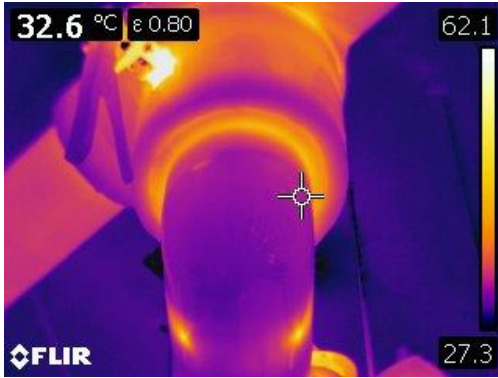
Figure 11 Thermographic image of recently done work showing inadequate insulation at the elbow and hot spots in various areas.

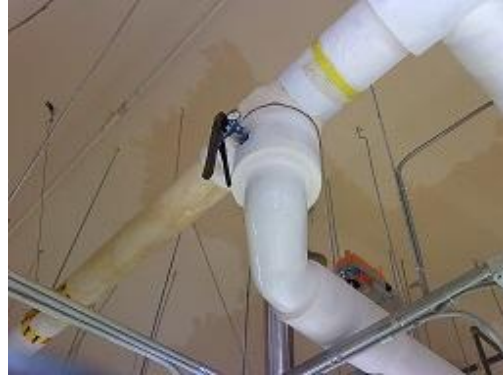
Figure12 This is a conventional image of the same valve and elbow. The thermal image shows the lack of insulation in some areas which is invisible to the naked eye.

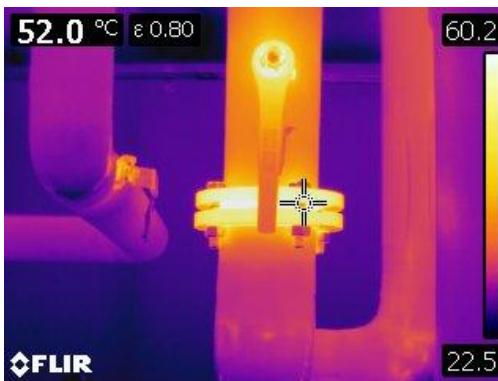
Figure 13 This thermographic image is of bare flange to hot water tanks.

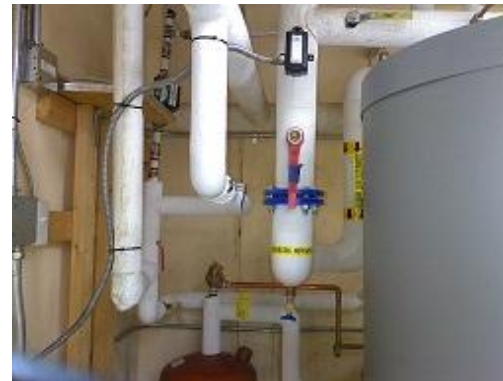
Figure 14 conventional image of the same flange.

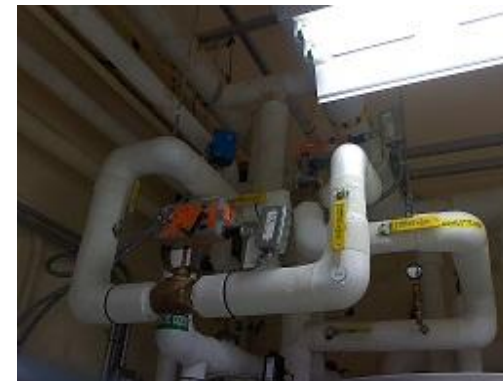
Figure 16 Conventional image of the same motorized valve.

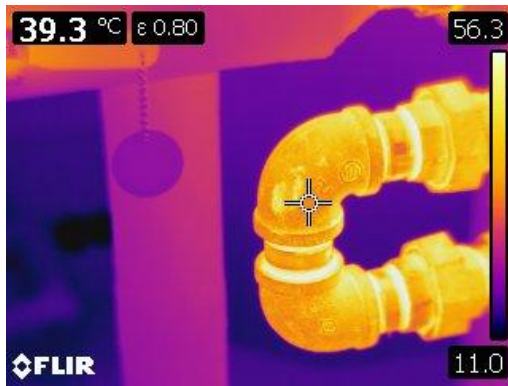
Figure 17 Thermographic image of a by-pass on the back of the boiler.

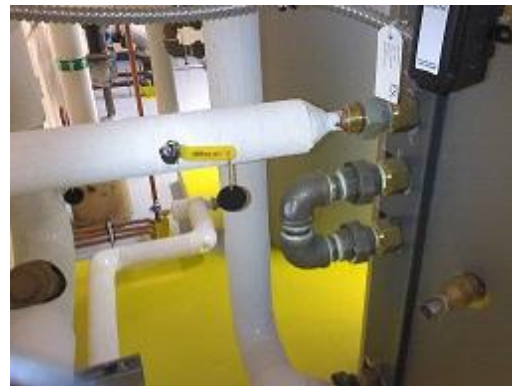
Figure 18 Conventional image of the same by-pass. Note the other bare piping/unions and strainer protruding through the insulation. Each object is a source of heat loss.

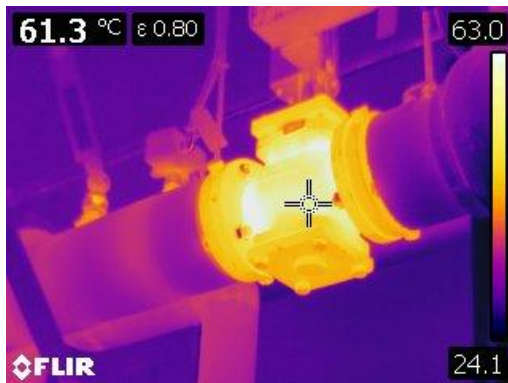
Figure 19 Thermographic image of motorized valve at 61° C or 141° F.

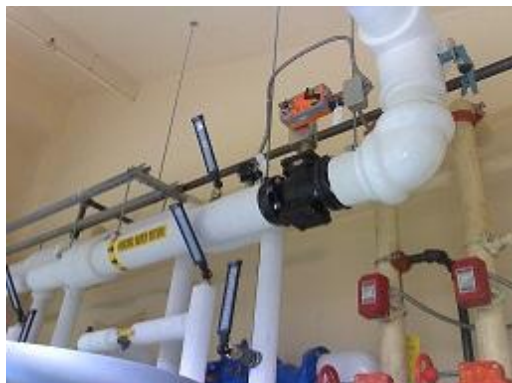
Figure 20 Conventional picture of the same motorized valve.

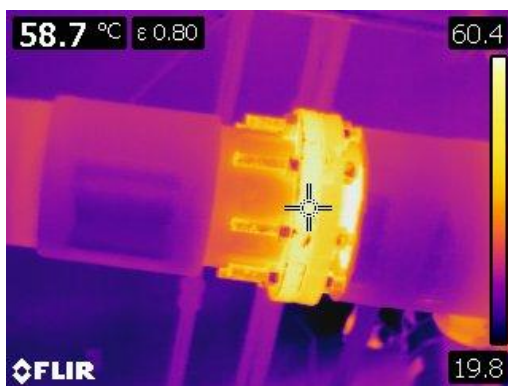
Figure 21 Thermographic image of a bare flange tying into existing systems.

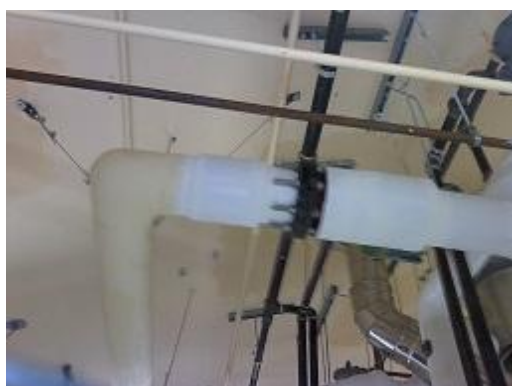
Figure 22 Conventional image of the same flange.

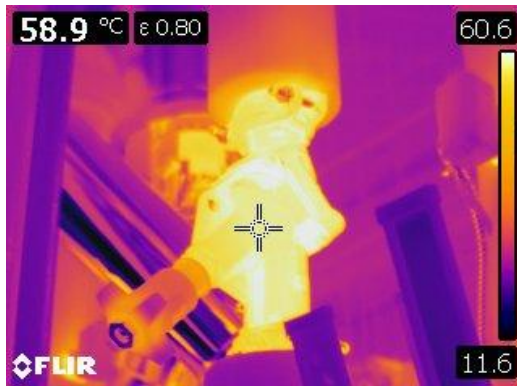
Figure 23 Thermographic image of control valves at the back of the boilers.

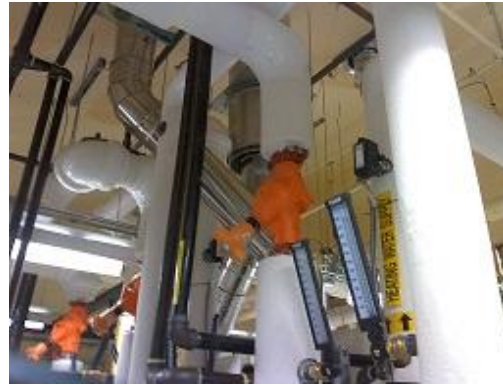
Figure 24 conventional image of the same control valves.

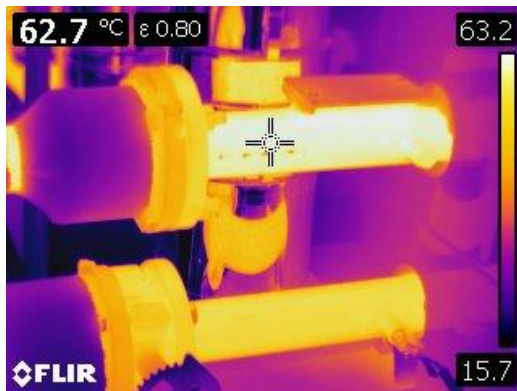
Figure 25 Thermographic image of the supply and return lines at the back of the boiler.

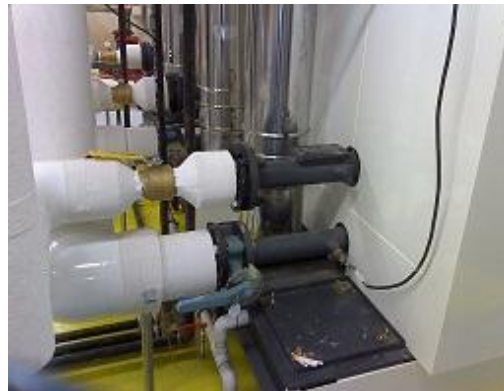
Figure 26 Conventional image of the same lines.

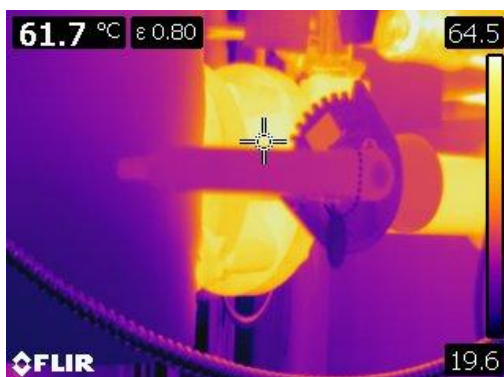
Figure 27 Thermographic image of a gate valve and piping at back of the boiler.

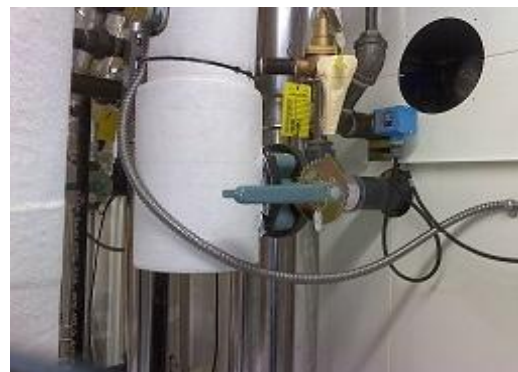
Figure 28 Conventional image of the same gate valve and piping.

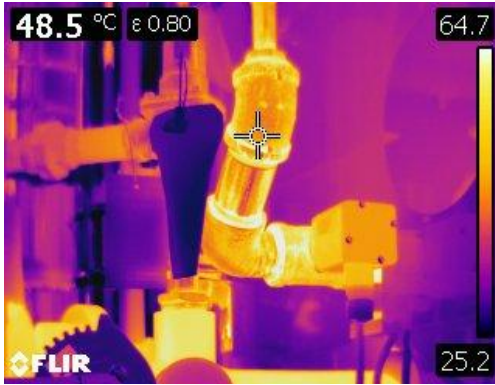
Figure 29 Thermographic image of piping at back of boiler.

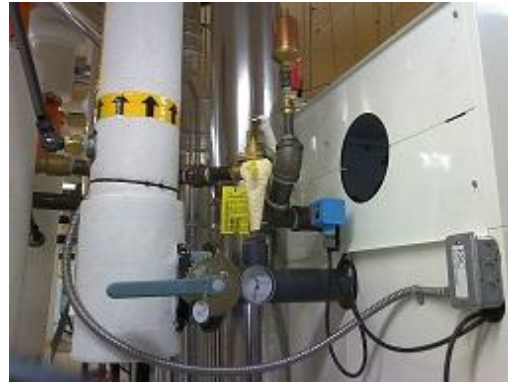
Figure 30 Conventional image of the same pipe.

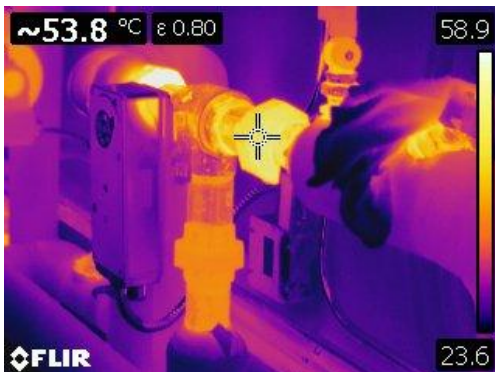
Figure 31 Thermographic image of bare motorized Tee at AHU -1.

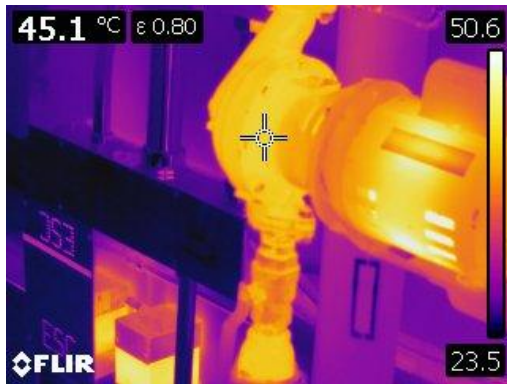
Figure 33 Thermographic image of bare motorized heating pump P-1.

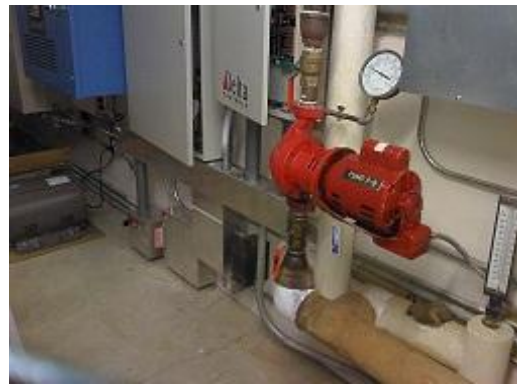
Figure 34 Conventional image of the same motorized heating pump.

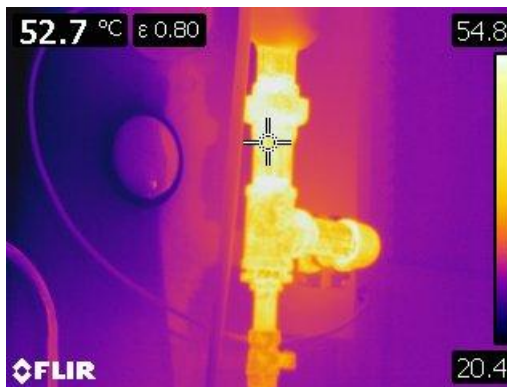
Figure 35 Thermographic image of bare heating supply to coils.

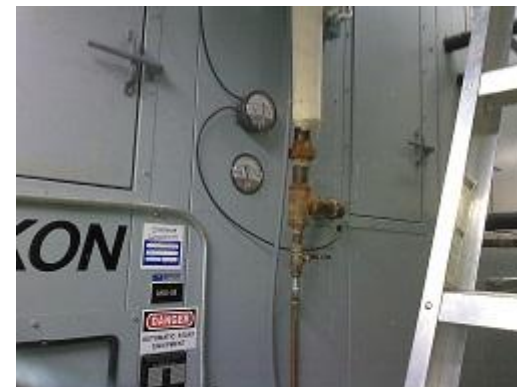
Figure 36 Conventional image of bare small bore heating supply to coils.

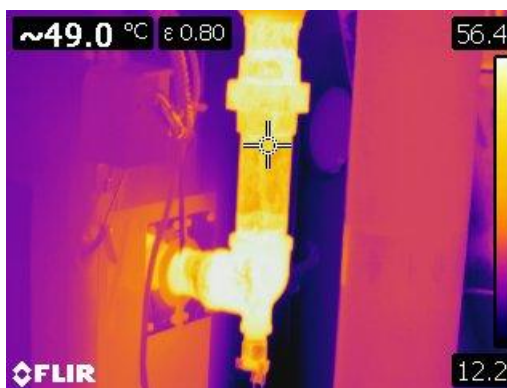
Figure 37 Thermographic image of bare heating supply to coils.

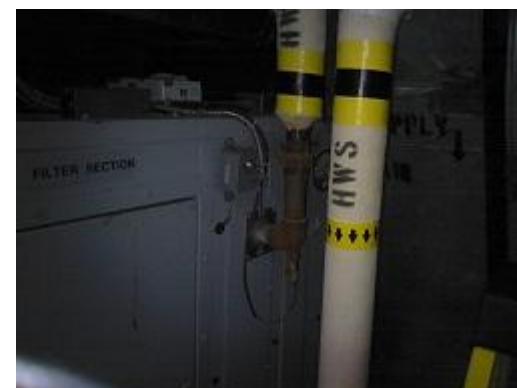
Figure 38 Conventional image of bare small bore heating supply and return to coils.

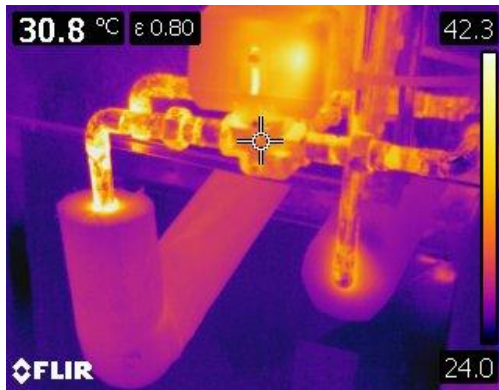
Figure 39 Thermographic image of bare copper heating supply to coils.

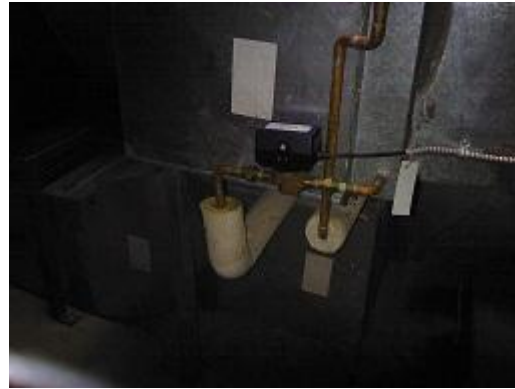
Figure 40 Conventional image of bare small bore heating supply and return to coils.

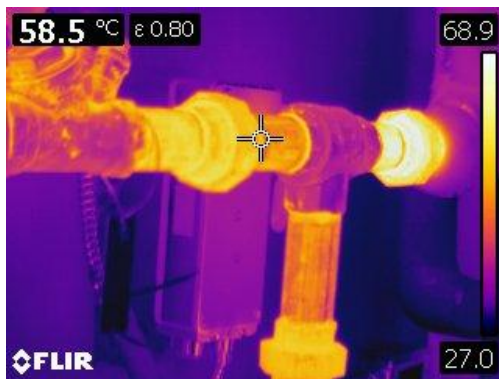
Figure 41 Thermographic image of bare three way small bore supply and return.

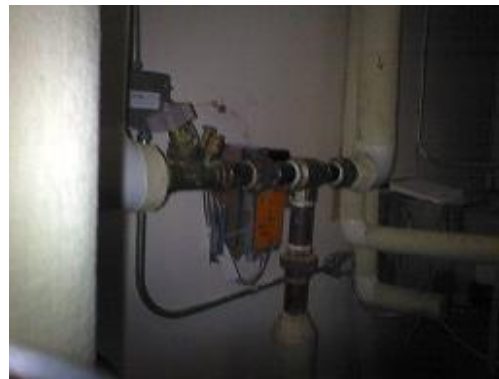
Figure 42 Conventional image of the same small bore supply and return lines.

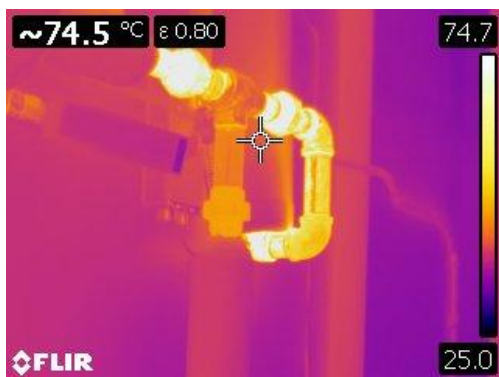
Figure 43 Thermographic image of bare three way small bore supply and return.

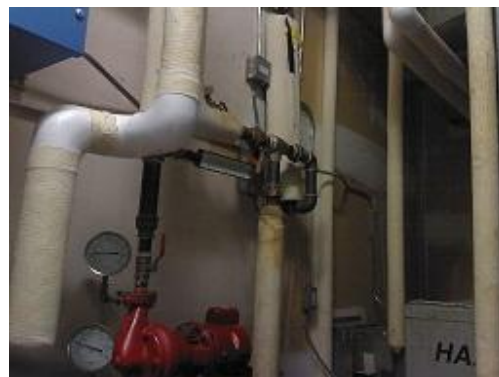
Figure 44 Conventional image of the same small bore supply and return lines.

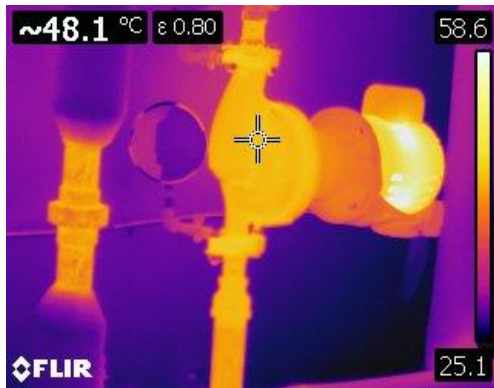
Figure 45 Thermographic image of bare small bore supply and return and motorized pump.

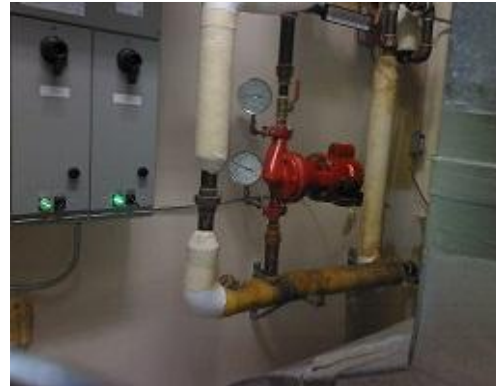
Figure 46 Conventional image of the same small bore supply and return lines and motorized pump.
