SALAMANDER INSPECTIONS LTD

Mechanical Insulation Energy Audits

Energy Audit

Nanaimo Regional Hospital

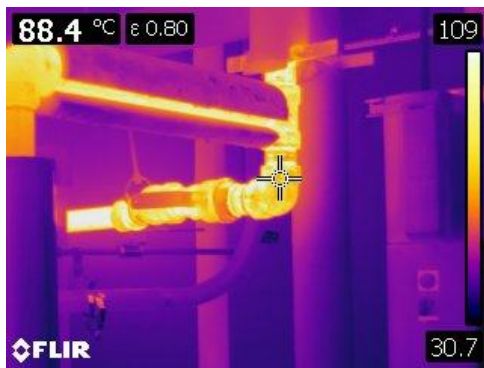
Figure 7 This is a thermographic image of a bare piping and valve at 88.4° C or 191° F.

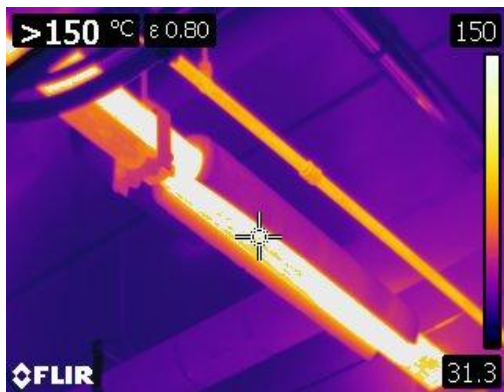
Figure 19 Thermographic image of the bare steam line at 150° C or 302° F

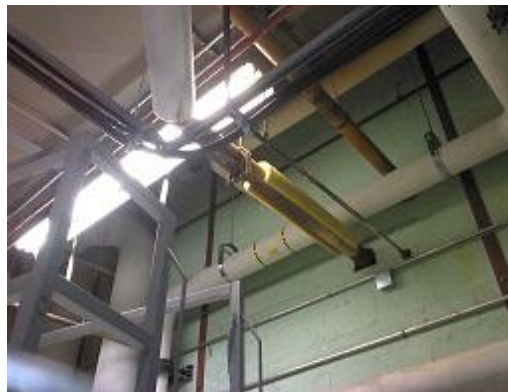
Figure 20 Conventional image of the same steam line.

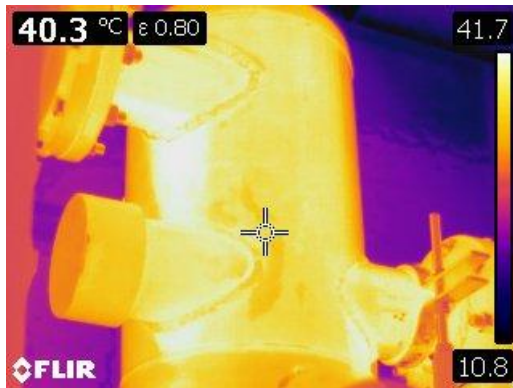
Figure 25 Thermographic image of a receiver tank above heat exchanger at 40.3° C or 106° F.

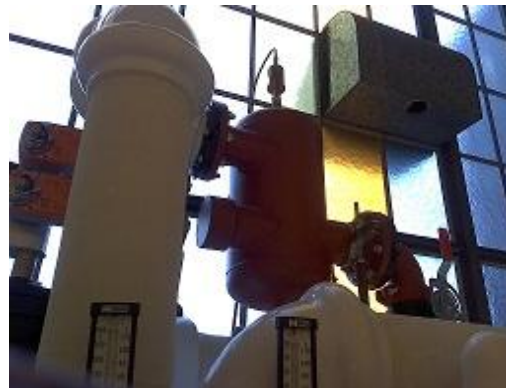
Figure 26 conventional image of the same tank and flanges above heat exchanger.

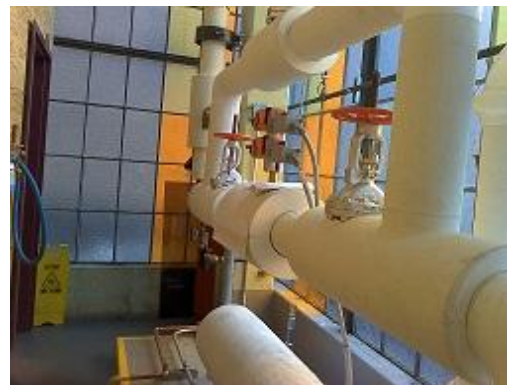
Figure 28 Conventional image of the same valves and piping.

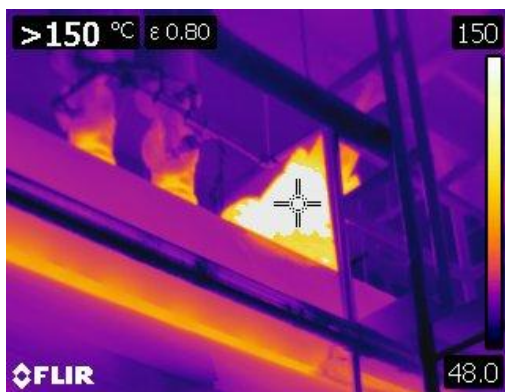
Figure 31 Thermographic image of valves at top of boilers at 150° C or 302° F.

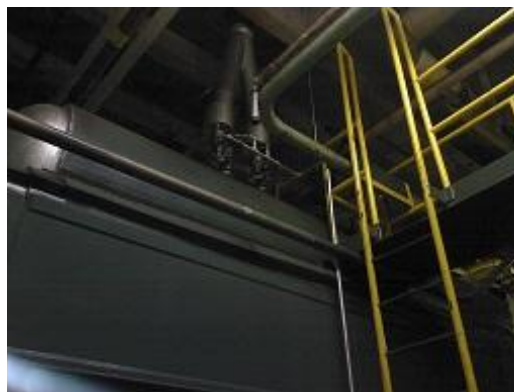
Figure 32 Conventional image of the same valves.

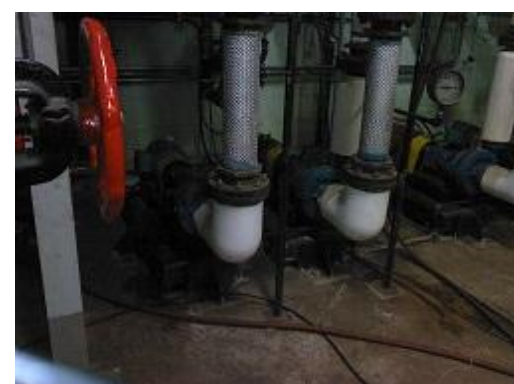
Figure 36 Conventional image of the same pumps and flanges.

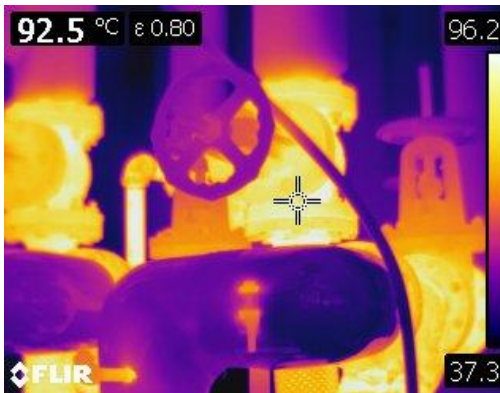
Figure 39 Thermographic image of bare valves and flanges at 92.5° C or 198° F.

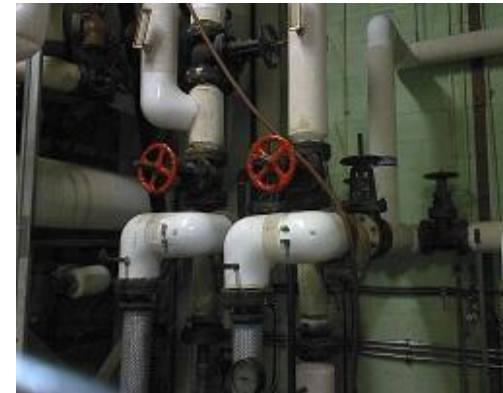
Figure 40 Conventional image of the same valves and flanges.

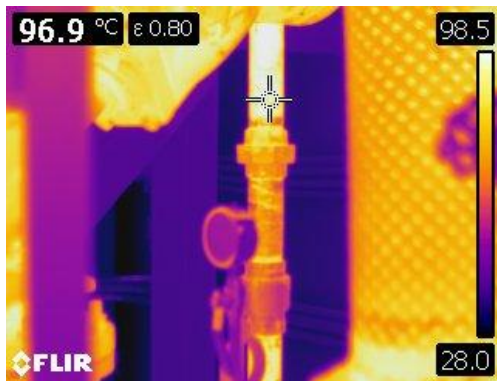
Figure 45 Thermographic image of bare stainless flex hoses from pumps at 96.9° C or 206° F.

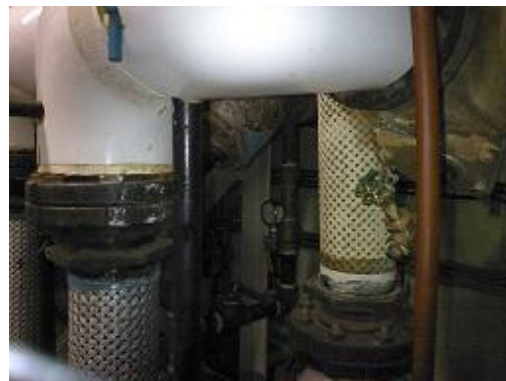
Figure 46 Conventional image of the same stainless hoses and associated piping.

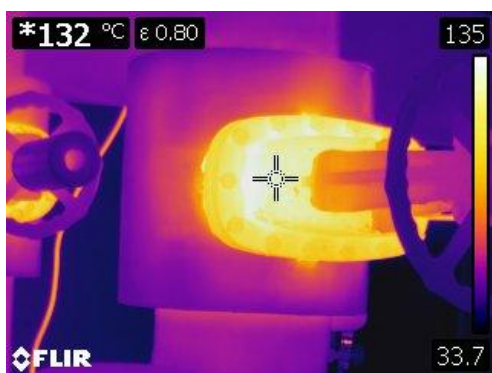
Figure 47 Thermographic image of bare vane bonnets at 132° C or 269° F.

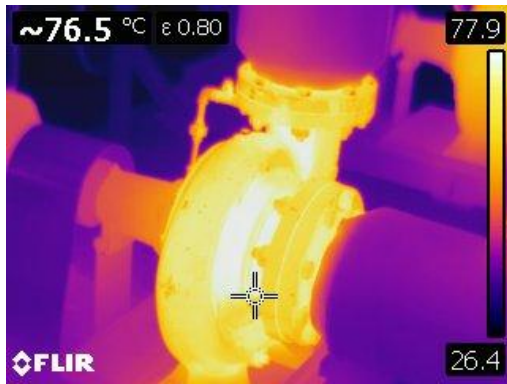
Figure 59 Thermographic image of bare heating supply pump at 76.5° C or 169° F

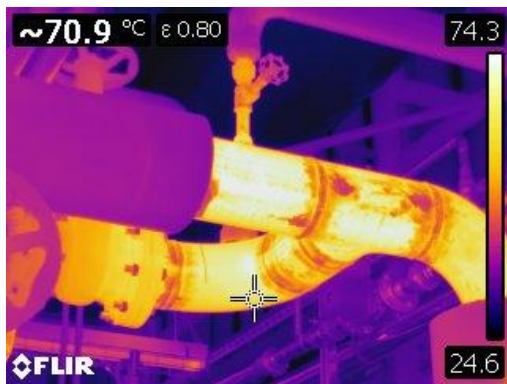
Figure 61 Thermographic image of bare 6 inch heating supply pipe at 70.9° C or 159° F

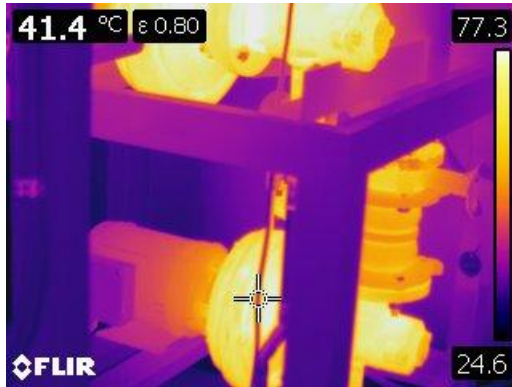
Figure 65 Thermographic image of bare motorized heating pump and piping at 41° C or 105° F

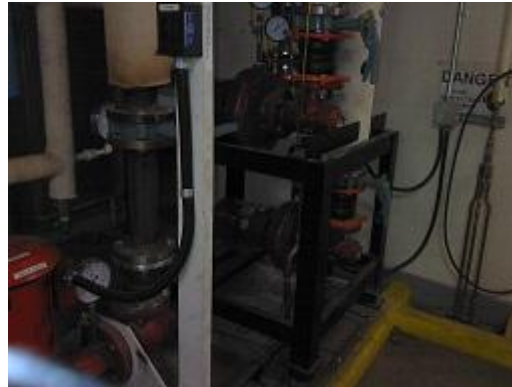
Figure 66 Conventional image of the same motorized pumps and piping.

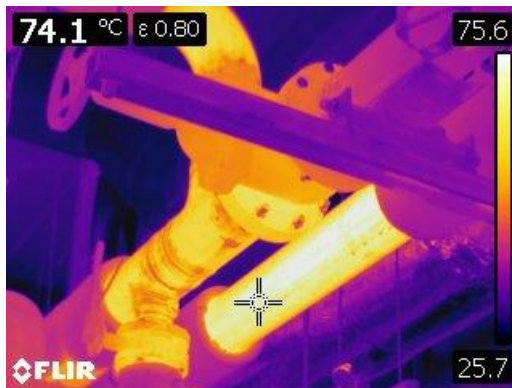
Figure 67 Thermographic image of bare pipe and flanges at 74° C or 165° F

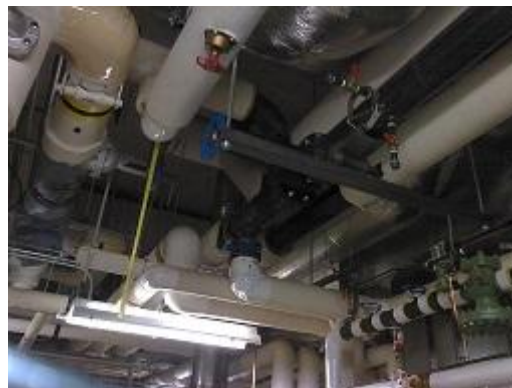
Figure 68 Conventional image of the same piping and flanges.

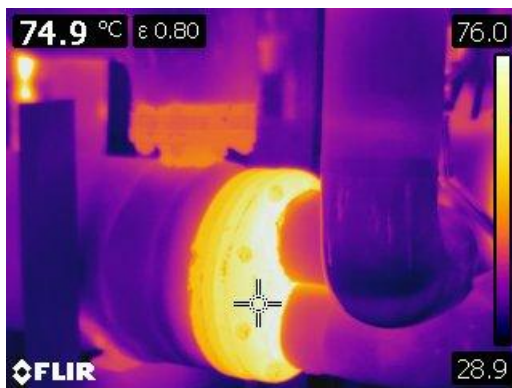
Figure 69 Thermographic image of a heat exchanger at 74.9° C or 165° F

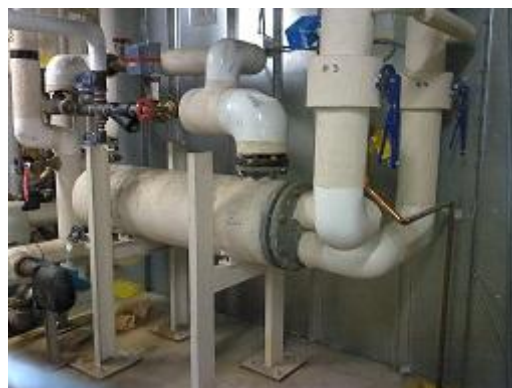
Figure 70 Conventional image of the same heat exchanger head.

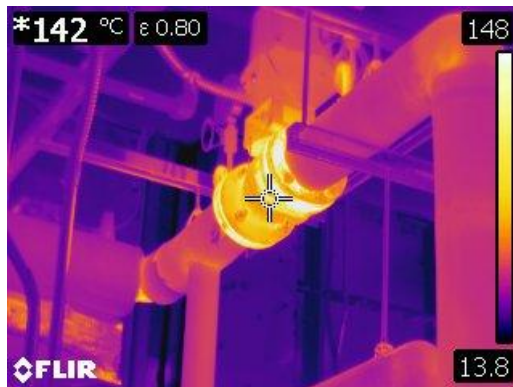
Figure 73 Thermographic image of a motorized valve at 142° C or 287° F

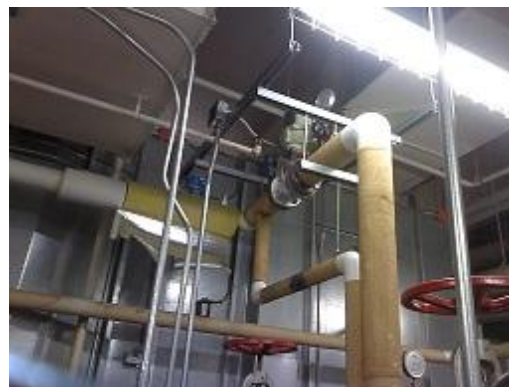
Figure 74 Conventional image of the same motorized valve.

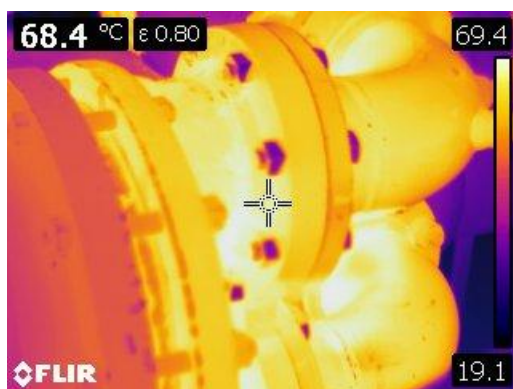
Figure 75 Thermographic image of a heat exchanger at 68.4° C or 155° F

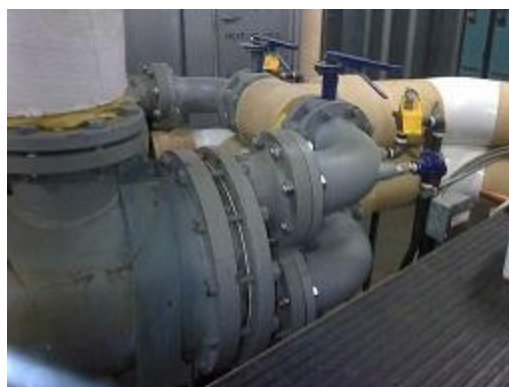
Figure 76 Conventional image of the same heat exchanger.

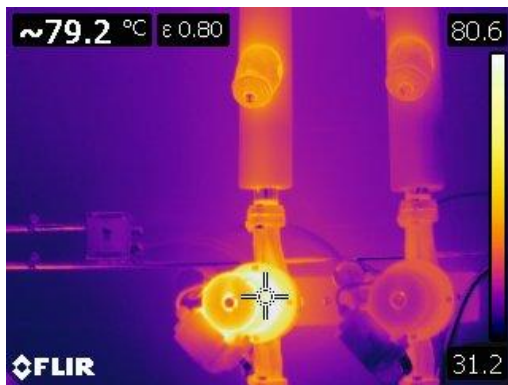
Figure 83 Thermographic image of 2 motorized pumps at hot water tanks at 79.6° C or 175° F

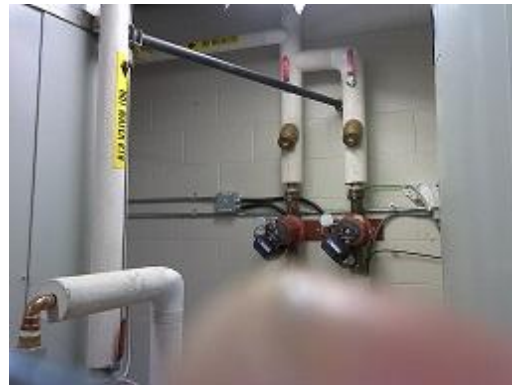
Figure 84 Conventional image of the same bare pumps.

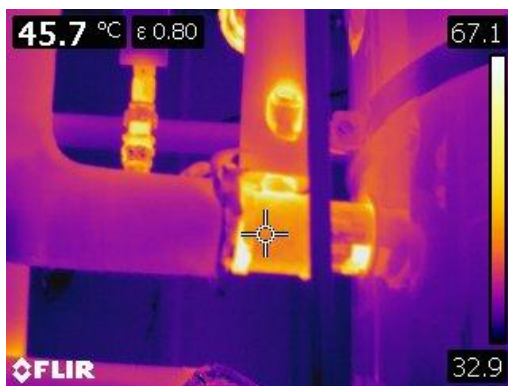
Figure 85 Thermographic image of missing insulation at hot water tanks at 45.7° C or 114° F

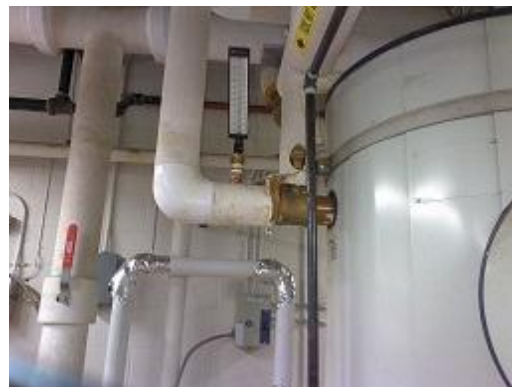
Figure 86 Conventional image of the same missing insulation.

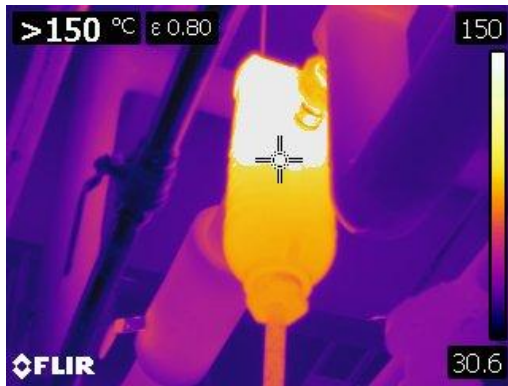
Figure 87 Thermographic image of missing insulation on steam condensate line at 150° C or 302° F

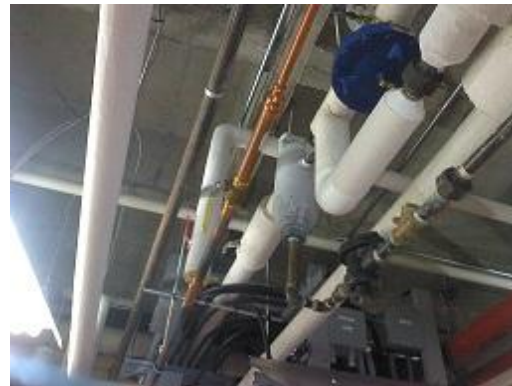
Figure 88 Conventional image of the steam condensate line.

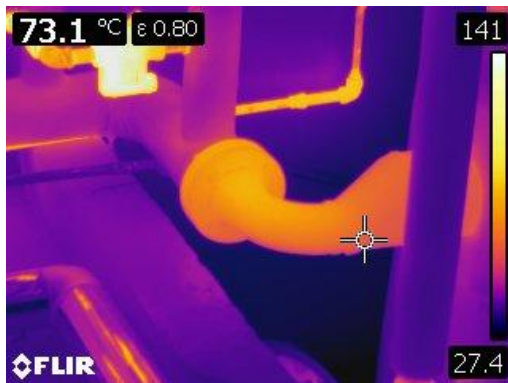
Figure 89 Thermographic image of missing insulation on steam condensate line at 73.1° C or 163° F

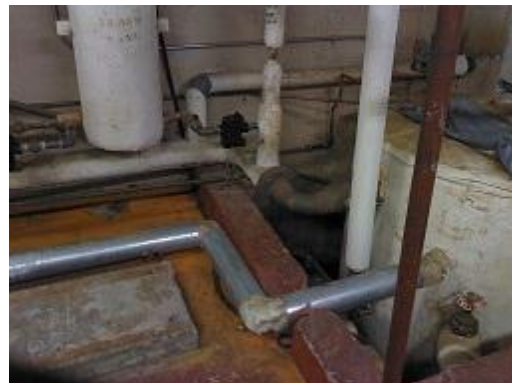
Figure 90 Conventional image of the steam condensate line.

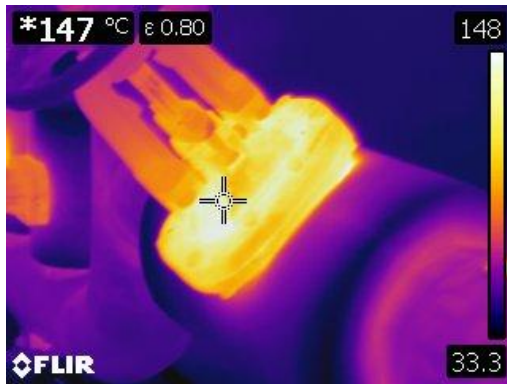
Figure 93 Thermographic image of bare valve bonnet on steam line at 147° C or 296° F

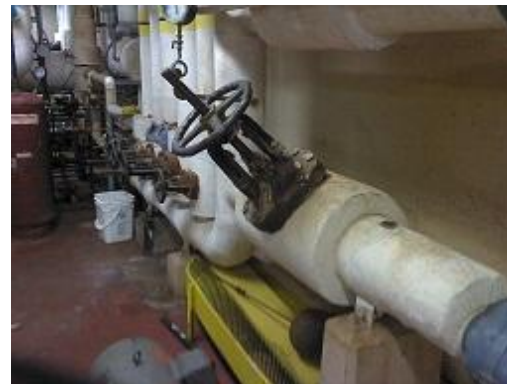
Figure 94 Conventional image of six (6) valve bonnets.

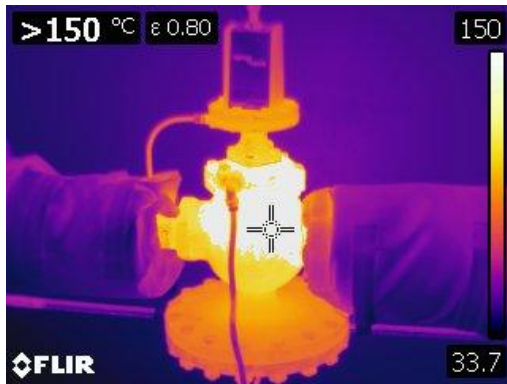
Figure 105 Thermographic image of pressure reducing valve at 150° C or 302° F

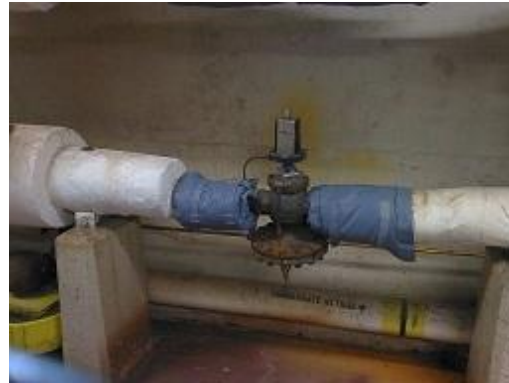
Figure 106 Conventional image of the same valve.

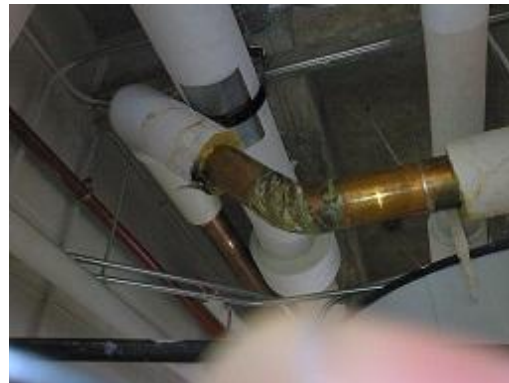
Figure 108 Conventional image of the same copper pipe.

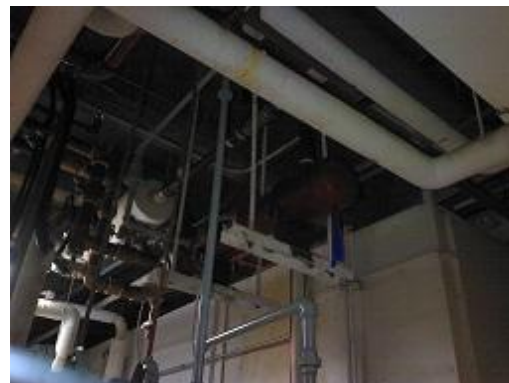
Figure 110 Conventional image of the same exchanger.

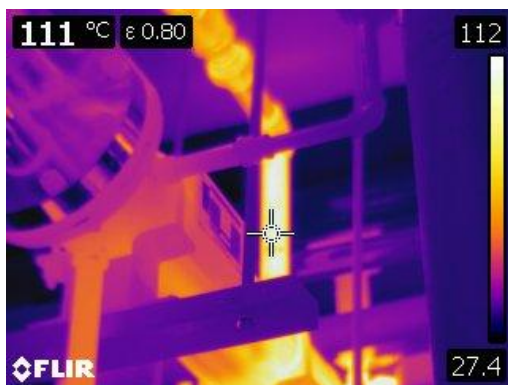
Figure 111 Thermographic image of a small heat exchanger at 111° C or 231° F

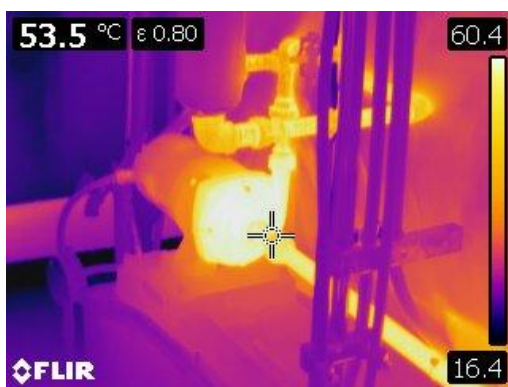
Figure 113 Thermographic image of a motorized pump and piping at 53.5° C or 128° F

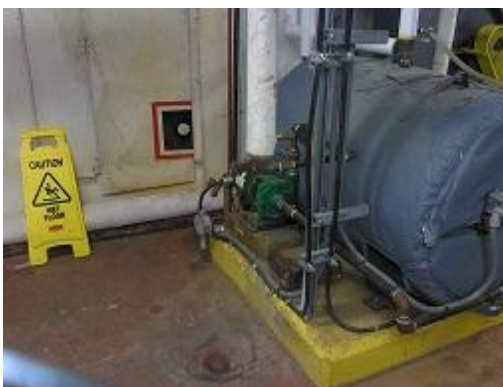
Figure 114 Conventional image of the same pump and piping.

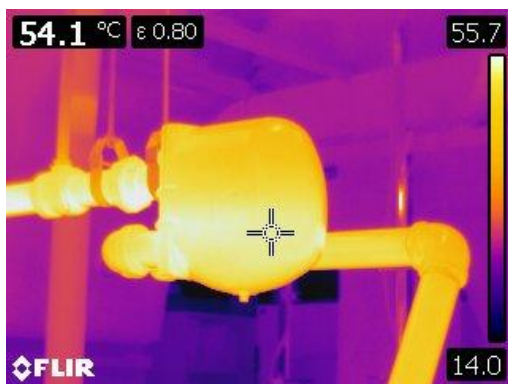
Figure 115 Thermographic image of a steam trap at 54° C or 129° F

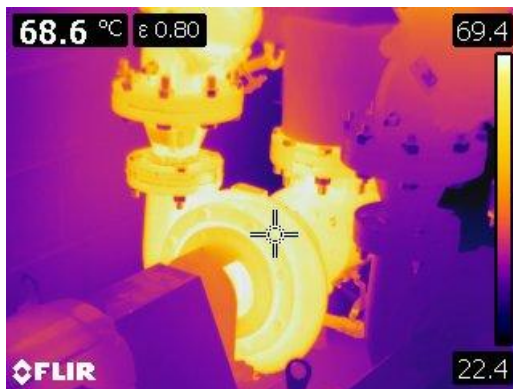
Figure 117 Thermographic image of heating pumps and valves at 68.6° C or 155° F

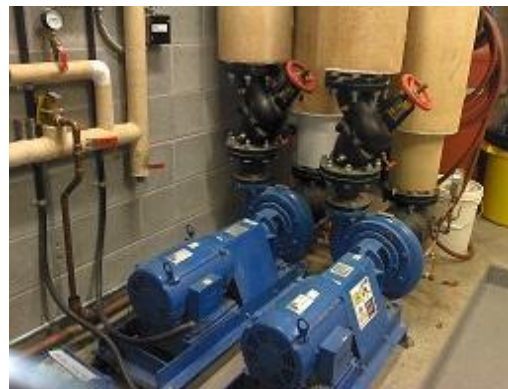
Figure 118 Conventional image of the same heating pumps and valves.

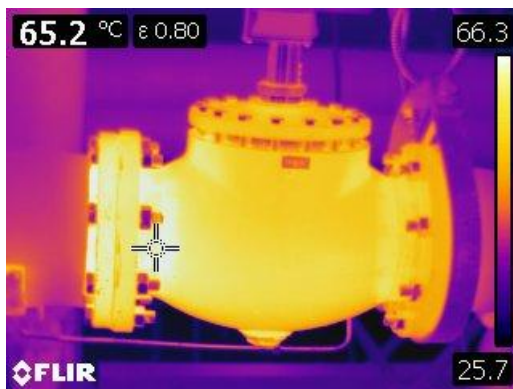
Figure 119 Thermographic image of a control valve at 65.2° C or 149° F

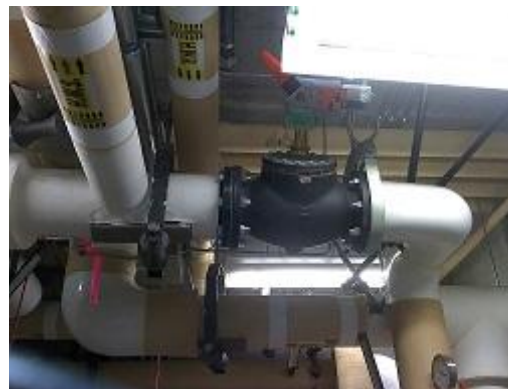
Figure 120 Conventional image of the same control valve.

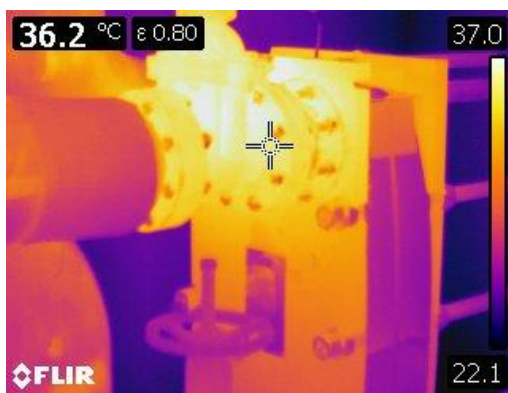
Figure 121 Thermographic image of a heat exchanger and valves at 36.2° C or 97° F

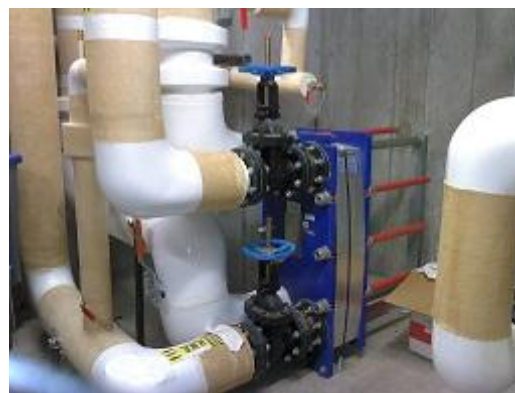
Figure 122 Conventional image of the same heat exchanger and valves.

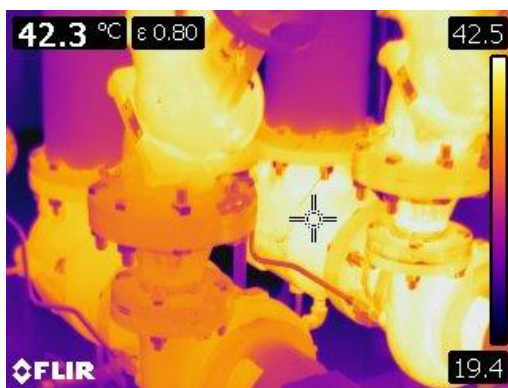
Figure 123 Thermographic image of motorized heating pumps and valves at 42.3° C or 108° F

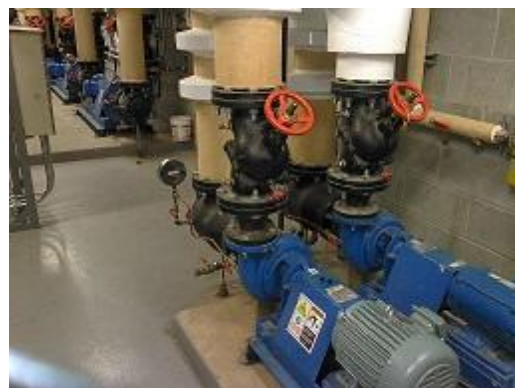
Figure 124 Conventional image of the same heating pumps and valves.

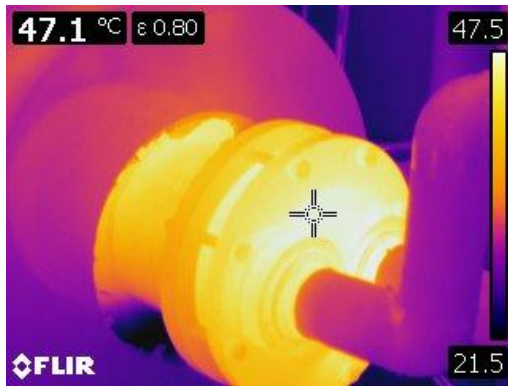
Figure 125 Thermographic image of a heat exchanger in hot water tanks at 47.1° C or 116° F

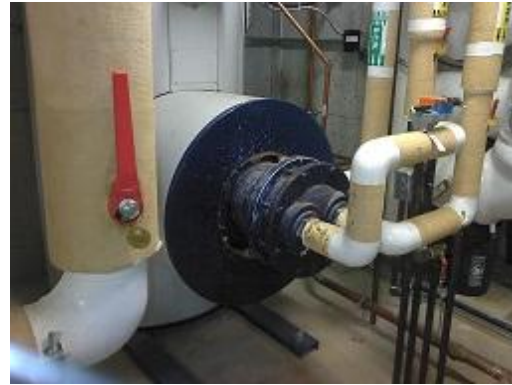
Figure 126 Conventional image of the same heat exchanger and hot water tank.

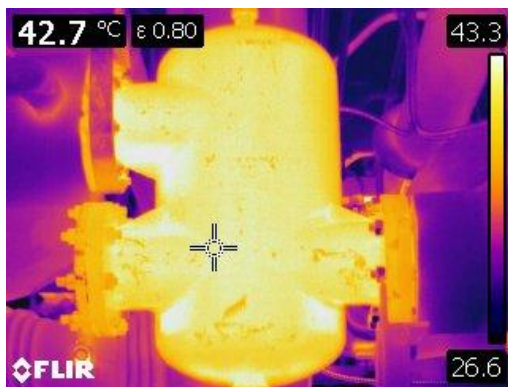
Figure 127 Thermographic image of an expansion tank at 42.7° C or 108° F

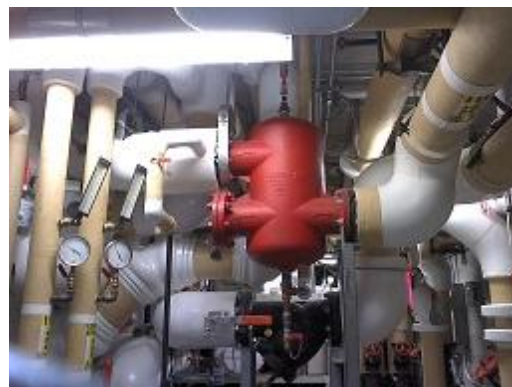
Figure 128 Conventional image of the same expansion tank.

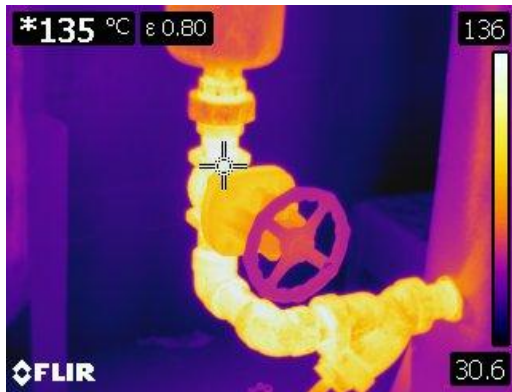
Figure 129 Thermographic image of an vertical heat exchanger piping at 135° C or 275° F

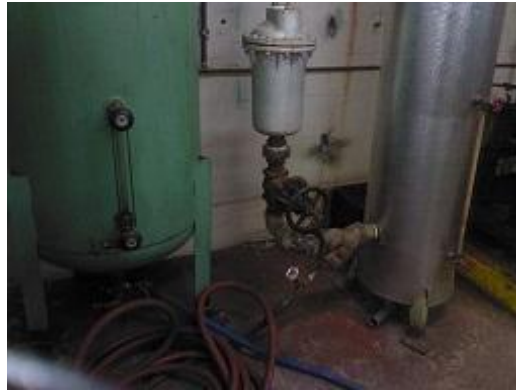
Figure 130 Conventional image of the same exchanger and exposed piping.

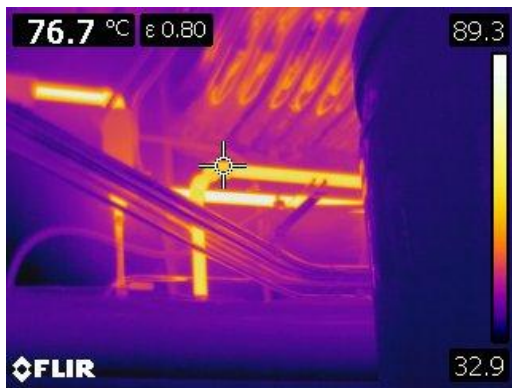
Figure 131 Thermographic image of exposed bare piping at 76.7° C or 170° F

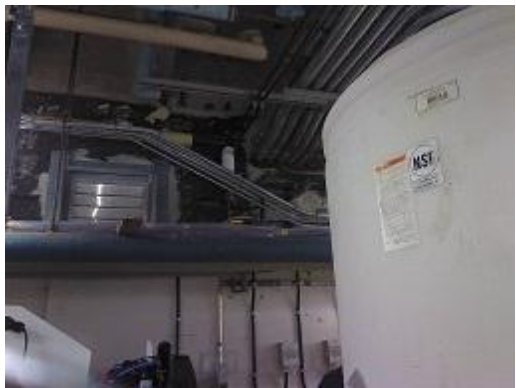
Figure 132 Conventional image of the same exposed piping.

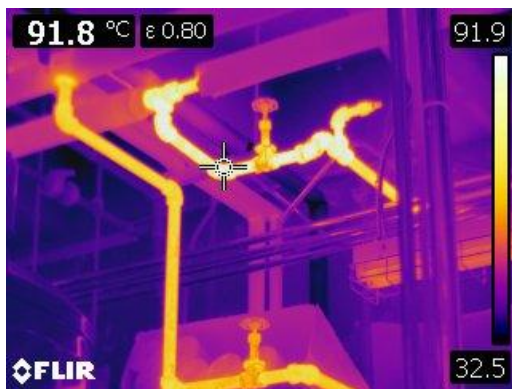
Figure 133 Thermographic image of exposed bare piping at 76.7° C or 170° F

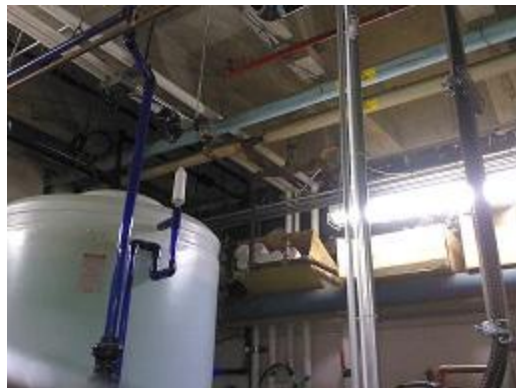
Figure 134 Conventional image of the same exposed piping.

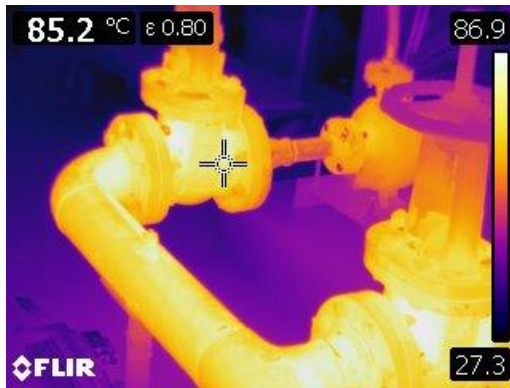
Figure 135 Thermographic image of exposed bare piping and valves at 85.2° C or 185° F

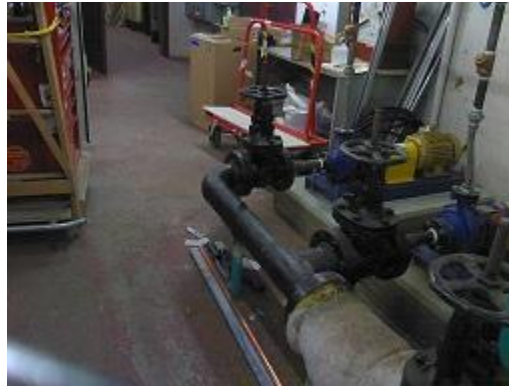
Figure 136 Conventional image of the same exposed piping and valves.

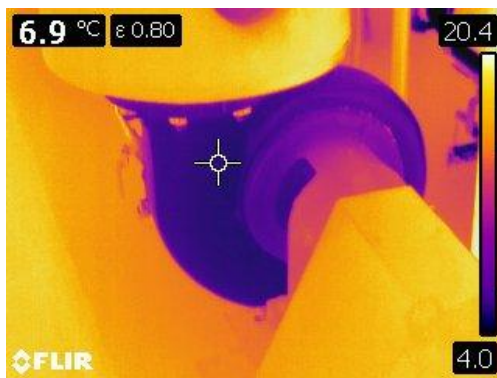
Figure 137 Thermographic image of bare pumps and filter housings which result in condensation and corrosion.

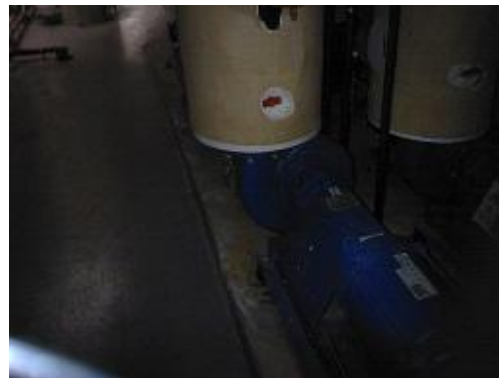
Figure 138 Conventional image of the same exposed pump housings.

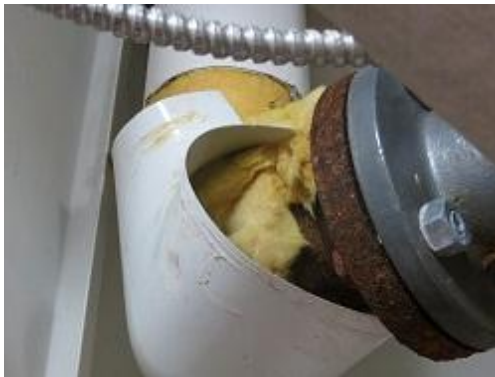
Figure 141 This image shows why an integral vapor barrier is necessary. Lack of a vapor barrier will lead to future corrosion issues.

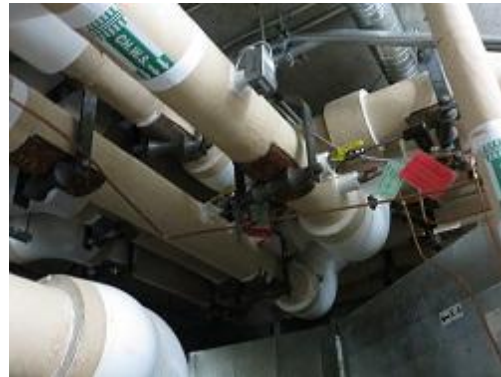
Figure 142 This image shows the wrong use of pipe supports on chilled systems where the vapor barrier is compromised.

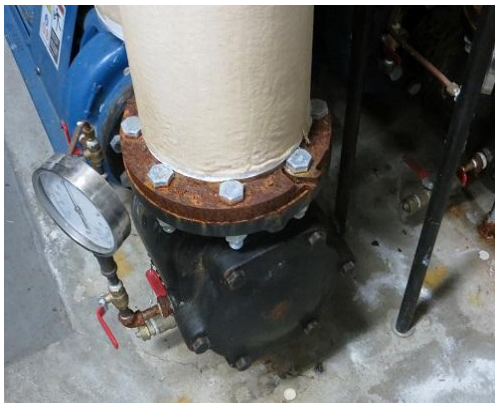
Figure 143 The flange pictured here shows rusting which will allow moisture into the insulation.

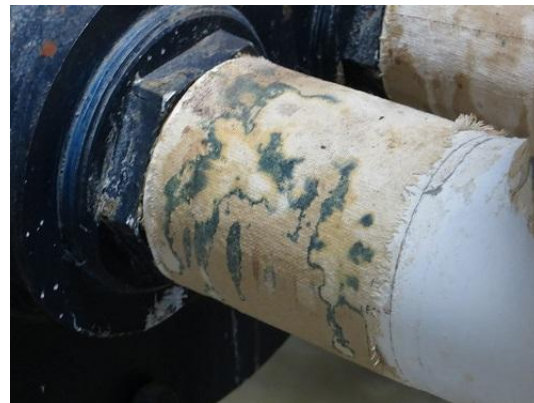
Figure 144 The result of moisture forming on the exposed steel allows for the formation of mold in the canvas. This happening in many areas where vapor barrier is incomplete.
