Mechanical Insulation Energy Audits

Energy Audit

Tofino General Hospital

261 Neill Street, Tofino

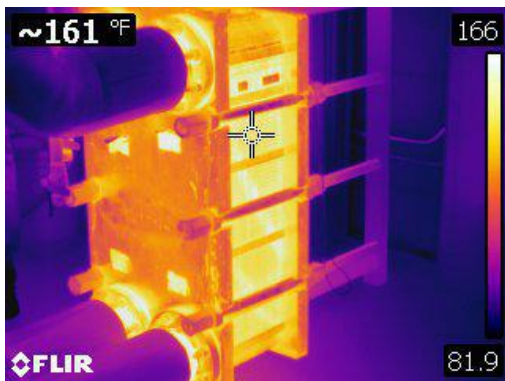
Figure 1 This is an infrared photo of the heat exchanger showing the areas with where large temperature differences create high rates of heat transfer.

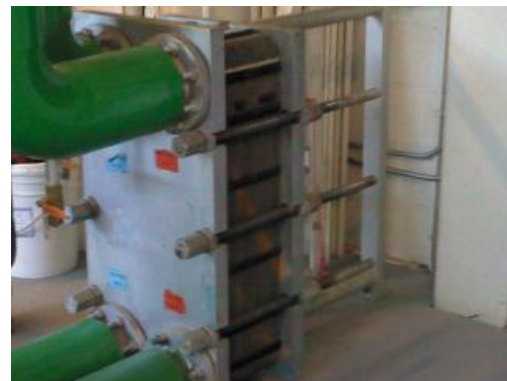
Figure 2 This photo shows the same plate heat exchanger.

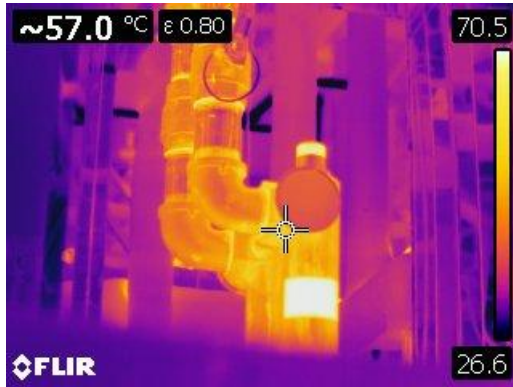
Figure 3 This thermographic image of copper piping within a stainless cabinet.

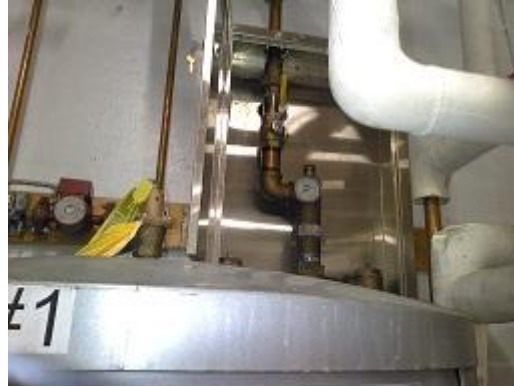
Figure 4 This is a conventional photo of the same piping.

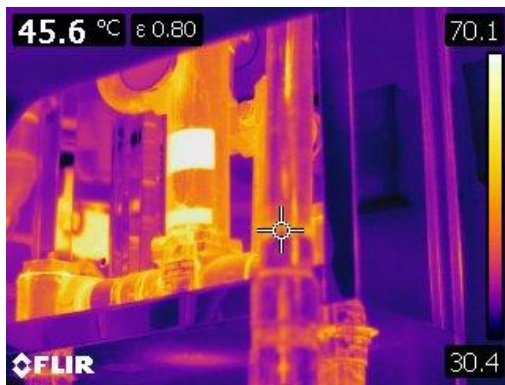
Figure 5 This Thermographic image of the copper piping within the cabinet and leaving the cabinet.

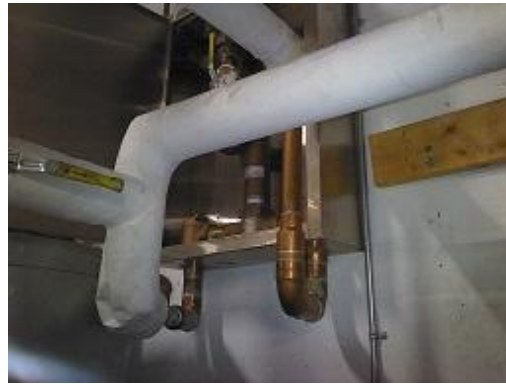
Figure 6 This conventional photo shows the same piping and also shows the deterioration of the mechanical insulation and fittings.

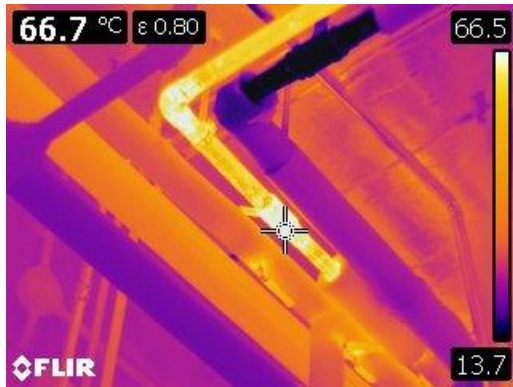
Figure 7 This is a thermographic image of a bare 1 1/4 pipe above the boilers.

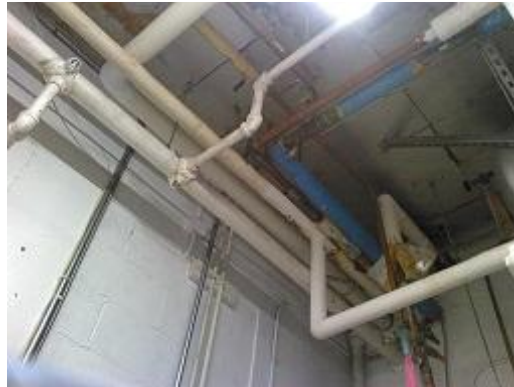
Figure 8 This is a conventional photo of the same piping.

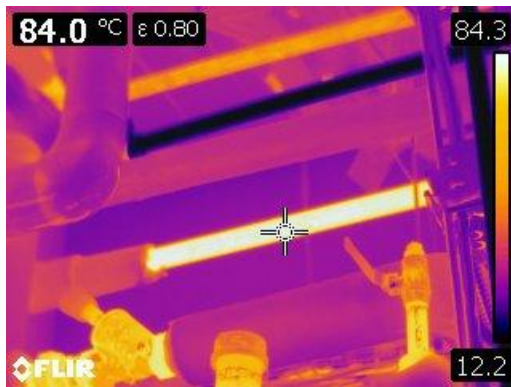
Figure 9 This is a thermographic image of a bare 2 inch line high above the boilers.

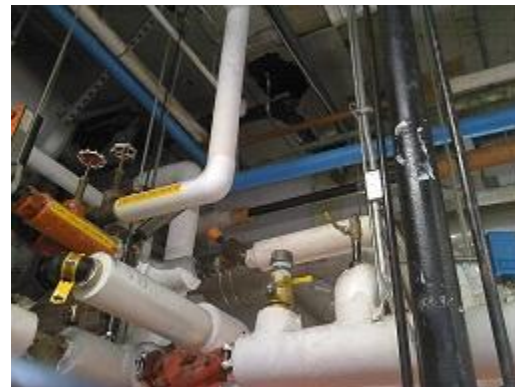
Figure 10 This is the conventional image of the same line. (just below the blue colored line)

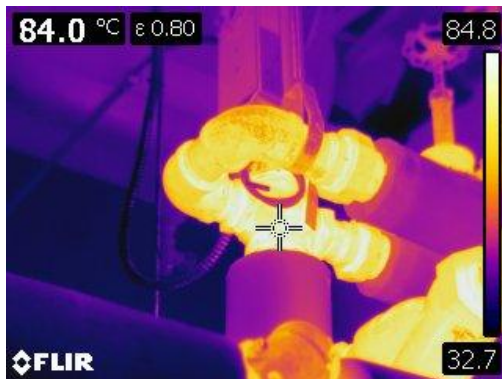
Figure 11 This thermographic image is of bare 1 1/4 iron pipe and associated fittings and valves.

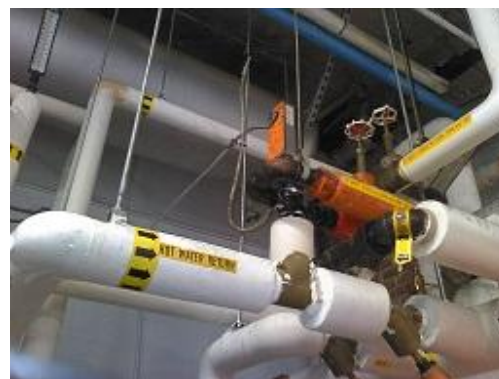
Figure 12 This is a conventional image of the same group of pipe, fittings and valves.

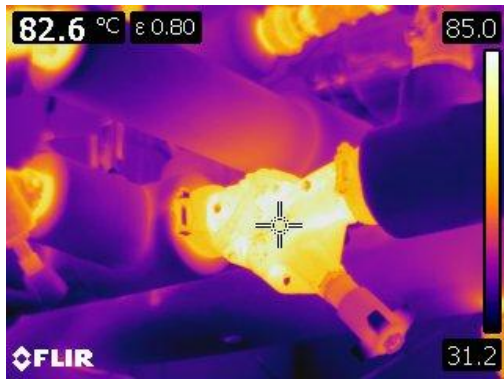
Figure 13 This thermographic image is of a bare control valve.

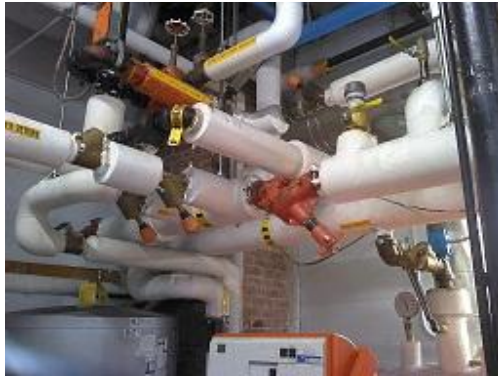
Figure 14 This is a conventional image of the same valve.

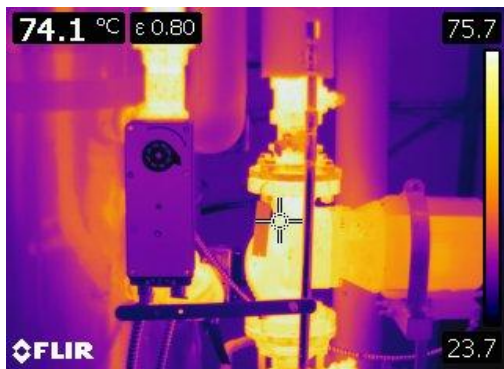
Figure 15 This thermographic image is of a motorized pump from the domestic hot water tank.

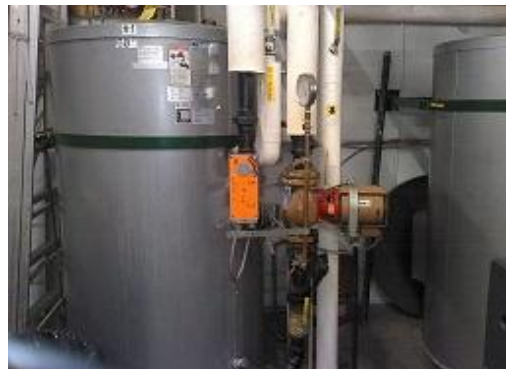
Figure 16 This conventional image is of the same circulation pump.

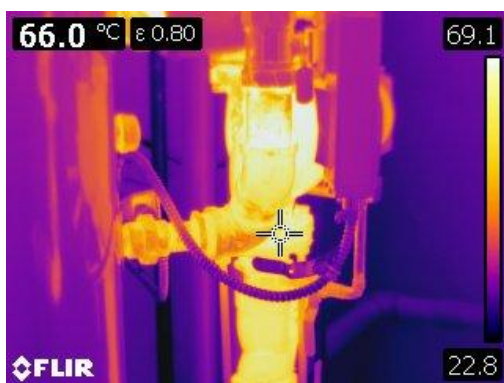
Figure 17 Thermographic image of a bare circulation pump and piping.

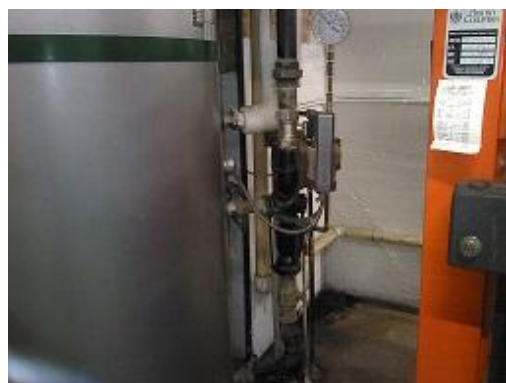
Figure 18 conventional image of the same pump and piping.

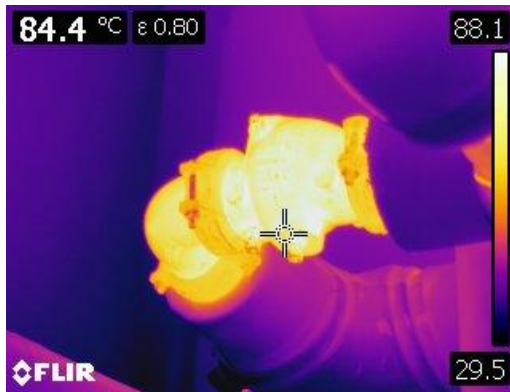
Figure 19 Thermographic image of a bare Victaulic elbow and backflow preventer.

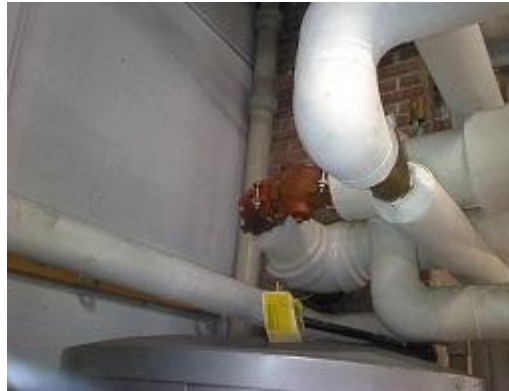
Figure 20 Conventional image of the same elbow and backflow preventer.

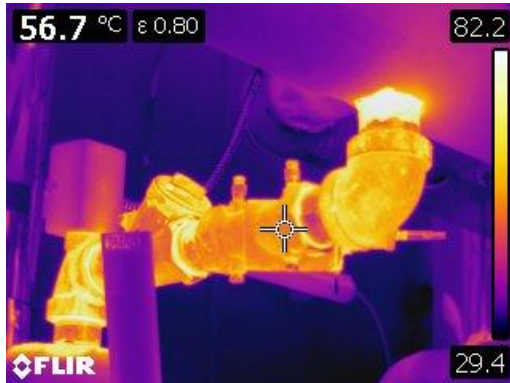
Figure 21 Thermographic image of a control valve, thermostat and elbow from the heating supply line.

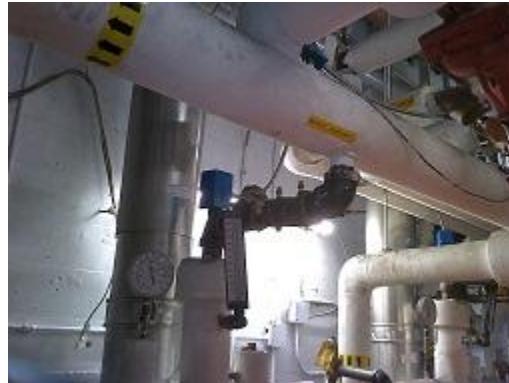
Figure 22 Conventional image of the same control valve.

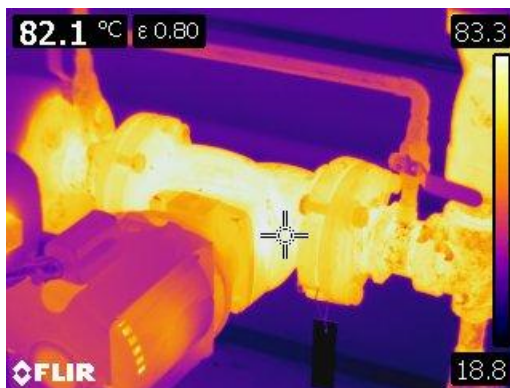
Figure 23 Thermographic image of motorized pump on heating system.

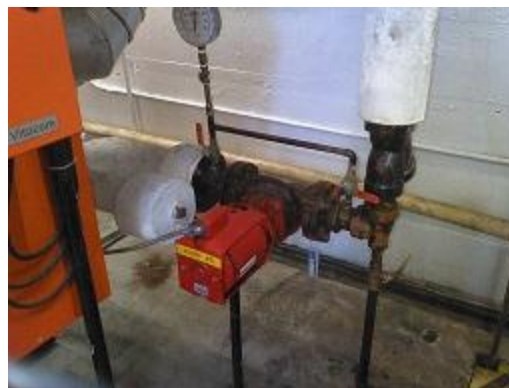
Figure 24 Conventional image of the same pump and associated flanges

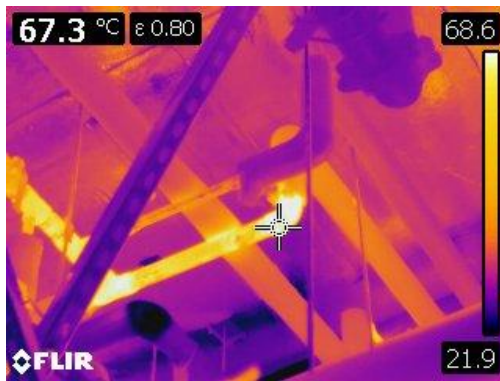
Figure 25 Thermographic image of missing insulation on small bore heating supply.

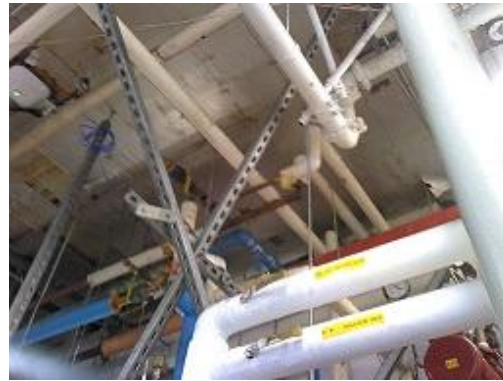
Figure 26 Conventional image of the same piping with damaged and missing insulation.

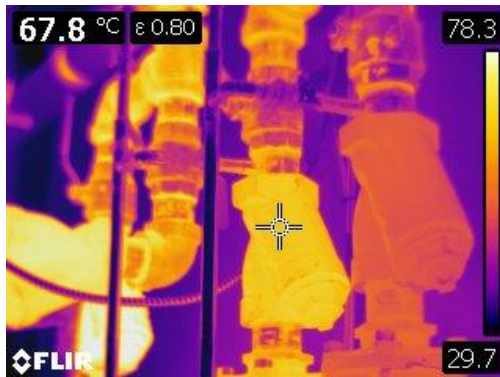
Figure 27 Thermographic image of hanger supports without insulation behind plates.

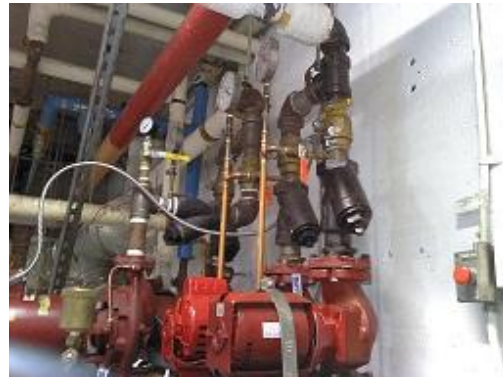
Figure 28 Conventional picture of hanger support.
