Mechanical Insulation Energy Audits

Energy Audit

Trillium Lodge

401 Moilliet Street, Parksville

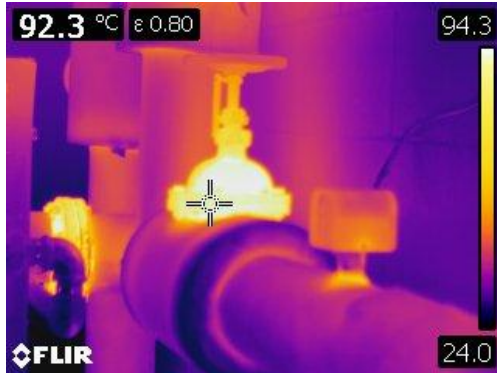
Figure 3 This thermographic image of exposed valve bonnets on the supply line from the E-Plus boiler.

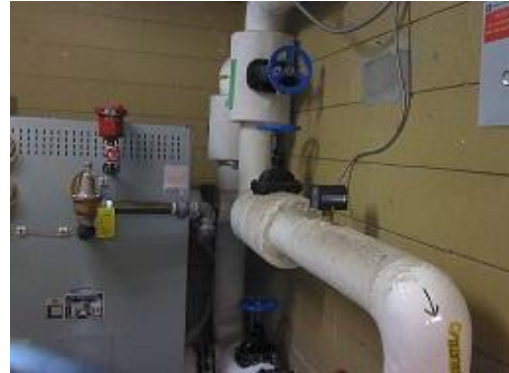
Figure 4 This is a conventional photo of the same piping from the E-Plus boiler.

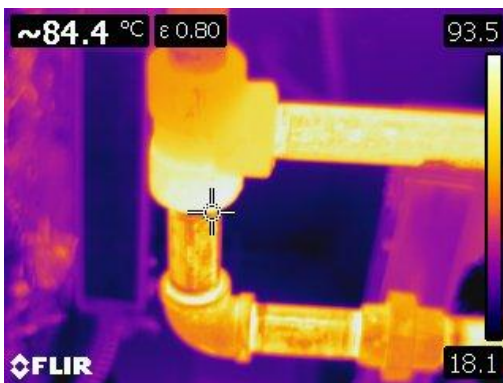
Figure 5 This Thermographic image of supply lines to a heat recovery coils.

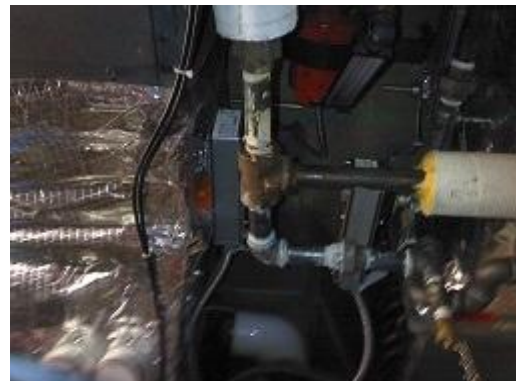
Figure 6 This conventional photo shows the same piping and also shows that the insulation was removed for maintenance.

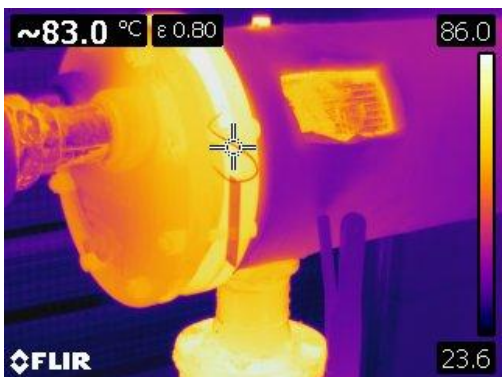
Figure 7 This is a thermographic image of the bare end of a heat exchanger.

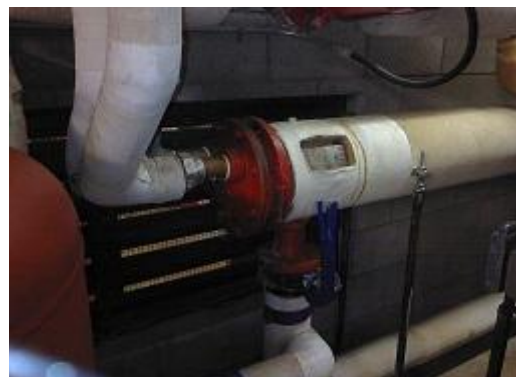
Figure 8 This is a conventional photo of the same heat exchanger.

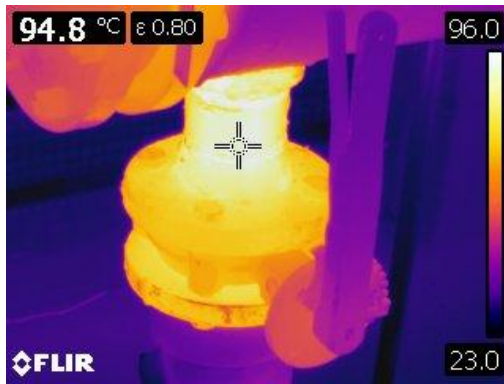
Figure 9 This is a thermographic image of a bare gate valve below the heat exchanger.

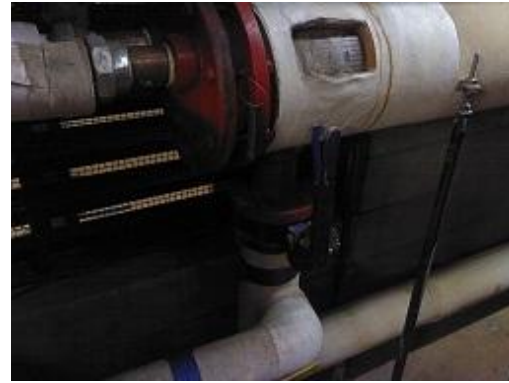
Figure 10 This is the conventional image of the same bare valve in the boiler room.

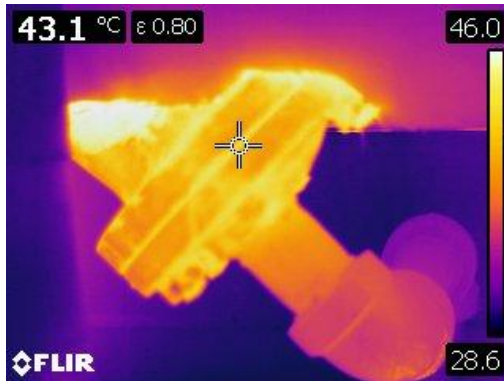
Figure 11 This thermographic image is of bare drain from the heat exchanger.

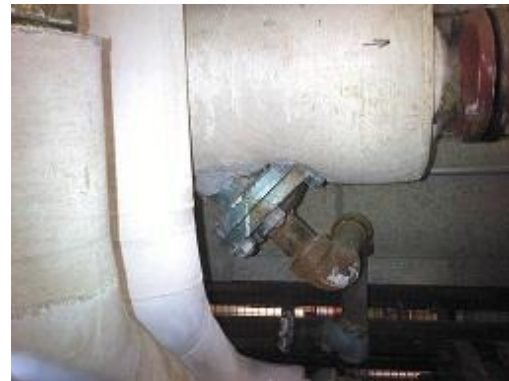
Figure12 This is a conventional image of the same group of pipe, fittings and valves.

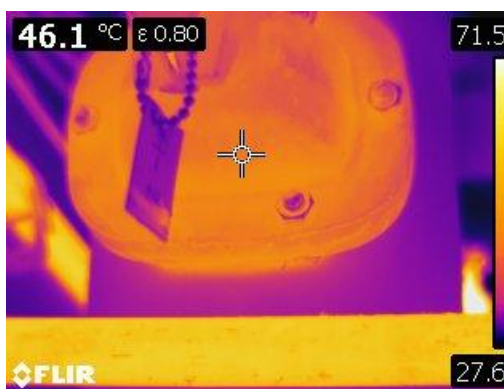
Figure 13 This thermographic image is of a bare valve bonnet.

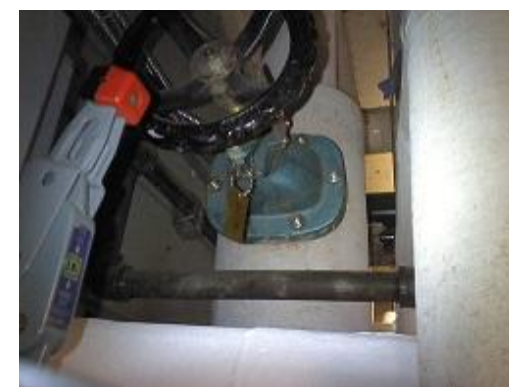
Figure 14 This is a conventional image of the same valve bonnet.

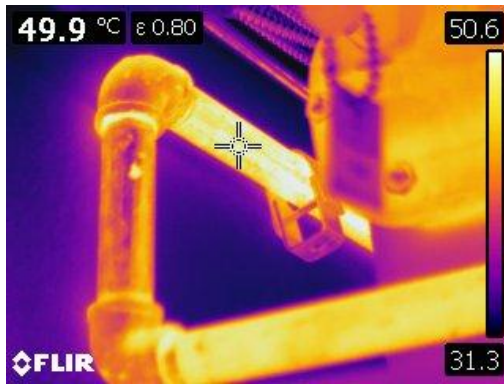
Figure 15 This thermographic image is of a bare 1 inch line adjacent to valve bonnet.

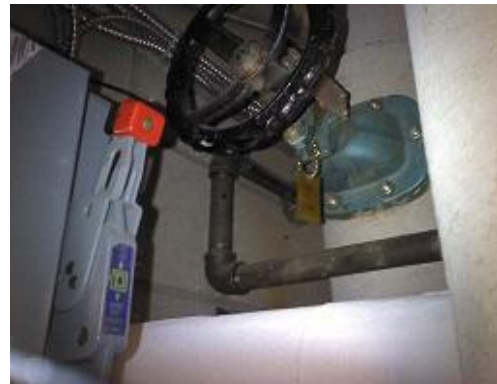
Figure 16 This conventional image is of the same 1 inch line.

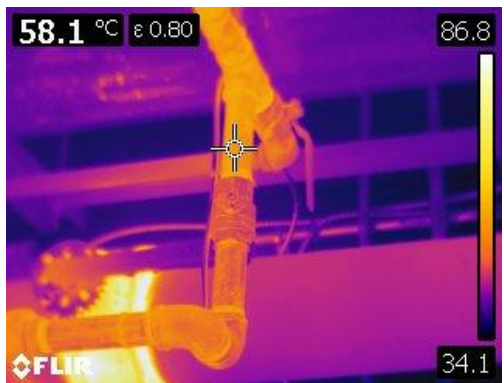
Figure 17 Thermographic image of the same 1 inch line at the other end.

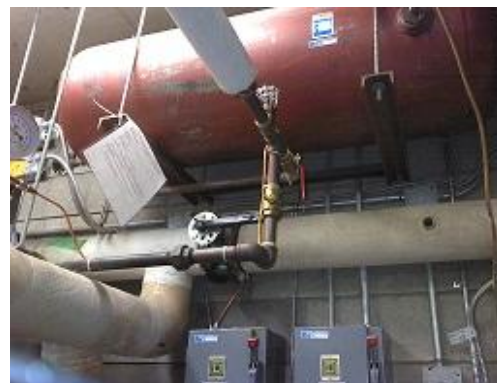
Figure 18 Conventional image of the same 1 inch line with valves and fittings.

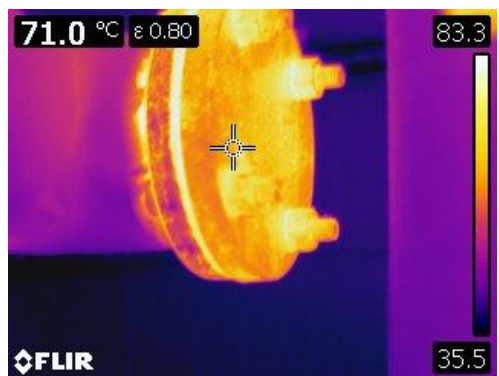
Figure 19 Thermographic image of a bare flange/endcap.

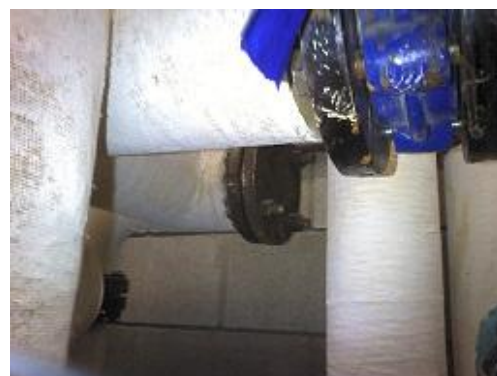
Figure 20 Conventional image of the same flange/endcap.

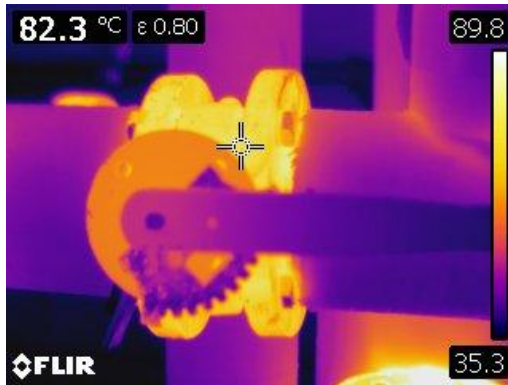
Figure 21 Thermographic image of a bare gate valve.

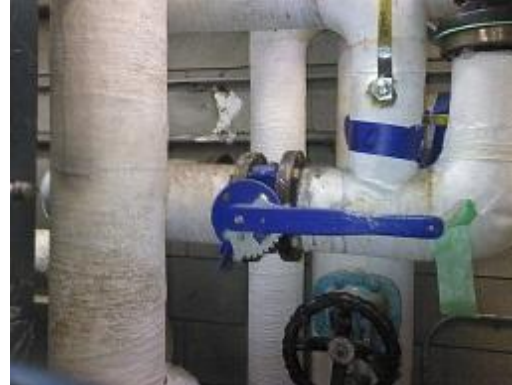
Figure 22 Conventional image of the same valve.

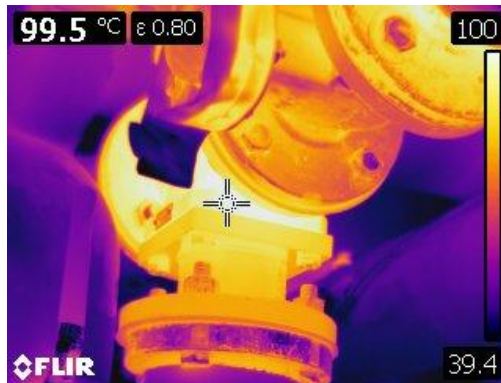
Figure 23 Thermographic image of a three way mixing valve and a gate valve.

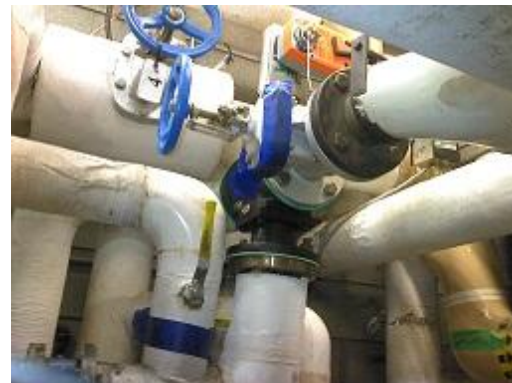
Figure 24 Conventional image of the same valve assembly.

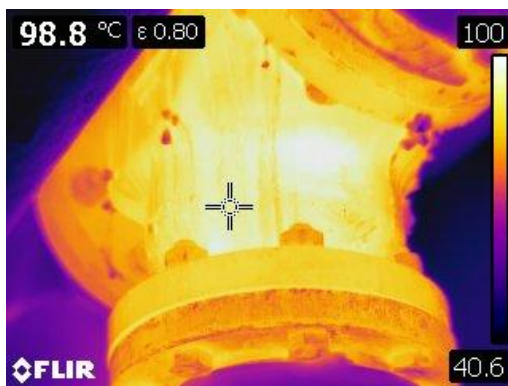
Figure 25 Thermographic image of a large bore three way valve.

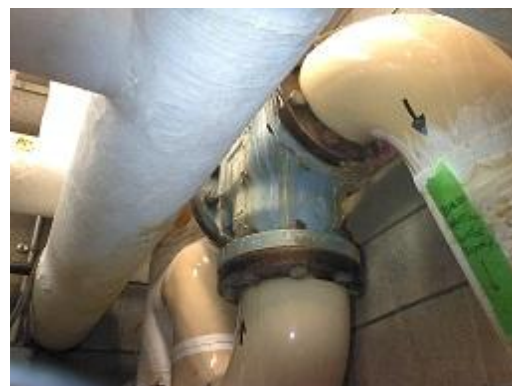
Figure 26 Conventional image of the same three way valve against back wall.

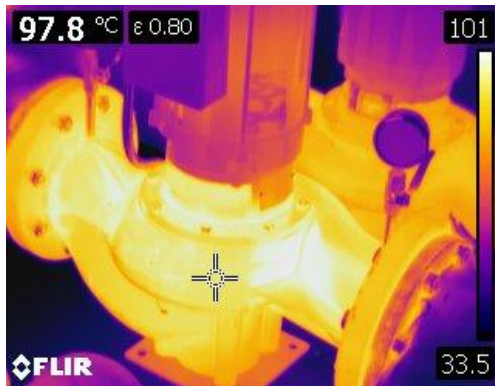
Figure 27 Thermographic image of motorized heating pumps.

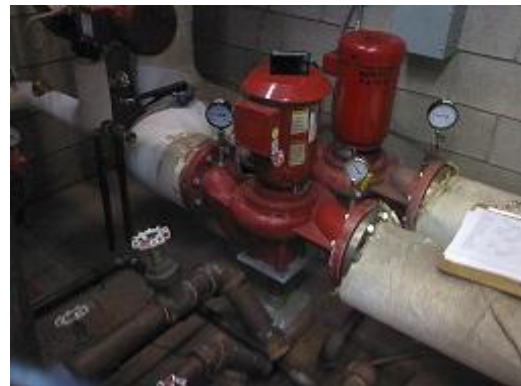
Figure 28 Conventional picture of the same pumps.

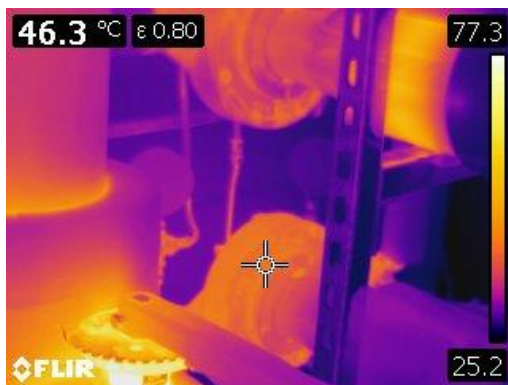
Figure 28 Thermographic image of motorized heating pumps in boiler room.

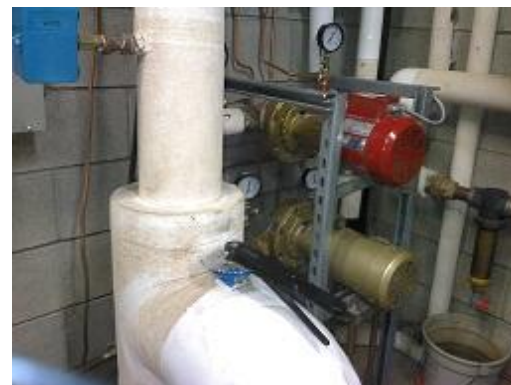
Figure 29 Conventional image of motorized heating pumps in boiler room.

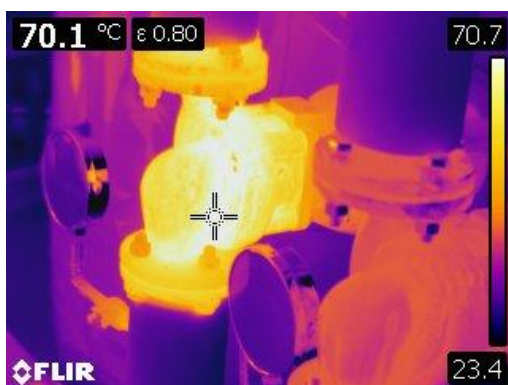
Figure 30 Thermographic image of motorized pumps from hot water tank.

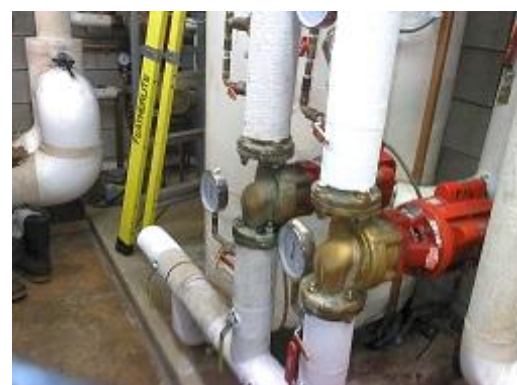
Figure 31 conventional image of the same pumps at the hot water tank.

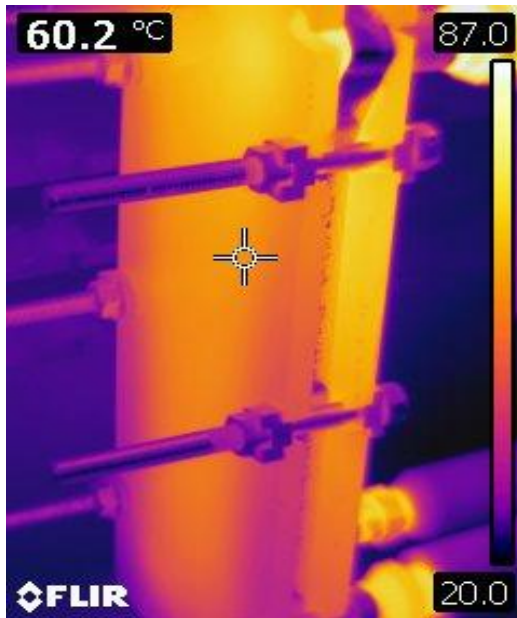
Figure 32 Thermographic image of the plate exchanger in mechanical area by boiler.

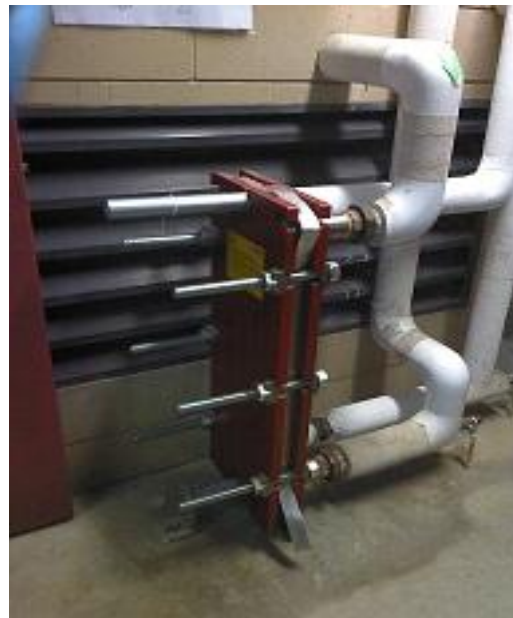
Figure 33 Conventional image of the same plate exchanger.

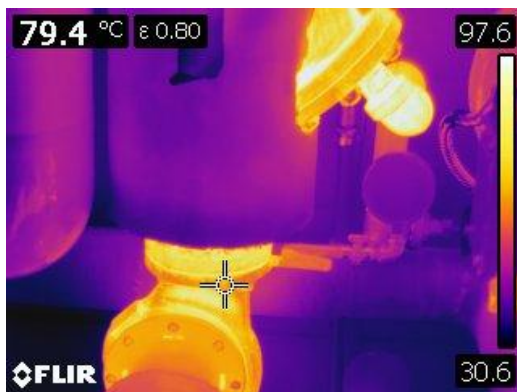
Figure 34 Thermographic image of another motorized heating pump in the boiler room.

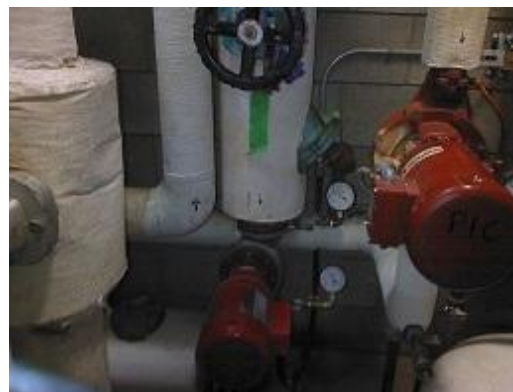
Figure 35 Conventional image of the same motorized pump in the boiler room.

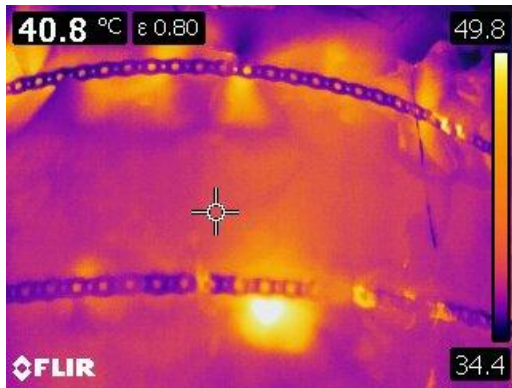
Figure 36 Thermographic image of the domestic hot water tank in boiler room. The insulation is not preventing the necessary heat loss as the surface temperature is 40.8

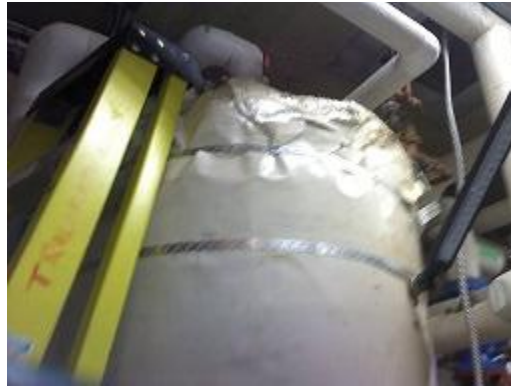
Figure 37 Thermographic image of the domestic hot water tank showing the damage to the insulation.
