**SALAMANDER INSPECTIONS LTD**  
**Mechanical Insulation Energy Audits**

# Energy Audit

Victoria General Hospital  
1 Hospital Way,  
Victoria, B.C.  
V8Z - 6R5

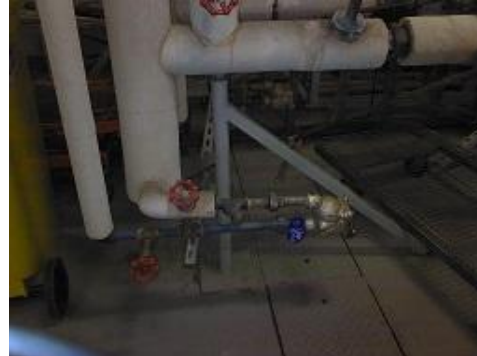
**Figure 6** This conventional photo shows the same steam trap and piping.

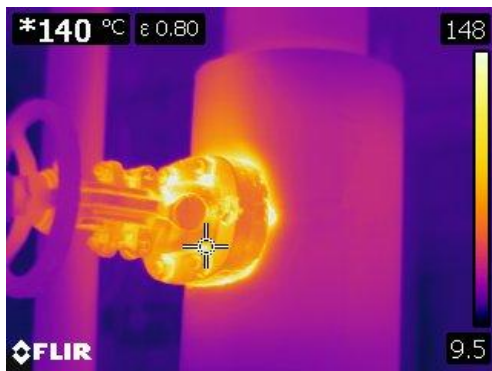
**Figure 7** This is a thermographic image of a bare valve bonnet at 140° C or 284° F.

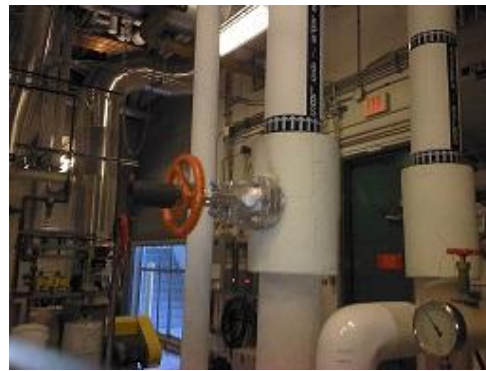
**Figure 8** This is a conventional photo of the same valve bonnet.

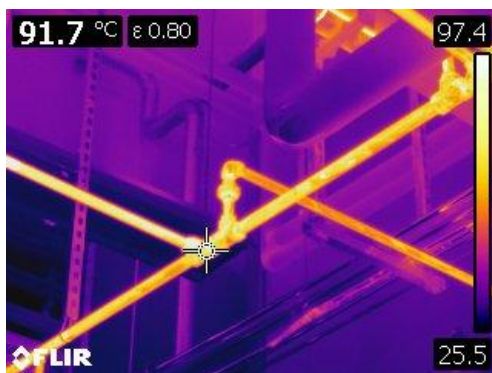
**Figure 9** This is a thermographic image of bare 1 1/4 steam line in the boiler room at 91° C or 195° F. (over 40 ft)

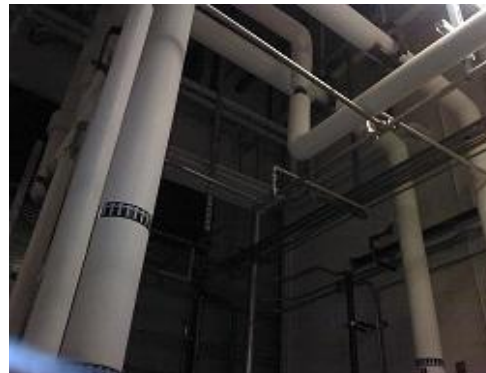
**Figure 10** This is the conventional image of the same bare steam line from sterilizer.

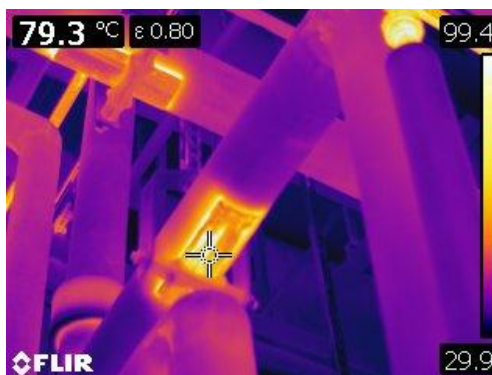
**Figure11** This is a thermographic image of pipe supports without insulation behind them at 79° C or 174° F. (12 of)

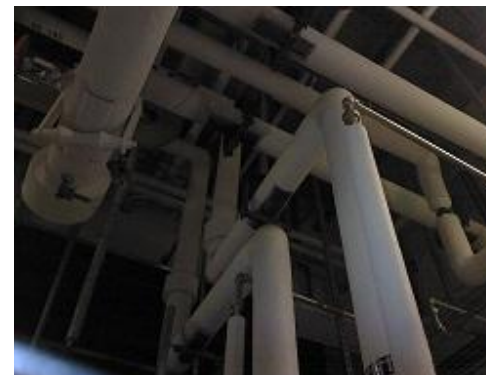
**Figure 12** This is the conventional image of the same pipe supports.

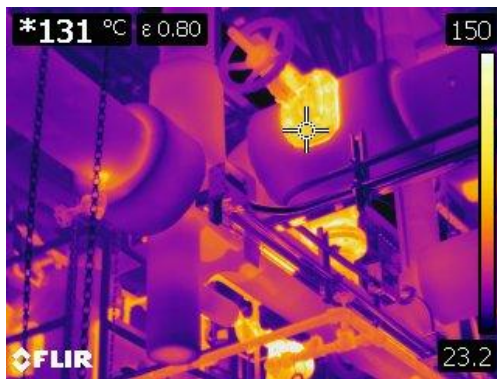
**Figure 13** Thermographic image of one specific valve bonnet but the image shows many bare areas missing insulation.

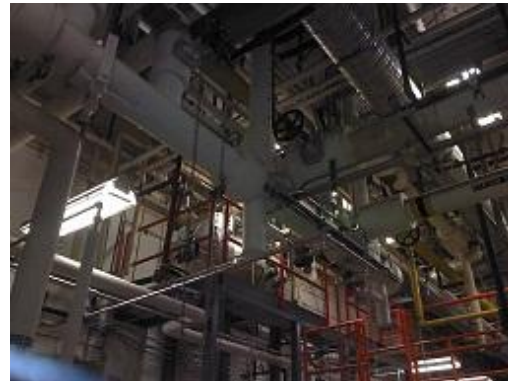
**Figure 14** This is a conventional image of the same mechanical piping with all the areas of heat loss invisible to the naked eye.

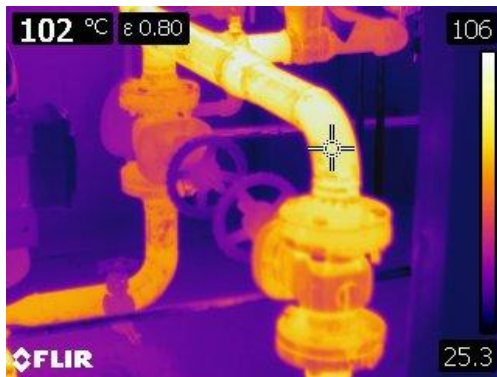
**Figure 15** This thermographic image is of bare piping and valves at 102° C or 215° F

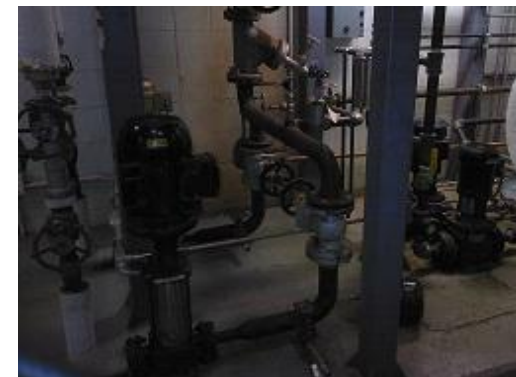
**Figure 16** conventional image of the same piping and valves.

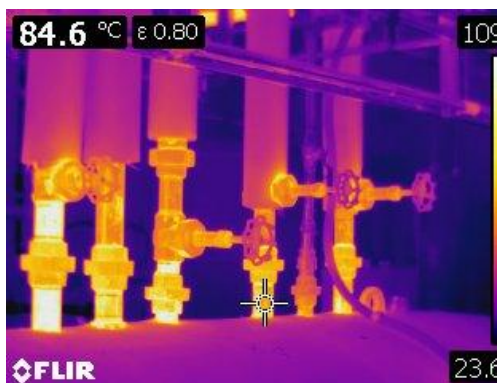
**Figure 17** Thermographic image of valves and unions on top of a vessel at 84° C or 183° F

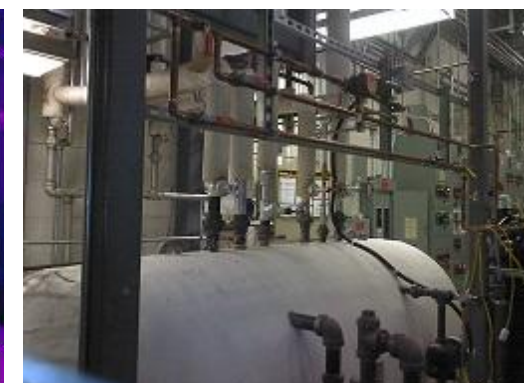
**Figure 18** Conventional image of the same valves and unions.

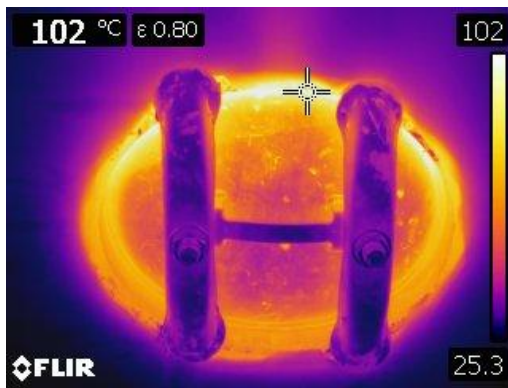
**Figure 19** Thermographic image of the access hatch to this vessel at 102° C or 215° F

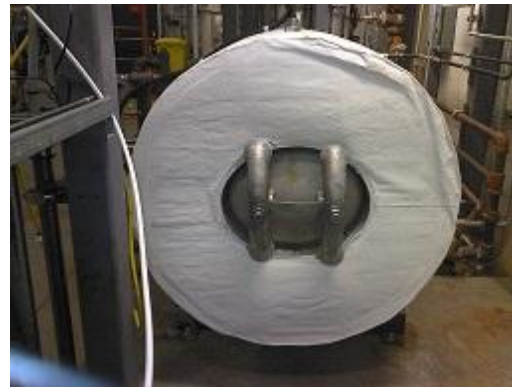
**Figure 20** Conventional image of the same access hatch.

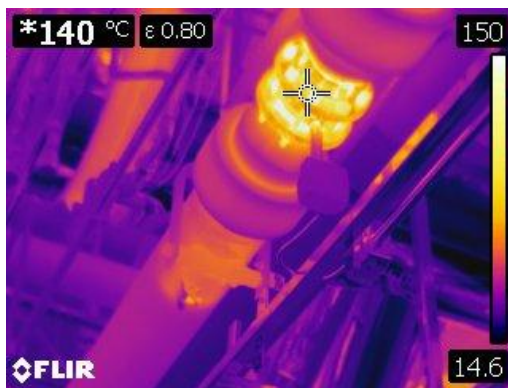
**Figure 21** Thermographic image of a flow meter at 140° C or 284° F.

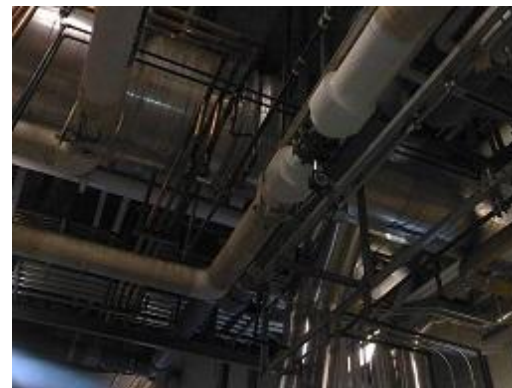
**Figure 22** Conventional picture of the same flow meter.

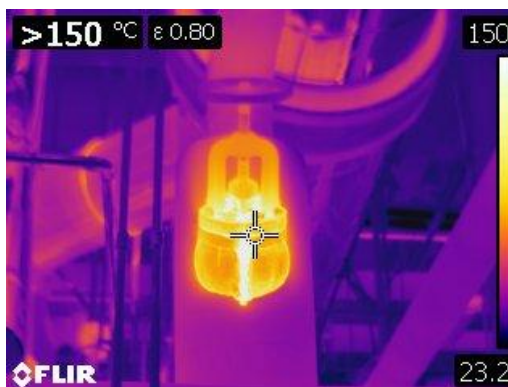
**Figure 23** Thermographic image of a large bore bare valve bonnet at 140° C or 302° F.

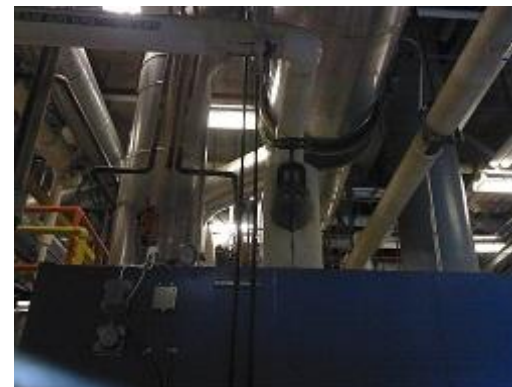
**Figure 24** Conventional image of the same valve above boiler .

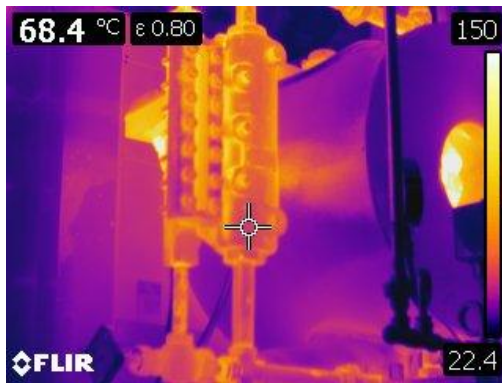
**Figure 25** Thermographic image of sightglass and piping at front of the boiler at 68° C or 154° F.

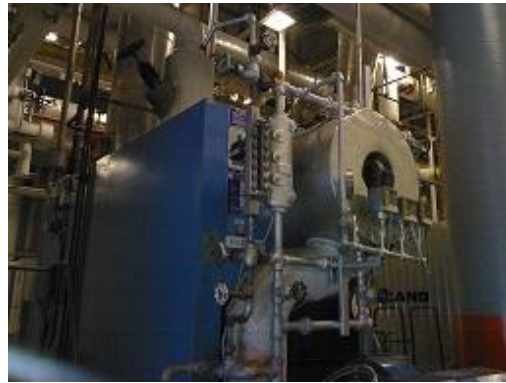
**Figure 26** conventional image of the same sightglass and piping.

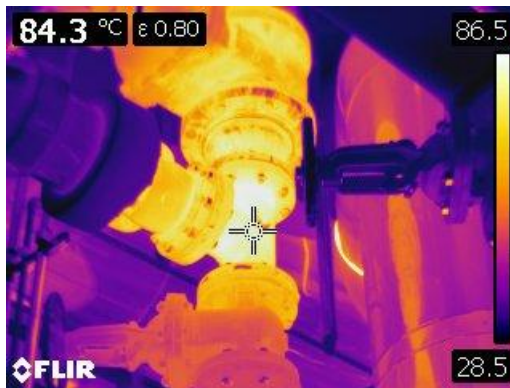
**Figure 27** Thermographic image of large bore valves above boilers to heating pumps at 84° C or 183° F.

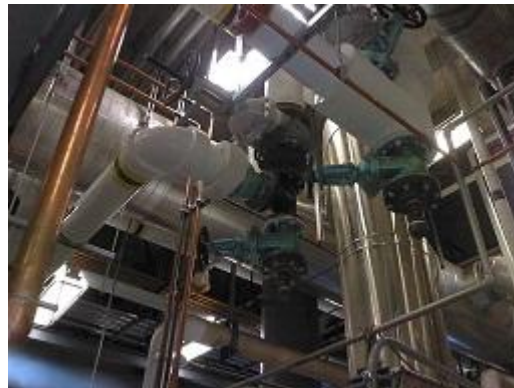
**Figure 28** Conventional image of the same cluster of valves.

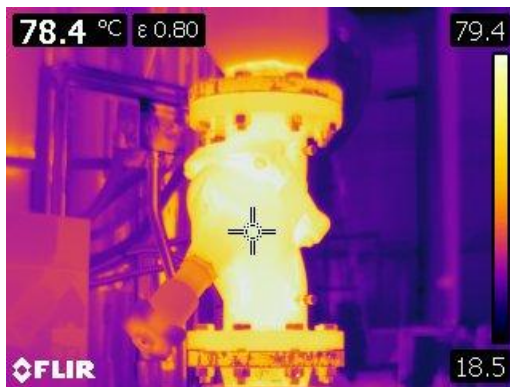
**Figure 29** Thermographic image of control valves adjacent to boilers at 78° C or 172° F.

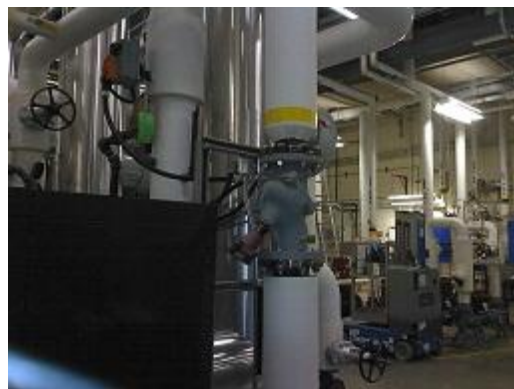
**Figure 30** Conventional image of the same control valves.

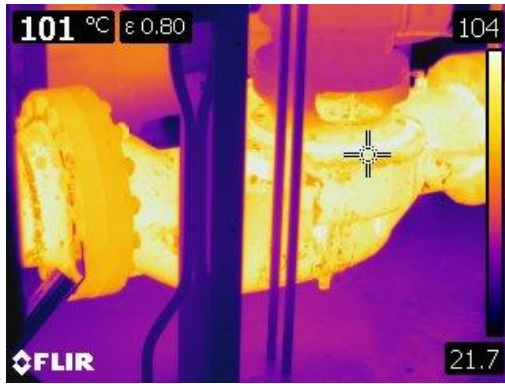
**Figure 31** Thermographic image of heating supply pumps at 101° C or 213° F.

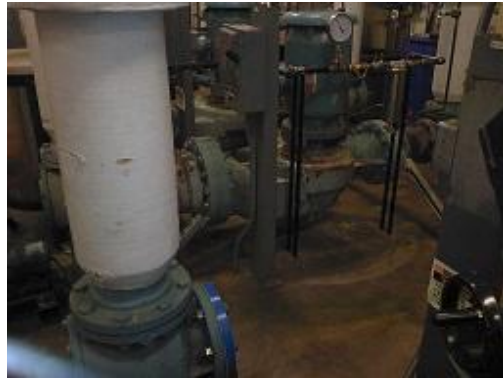
**Figure 32** Conventional image of the same pumps.

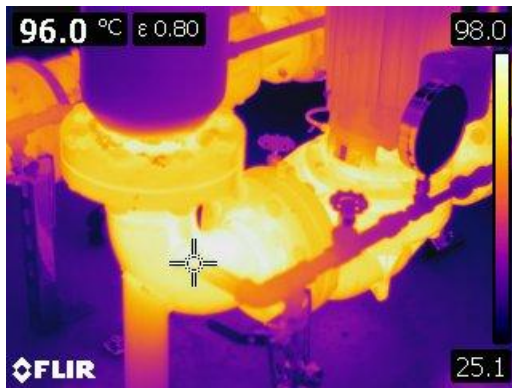
**Figure 33** Thermographic image of heating supply pumps at 96° C or 204° F.

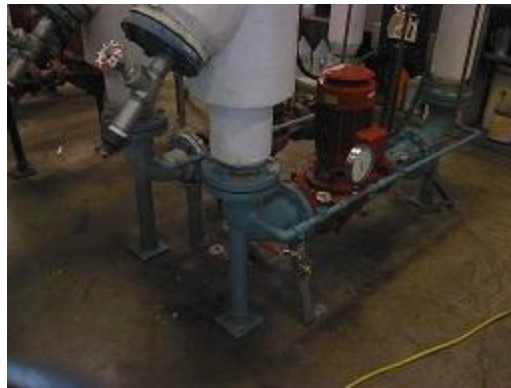
**Figure 34** Conventional image of the same pumps.

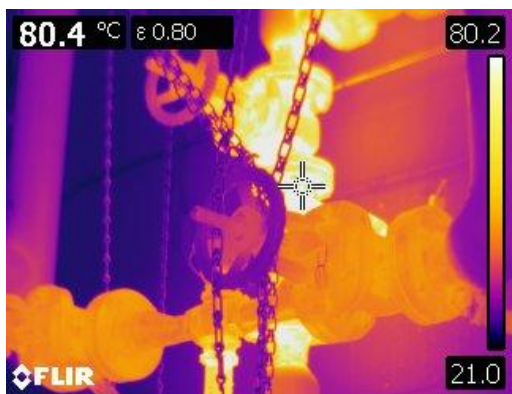
**Figure 35** Thermographic image of bare valves at 80° C or 176° F.

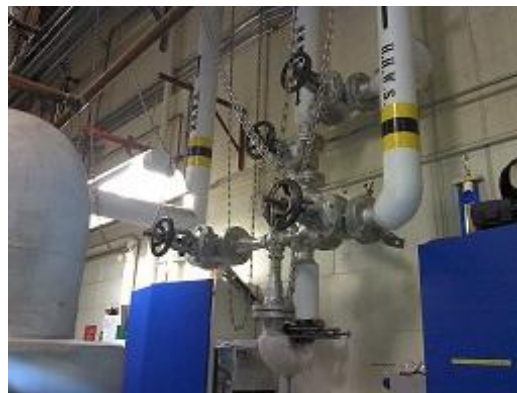
**Figure 36** Conventional image of the same valves and flanges.

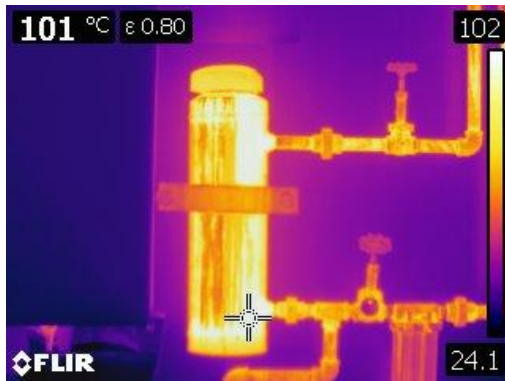
**Figure 37** Thermographic image of a chem. pot at 101° C or 213° F.

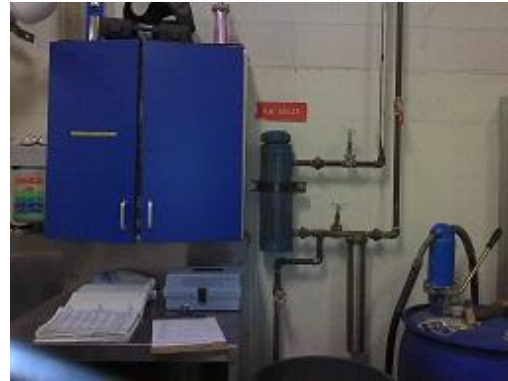
**Figure 38** Conventional image of the chem. pot and associated piping.

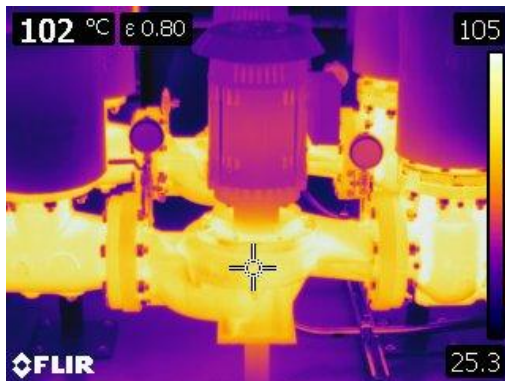
**Figure 39** Thermographic image of bare heating pumps at 102° C or 215° F.

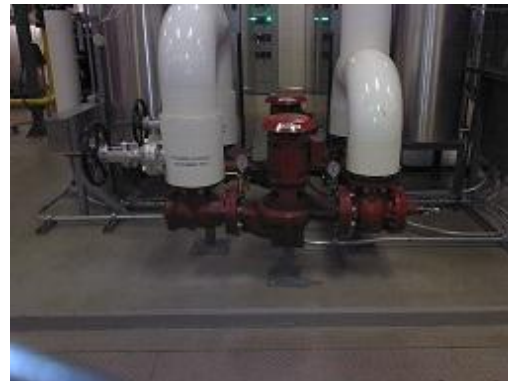
**Figure 40** Conventional image of the same motorized heating pumps.

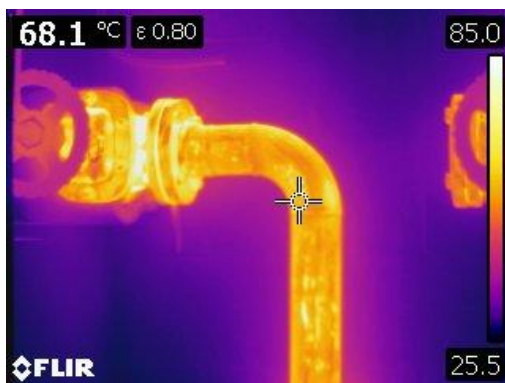
**Figure 41** Thermographic image of bare piping to hot water tanks at 68° C or 154° F.

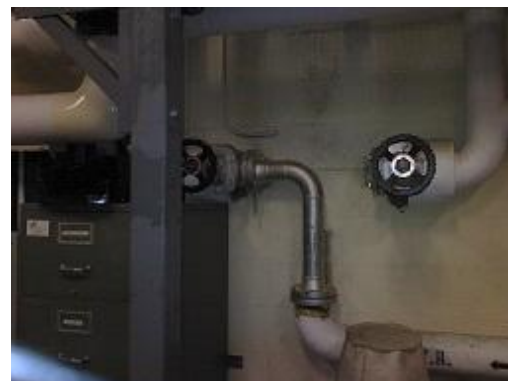
**Figure 42** Conventional image of bare piping to hot water tanks.

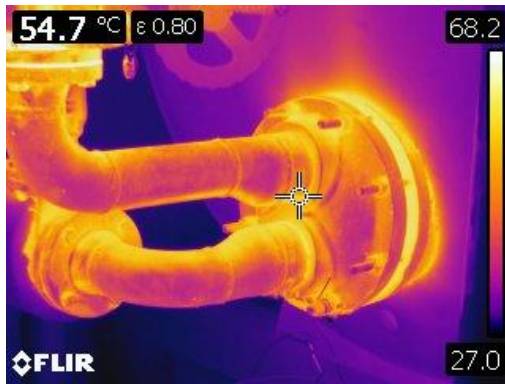
**Figure 43** Thermographic image of bare piping and heat exchanger at hot water tanks at 54° C or 129° F.

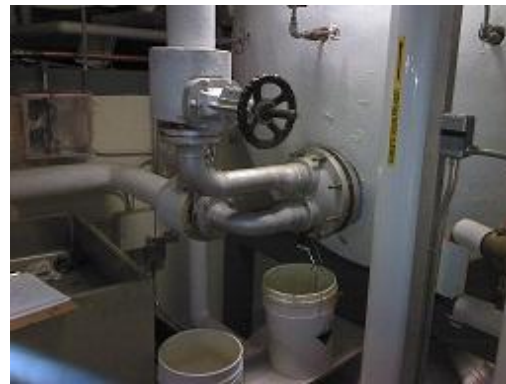
**Figure 44** Conventional image of the same piping and heat exchanger.

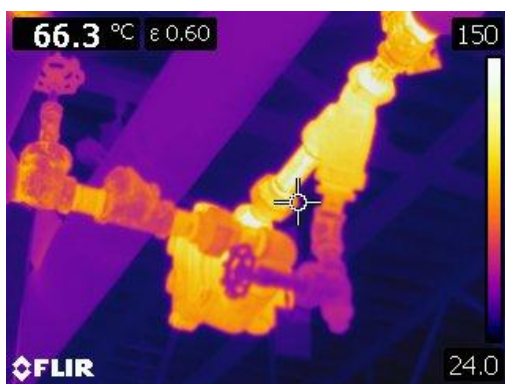
**Figure 45** Thermographic image of bare steam trap in the penthouse fan room at 66° C or 150° F.

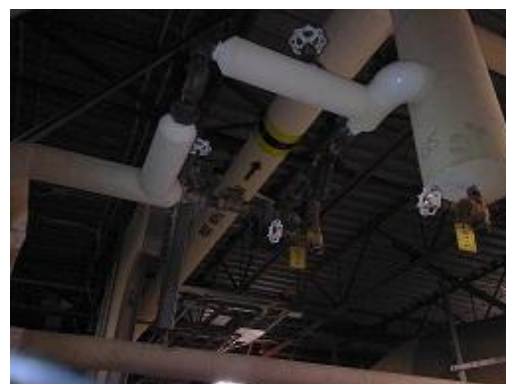
**Figure 46** Conventional image of the same steam trap and associated piping.

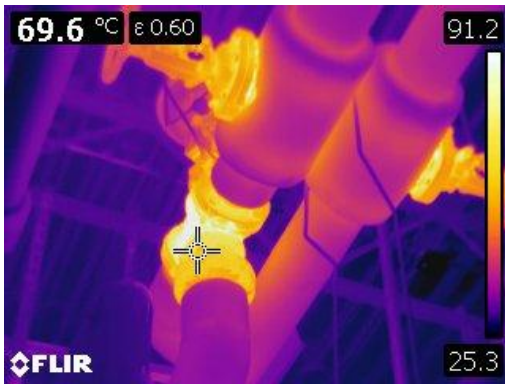
**Figure 47** Thermographic image of bare heating supply to 69° C or 156° F.

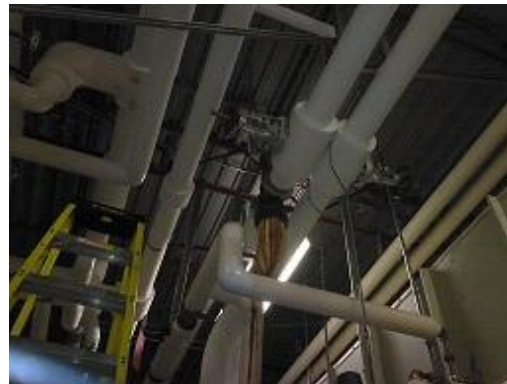
**Figure 48** Conventional image of bare small bore heating supply and return to coils.

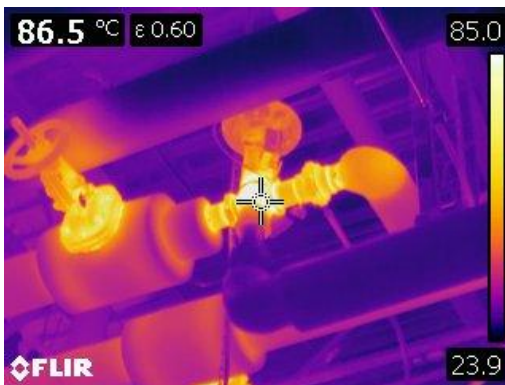
**Figure 49** Thermographic image of bare three way valve and bare valve bonnet at 86° C or 186° F

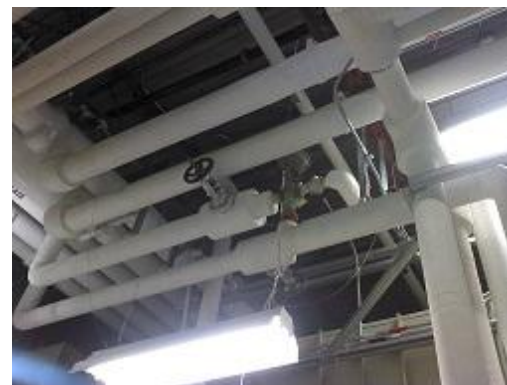
**Figure 50** Conventional image of the bare three way valve and valve bonnet.

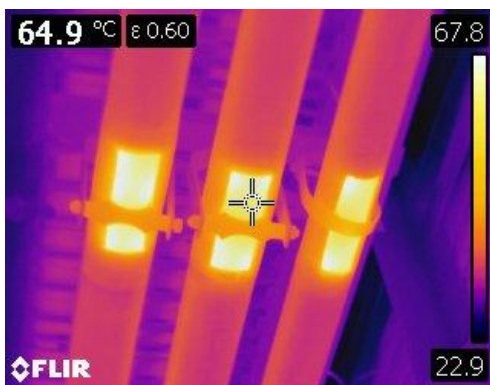
**Figure 51** Thermographic image of pipe supports at 64° C or 147° F (67° F)

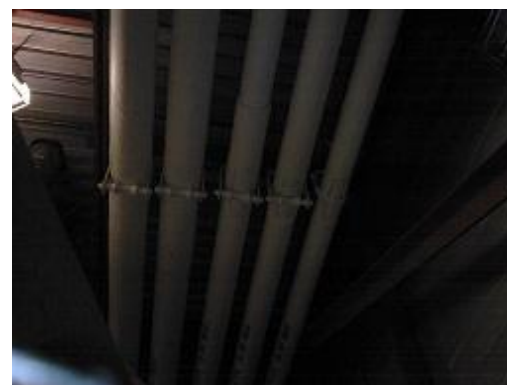
**Figure 52** Conventional image of the same insulation supports.

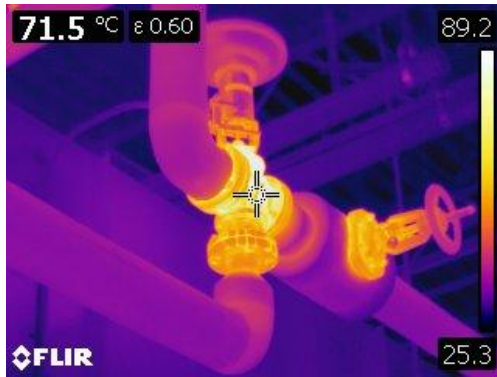
**Figure 53** Thermographic image of large three way valve and bare valve bonnet at 71° C or 159° F

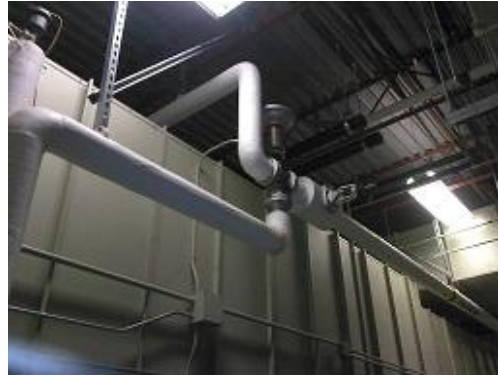
**Figure 54** Conventional image of the same three way valve and bare bonnet.

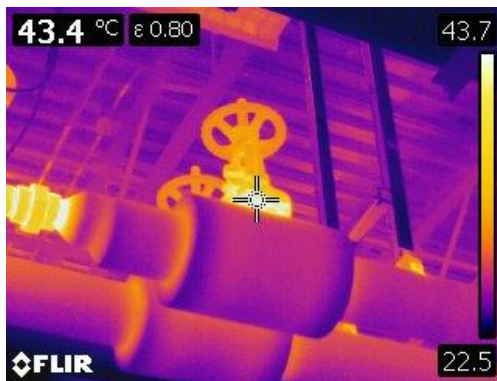
**Figure 55** Thermographic image of valve bonnets and three way valve at 43° C or 109° F

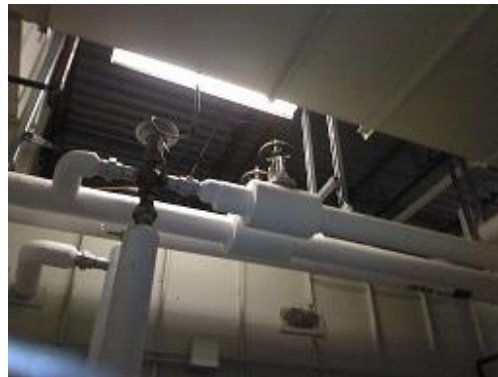
**Figure 56** Conventional image of the same three way valve and bare bonnets.

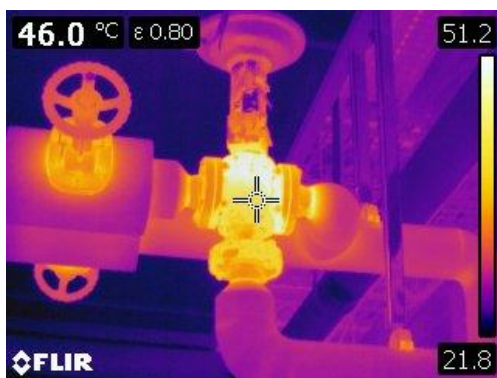
**Figure 57** Thermographic image of bare three way valve and bare bonnets at 46° C or 114° F

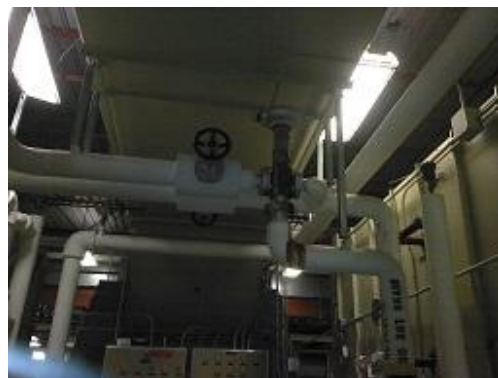
**Figure 58** Conventional image of the same valves.

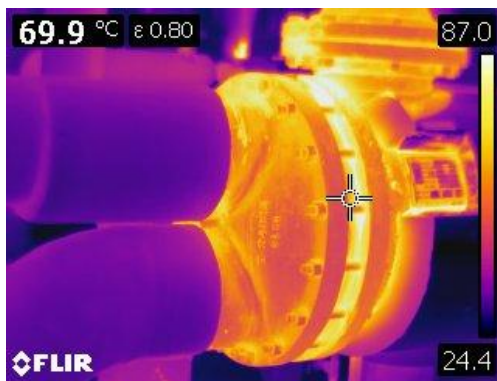
**Figure 59** Thermographic image of bare heat exchanger head at 69° C or 156° F

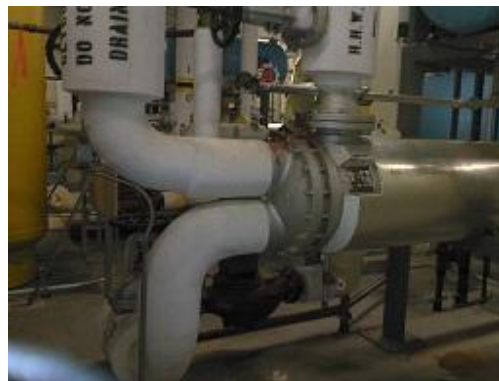
**Figure 60** Conventional image of the same heat exchanger.

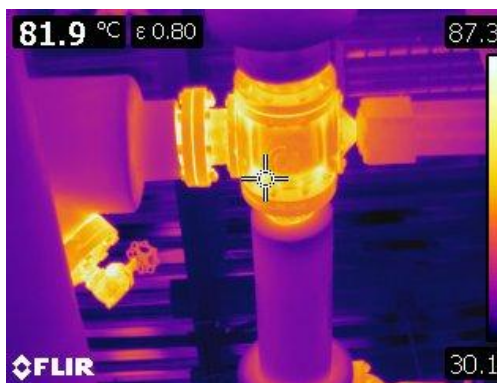
**Figure 61** Thermographic image of bare three way valve and strainer at 81° C or 177° F

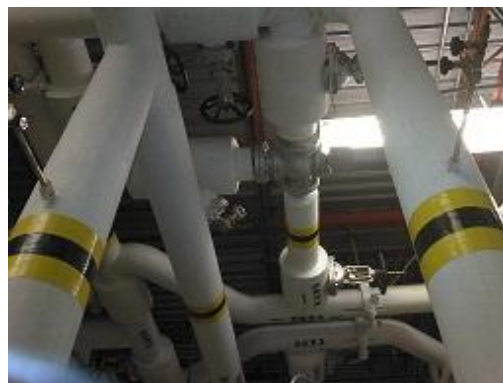
**Figure 62** Conventional image of the same group of valves and strainer.

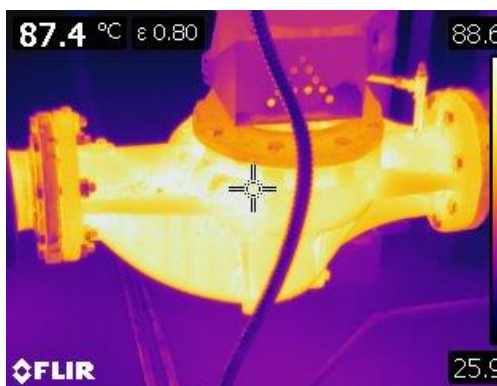
**Figure 63** Thermographic image of bare motorized heating pump at 87° C or 188° F

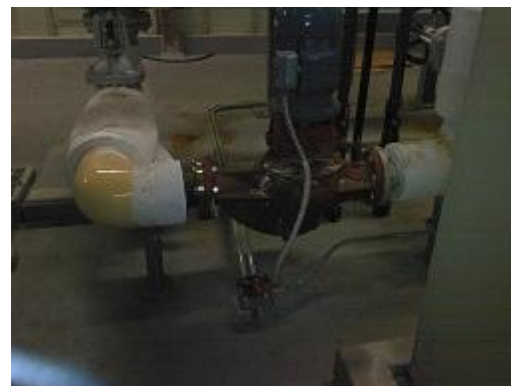
**Figure 64** Conventional image of the same motorized pump.

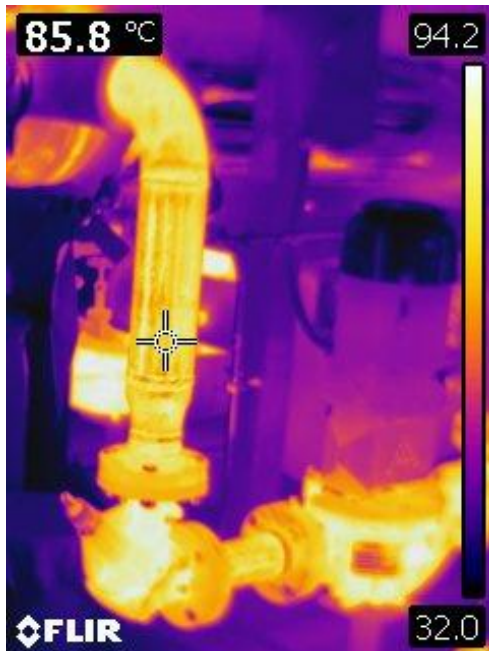
**Figure 65** Thermographic image of bare motorized heating pump and piping at 85° C or 185° F

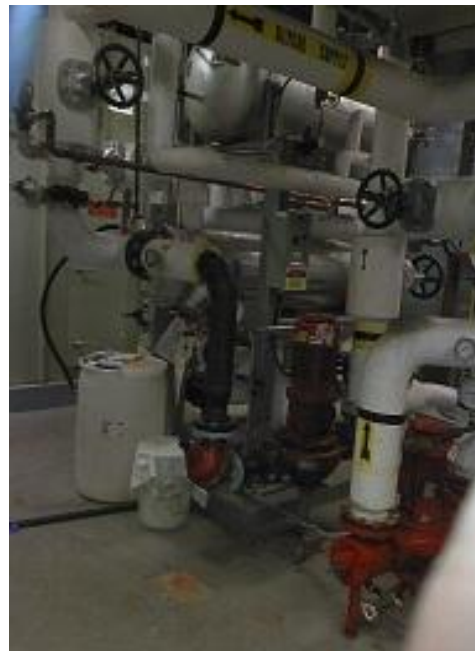
**Figure 66** Conventional image of the same motorized pumps and piping.

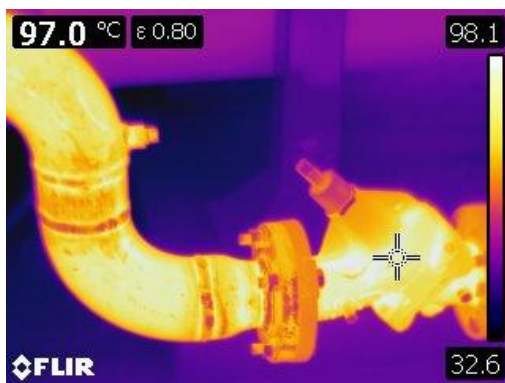
**Figure 67** Thermographic image of bare pipe and control valve and motorized pipe at 97° C or 206° F

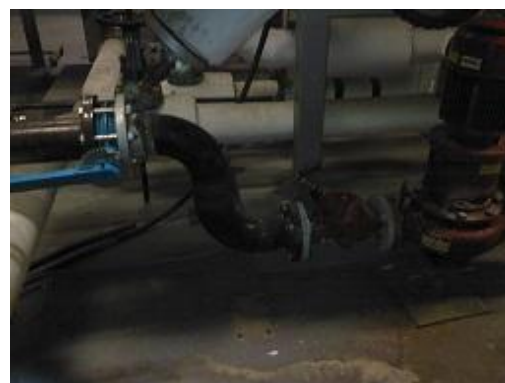
**Figure 68** Conventional image of the same motorized pumps, piping and control valve.

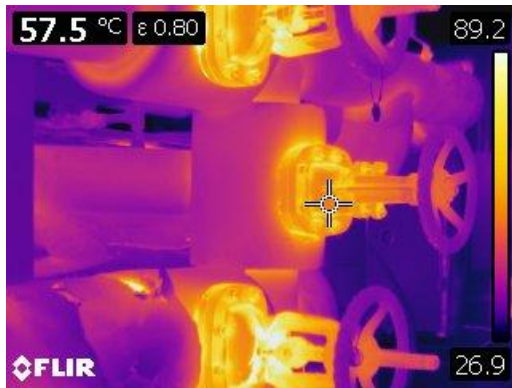
**Figure 69** Thermographic image of bare valve bonnets at 57° C or 134° F

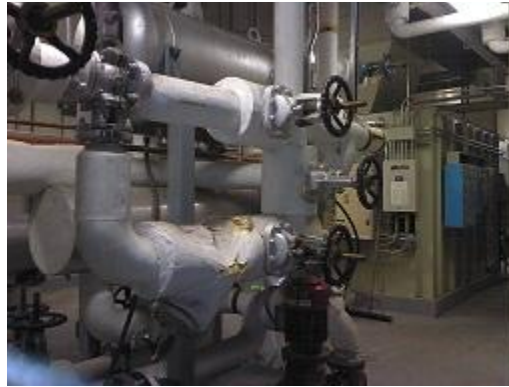
**Figure 70** Conventional image of the same valve bonnets and damaged insulation .

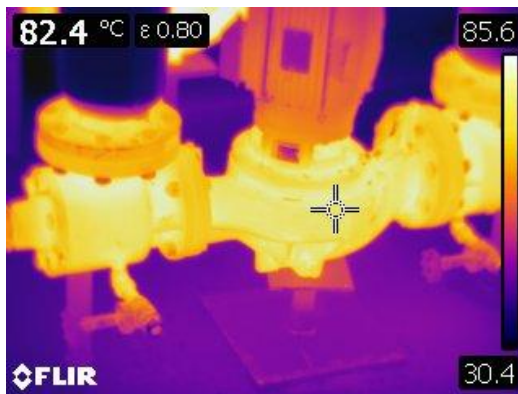
**Figure 71** Thermographic image of bare motorized heating pumps at 82° C or 179° F

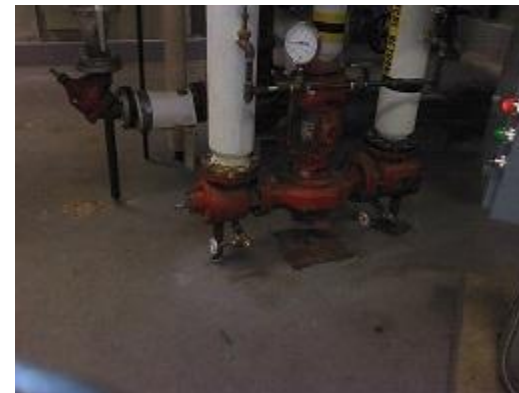
**Figure 72** Conventional image of the same heating pumps.

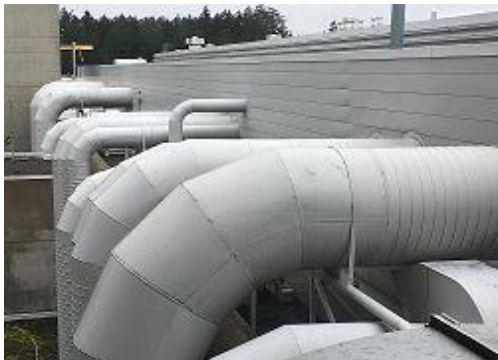
Note: in my conversation with the Chief Engineer these ducts coming from the penthouse fan room may be heating/cooling supply. It appears that these ducts are without any insulation applied. We have not included any results or costs for these ducts and feel that further investigation may be required.
