**SALAMANDER INSPECTIONS LTD**

**Mechanical Insulation Energy Audits**

# Energy Audit

West Coast General Hospital

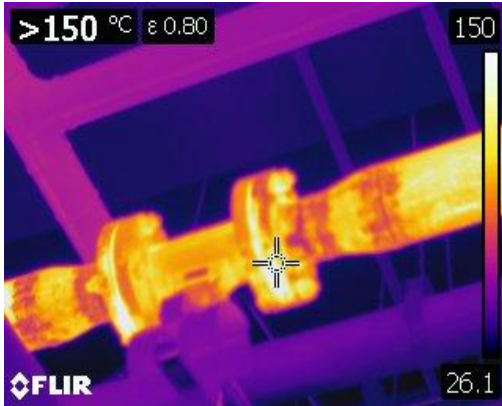
**Figure 3** This thermographic image of a 100mm pipe, flanges and flow meter.

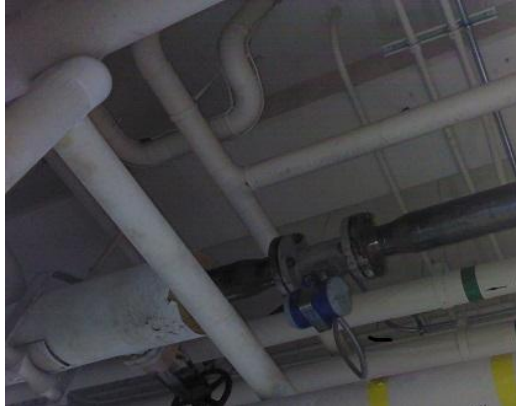
**Figure 4** This is a conventional photo of the same line.

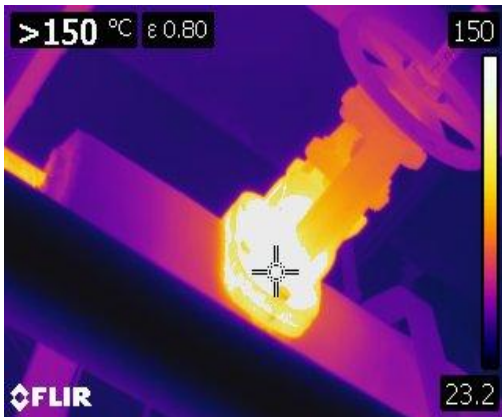
**Figure 5** This Thermographic image of a 100 mm valve bonnet. Note the high rate of heat loss as indicated by the bright color.

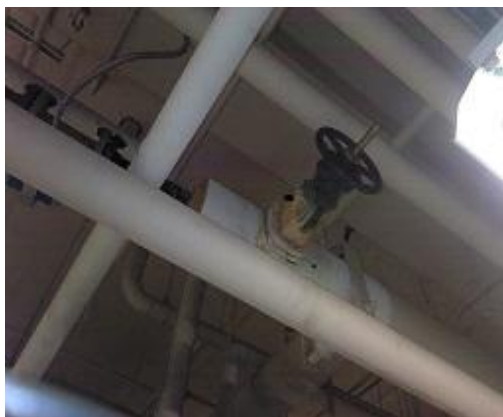
**Figure 6** This conventional photo shows the same valve bonnet.

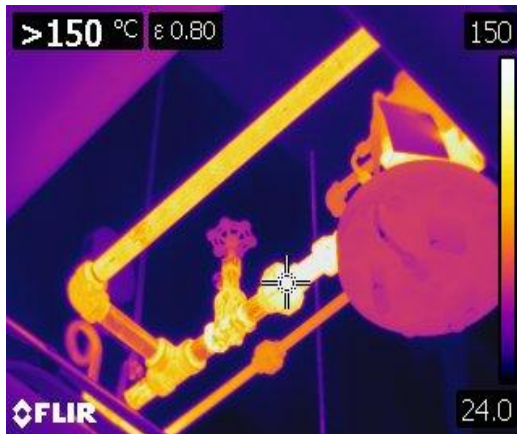
**Figure 7** This is a thermographic image of bare by-pass piping and associated valves and strainers.

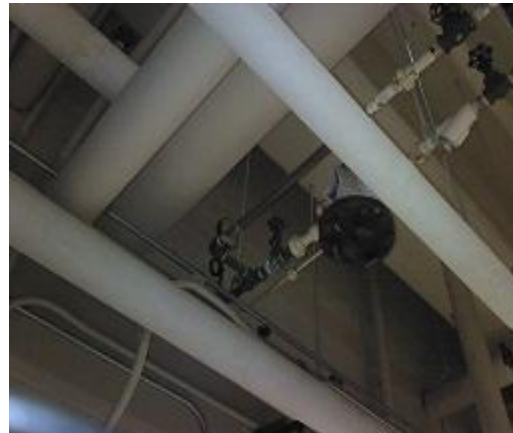
**Figure 8** This is a conventional photo of the same piping.

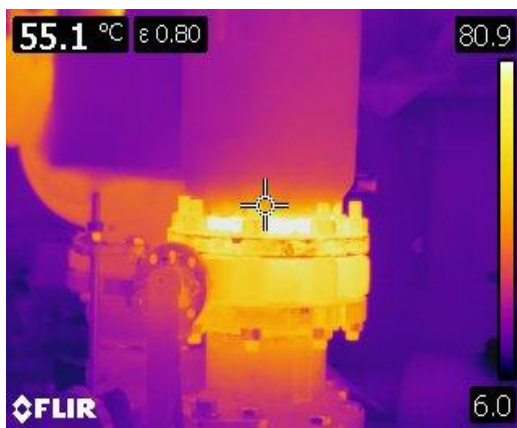
**Figure 9** This is a thermographic image of the supply lines to a circulation pump on the hot water system. The lines and the pump should be insulated to conserve energy.

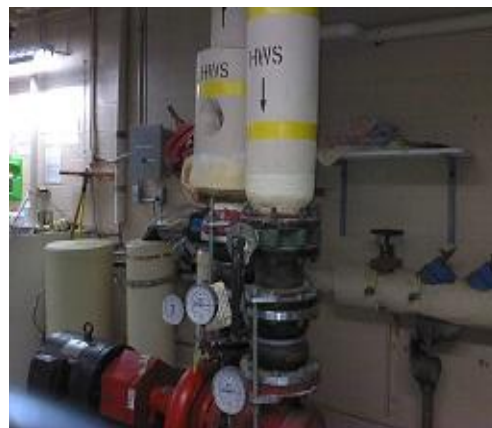
**Figure 10** This is the conventional image of the supply and return lines at the back of the boiler.

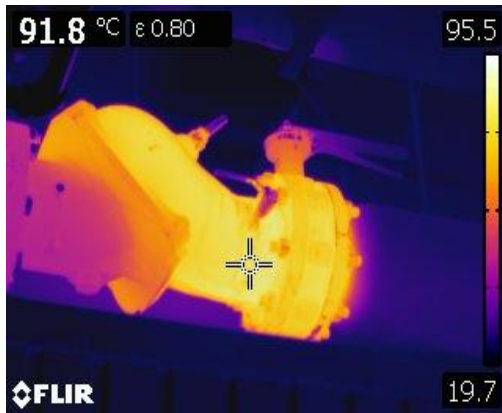
**Figure 11** This thermographic image is of the large bore valves above the boilers.

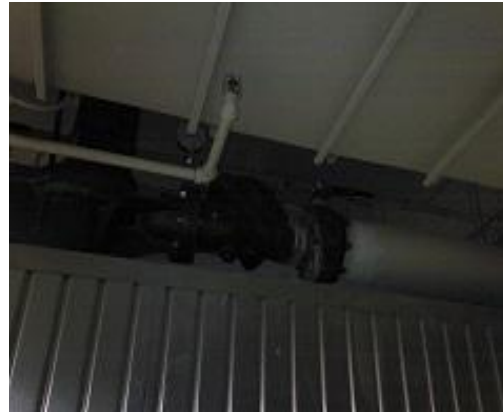
**Figure12** This is a conventional image of the same valve assemblies.

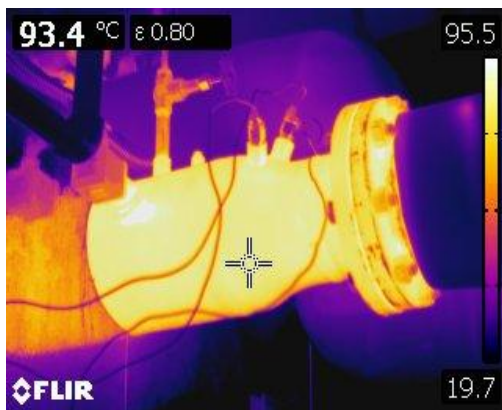
**Figure 13** This thermographic image is of a large bore pipe and flange to the boiler.

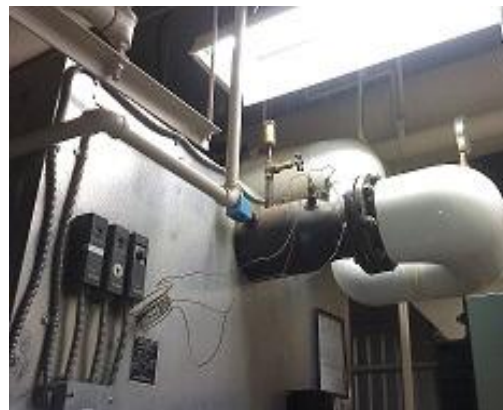
**Figure 14** This is a conventional image of the same pipe.

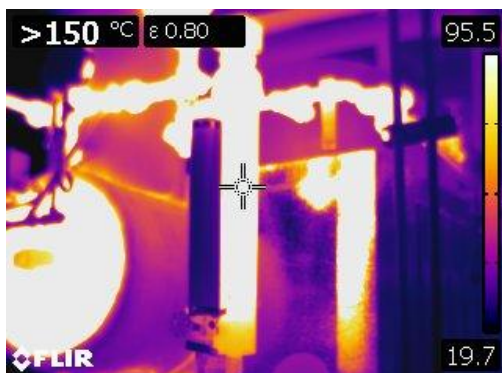
**Figure 15** This thermographic image is of instrument gauges and piping at front of the boilers.

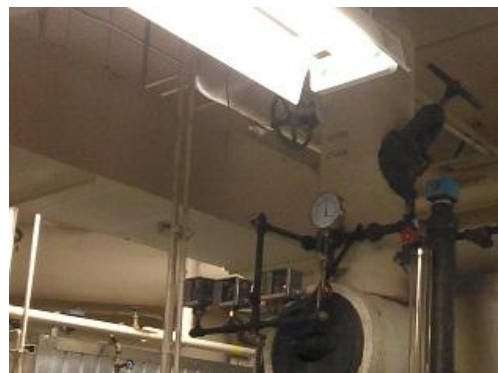
**Figure 16** This conventional image is of the same piping and gauge.

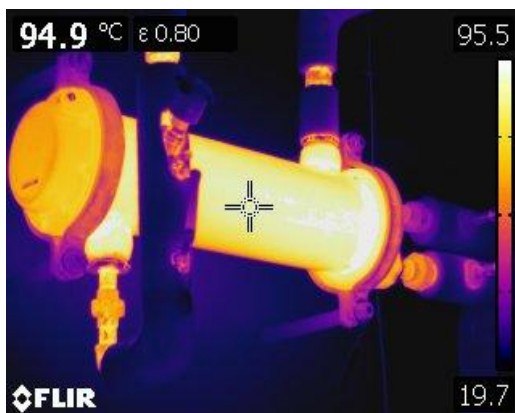
**Figure 17** Thermographic image of a wall mounted heat exchanger that is a source of heat loss.

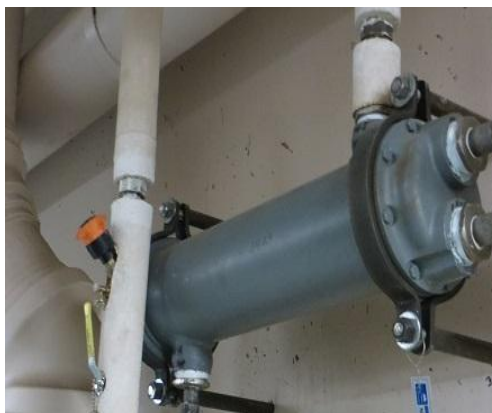
**Figure 18** conventional image of a similar heat exchanger.

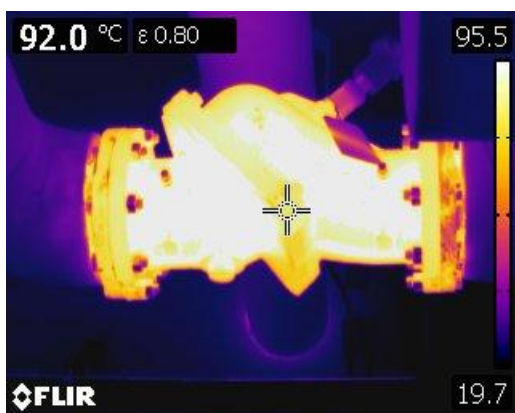
**Figure 19** Thermographic image of a control valve overhead in boiler room.

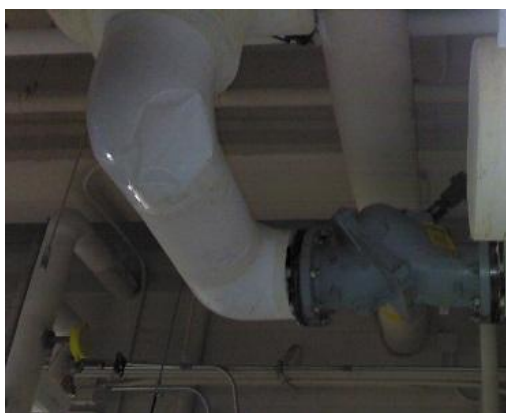
**Figure 20** Conventional image of the same control valve.

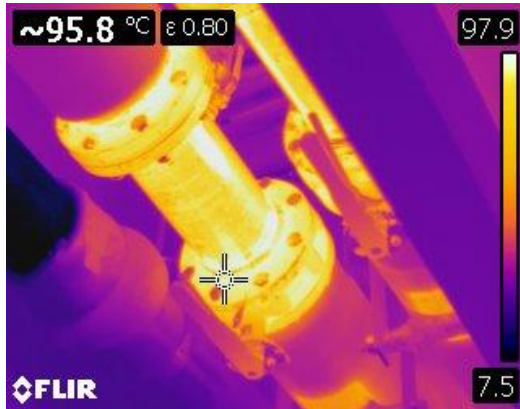
**Figure 21** Thermographic image of bare steam lines above the entrance of the fan room.

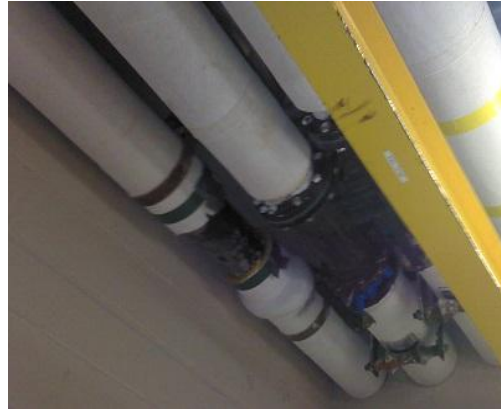
**Figure 22** Conventional image of the same steam lines.

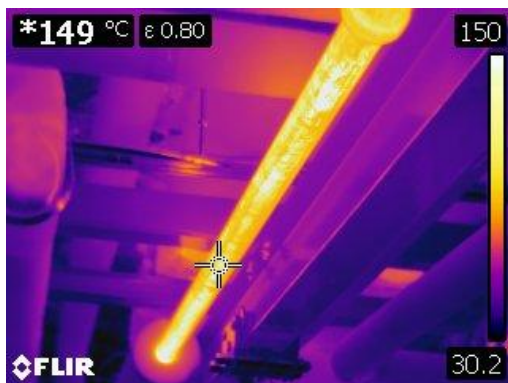
**Figure 23** Thermographic image of a bare steam supply line at the entrance of the fan room.

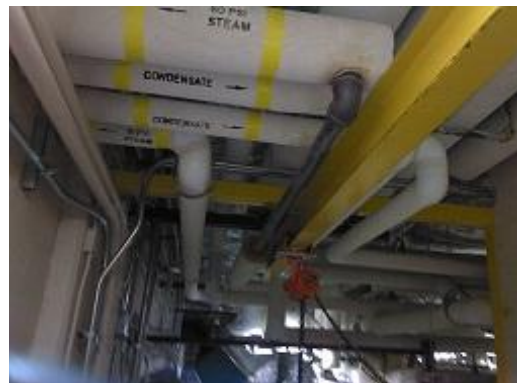
**Figure 24** Conventional image of the same bare steam line at the entrance to the fan room. This line is within reach to touch and is a burning hazard.

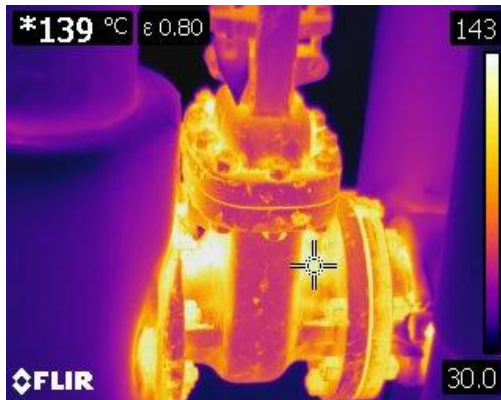
**Figure 25** Thermographic image of steam valve requiring insulation.

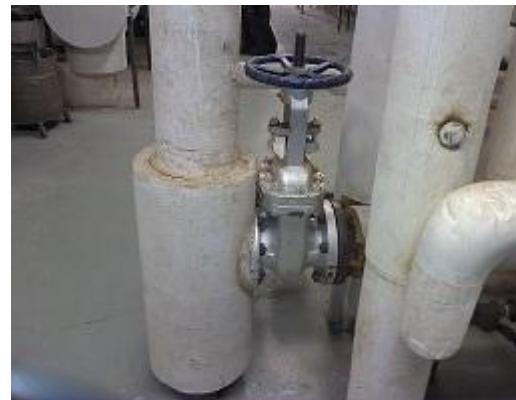
**Figure 26** Conventional image of the same valve and flanges requiring insulation.

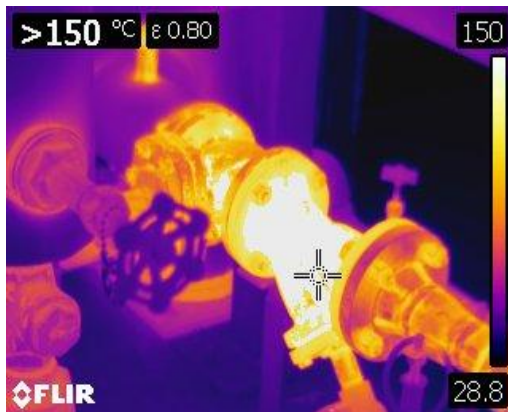
**Figure 27** Thermographic image of steam piping.

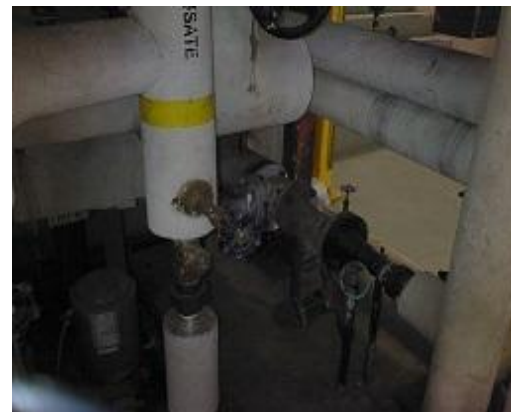
**Figure 28** Conventional image of same pipes.

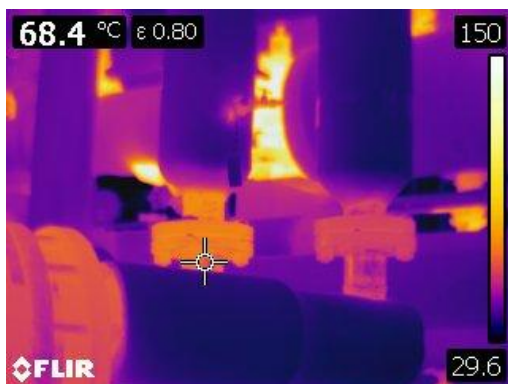
**Figure 29** Thermographic image of heat exchangers and pipe flanges to heat exchangers.

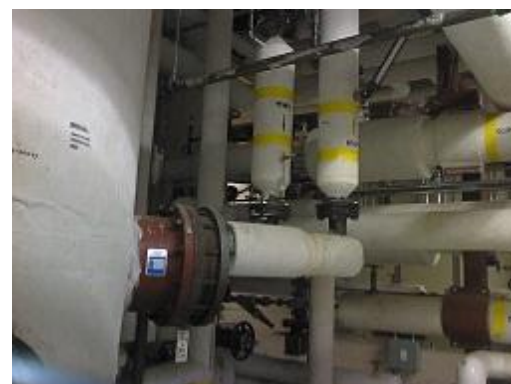
**Figure 30** Conventional picture of the same heat exchangers and flanges.

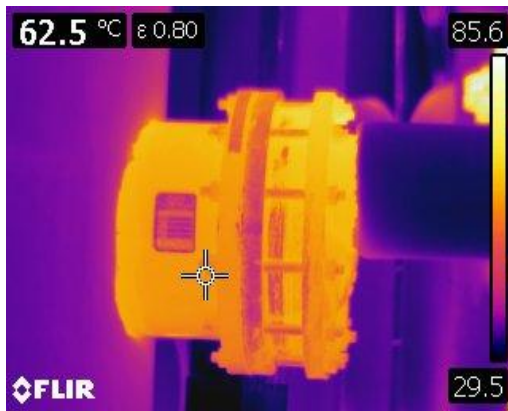
**Figure 31** Thermographic image of heat exchangers in the hot water tanks.

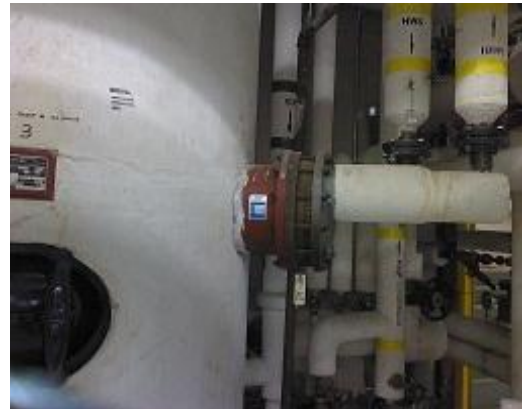
**Figure 32** Conventional image of the same heat exchanger.

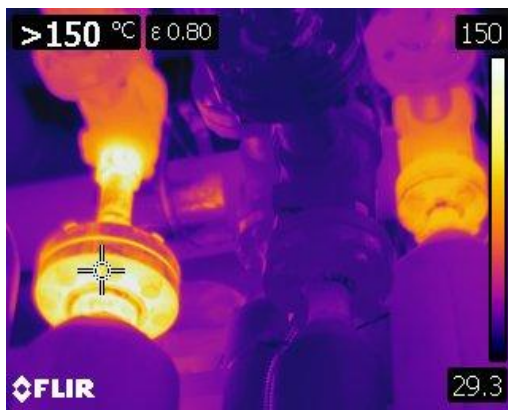
**Figure 33** Thermographic image of exposed steam lines at blow offs.

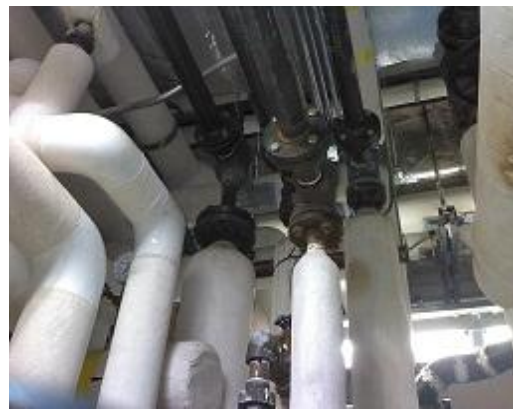
**Figure 34** Conventional image of the same pipes.

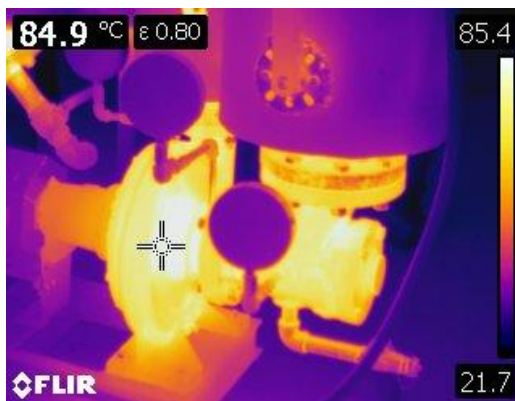
**Figure 35** Thermographic image of a motorized heating pump.

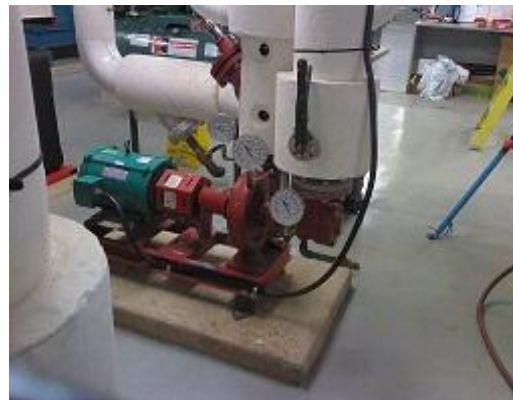
**Figure 36** Conventional image of the same pump.

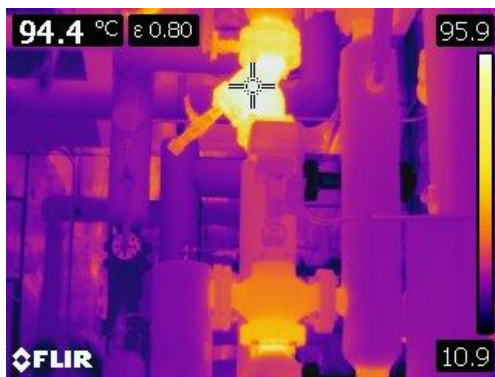
**Figure 37** Thermographic image of heating supply lines to unit.

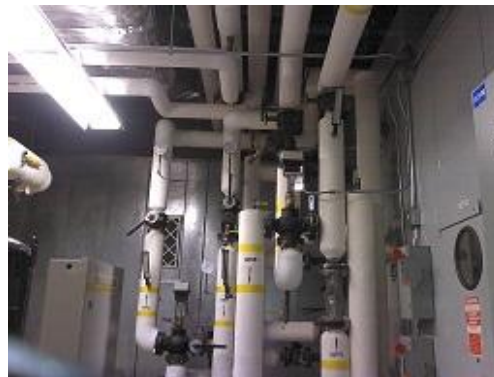
**Figure 38** Conventional image of the same lines to unit. Bare three way mixing valves and control valves.

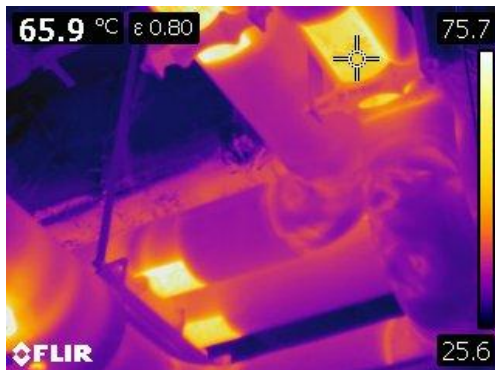
**Figure 39** Thermographic image of the pipe supports that have no insulation behind them. There are over 60 of these.

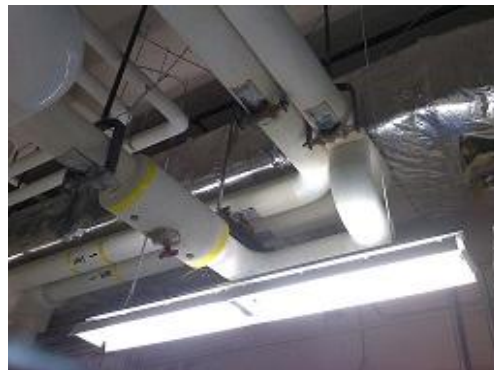
**Figure 40** Conventional image of the pipe supports in the fan room.

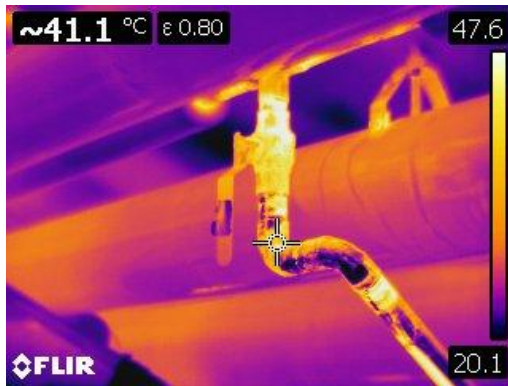
**Figure 41** Thermographic image of bare copper heating line in penthouse fan room.

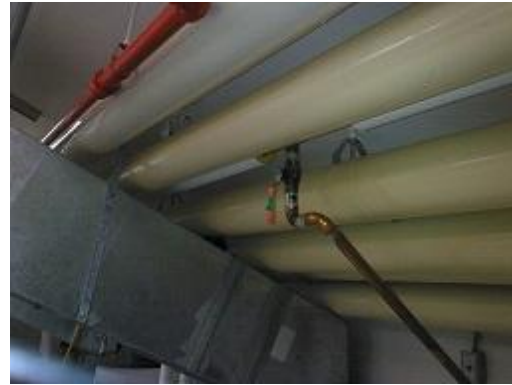
**Figure 42** Conventional image of the same copper line.

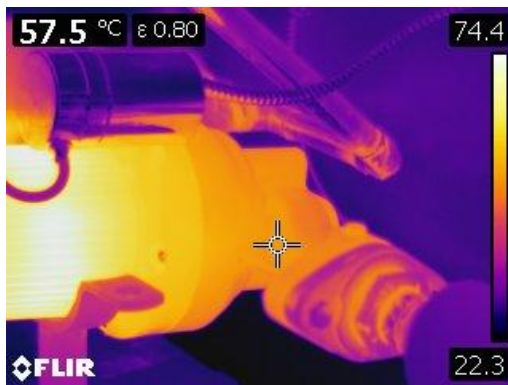
**Figure 43** Thermographic image of exposed heating pump.

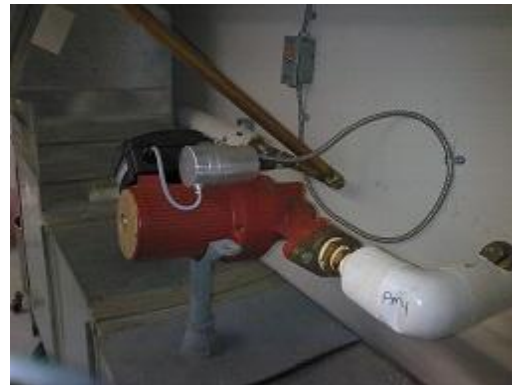
**Figure 44** Conventional image of the same pump.

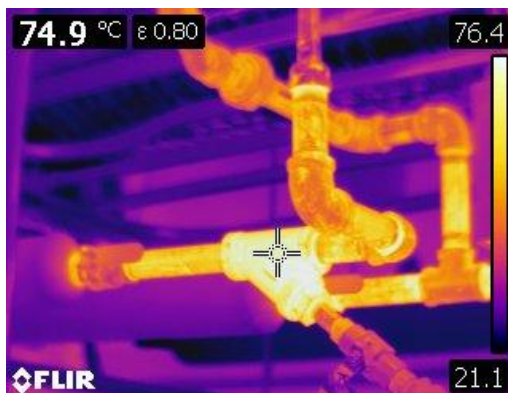
**Figure 45** Thermographic image of bare supply heating lines.

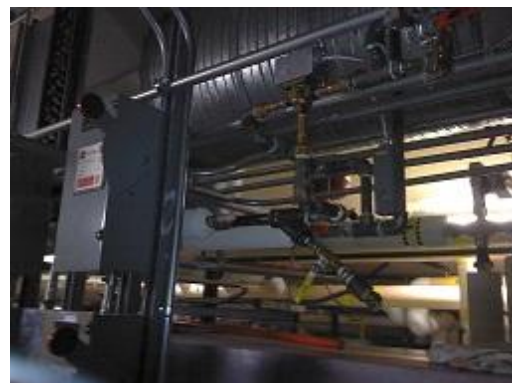
**Figure 46** Conventional image of the same piping.

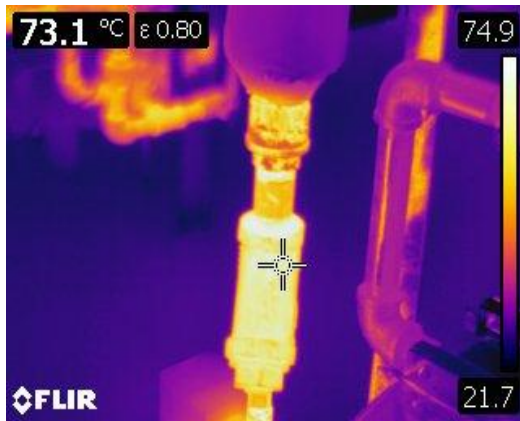
**Figure 47** Thermographic image of more bare heating supply lines to coils.

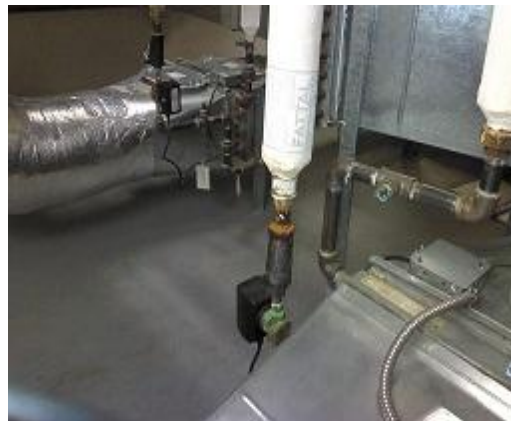
**Figure 48** Conventional image of the same iron heating lines to the coils.

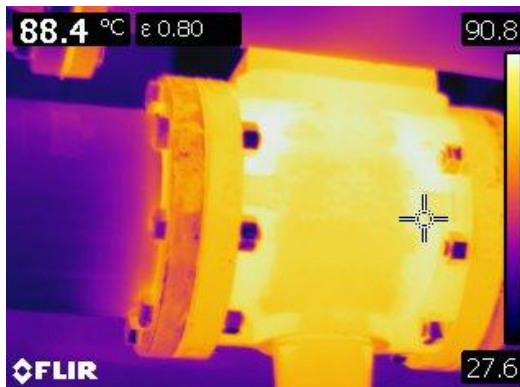
**Figure 49** Thermographic image of bare flow meter.

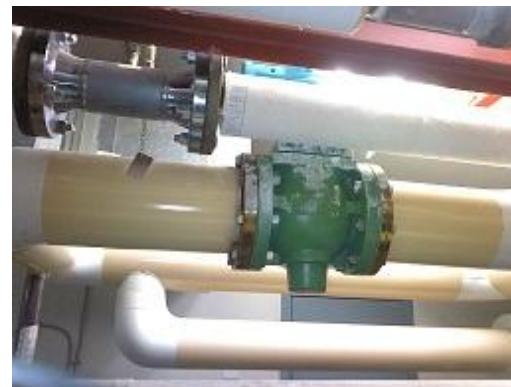
**Figure 50** Conventional image of the same flow meter.

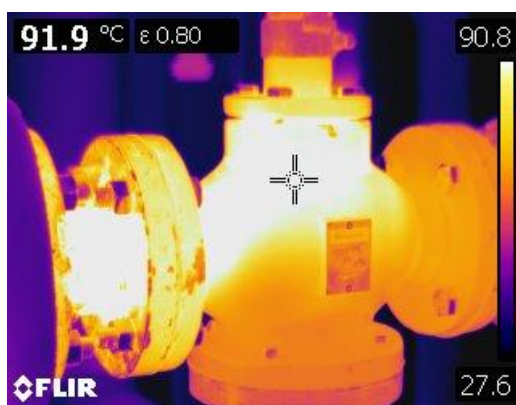
**Figure 51** Thermographic image of three way mixing valve.

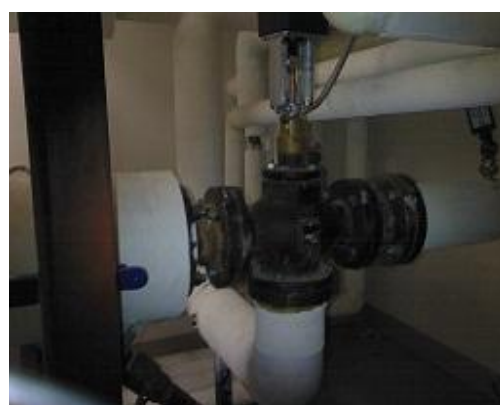
**Figure 52** Conventional image of the same three way mixing valve.

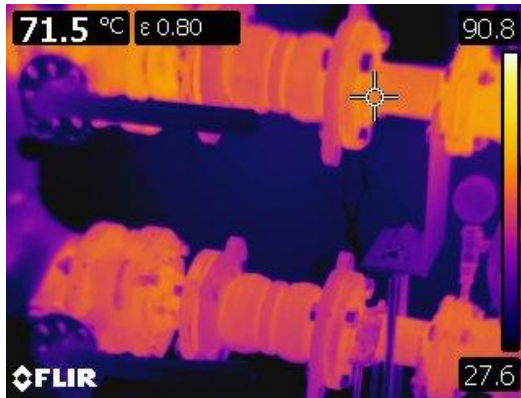
**Figure 53** Thermographic image of exposed heating supply to pumps.

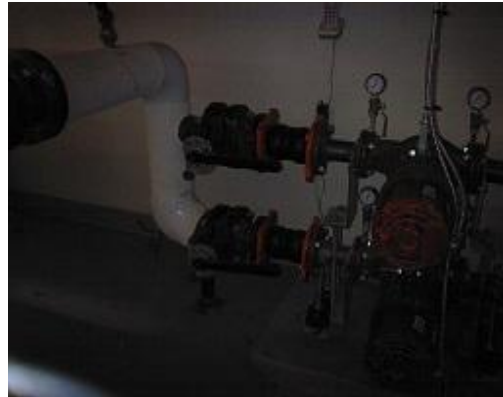
**Figure 54** Conventional image of exposed heating supply lines to pumps.

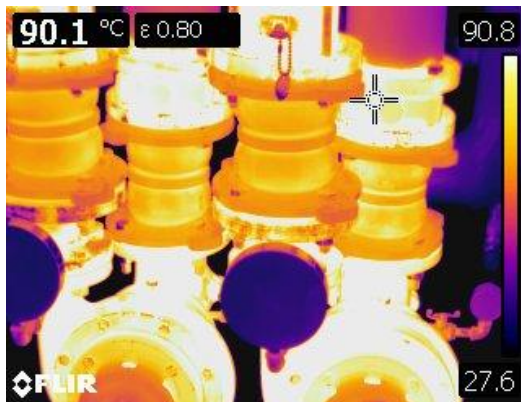
**Figure 55** Thermographic image of exposed heating pumps and associated piping.

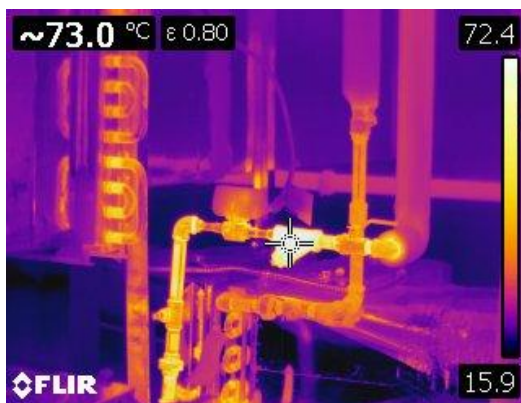
**Figure 56** Thermographic image of heating supply lines to coils.

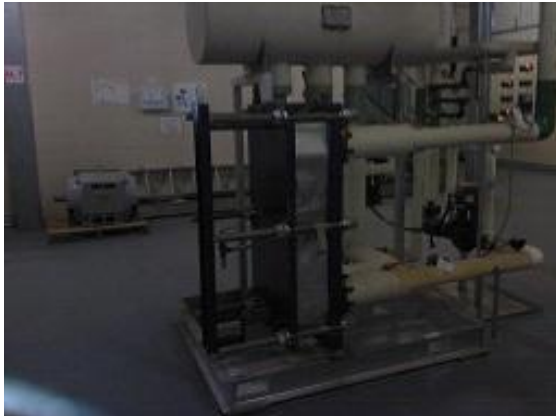
This heat exchanger was photographed with the Flir camera but the thermal image was not saved and not reproduced. This exchanger should be insulated as it will be a source of heat loss or gain.

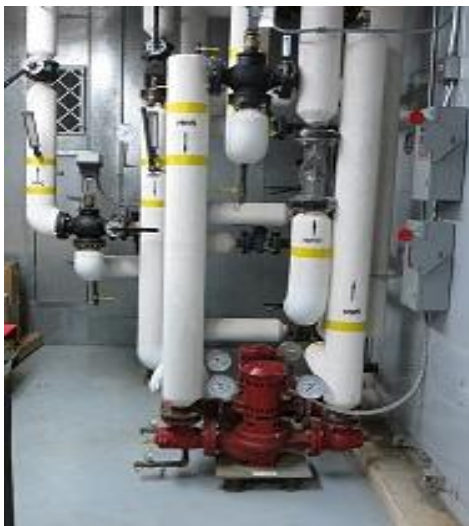
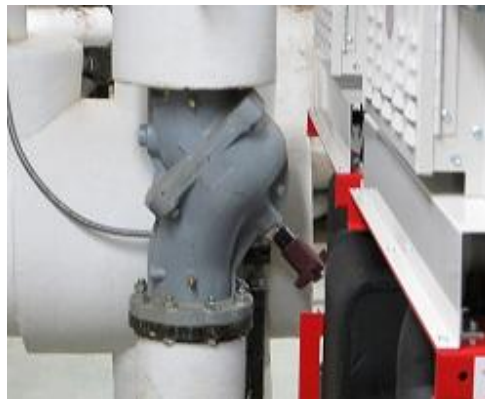
There are many sources of heat loss in this fan room. Heating pumps, valves and flanges and large bore control valves are primary sources of heat loss and need to be insulated. There are also many steam traps of various sizes that can and should be insulated to maximize efficiency.

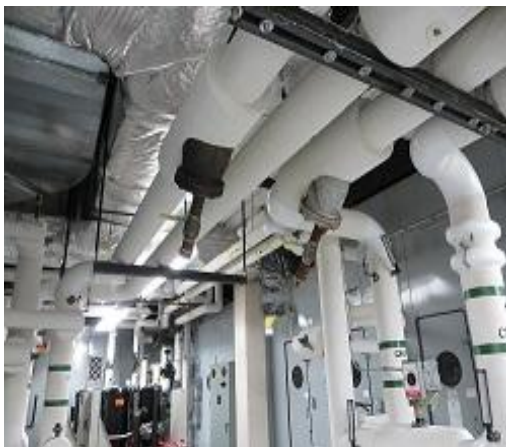
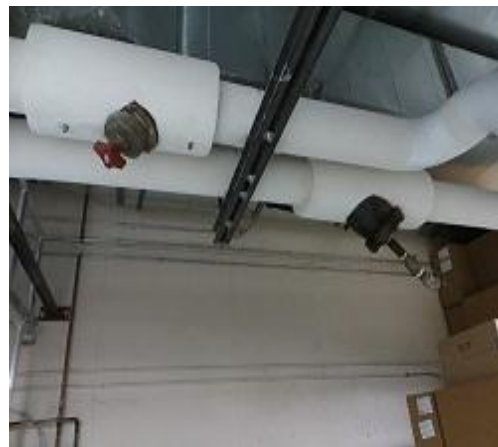
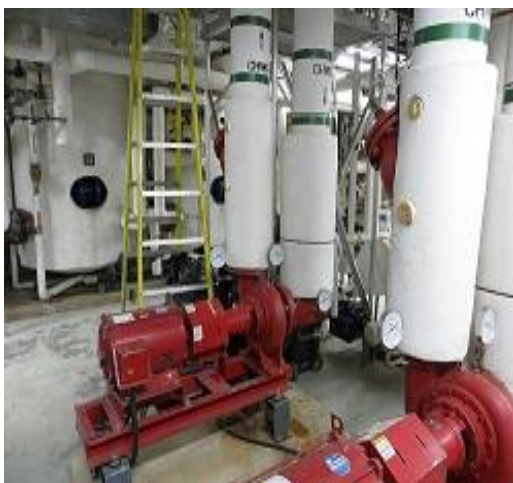
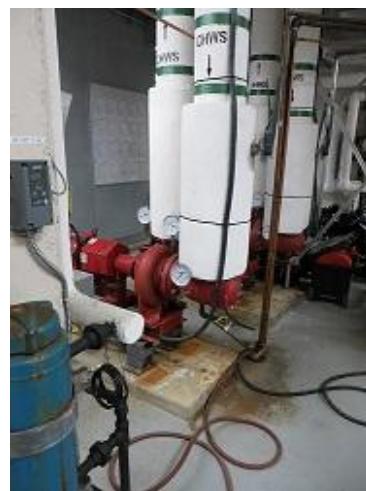
During the inspection of this fan room we noticed that the work done on the chilled systems was done very well with a couple of exceptions. We observed missing insulation in a number of areas. The stains on the floor and the rust on the unpainted surfaces are a clear indication of the pipes sweating. This can destroy the insulation system as there is not a 100% vapor barrier seal and it can also affect the surface of the pipe itself by causing corrosion of the substrate.
