SALAMANDER INSPECTIONS LTD

Mechanical Insulation Energy Audits

Energy Audit

For Alberta Infrastructure
Building 6950 – 113 Street, Edmonton
Alberta

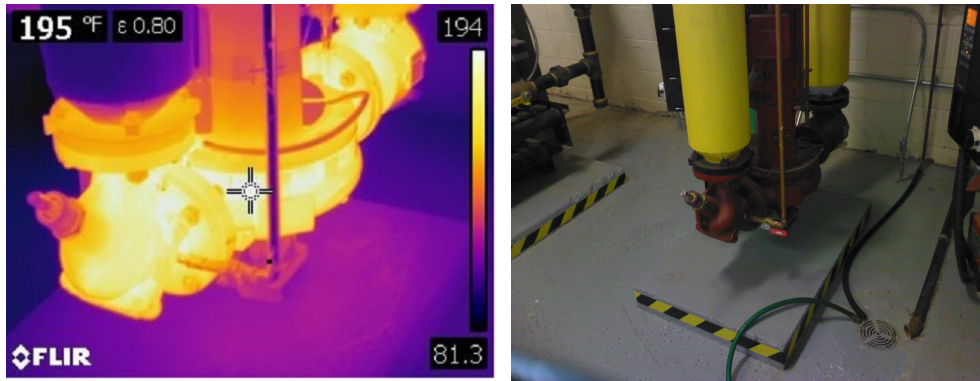
Heating pumps in the Alberta Infrastructure Building boiler room.

This heating pump, as photographed by the FLIR camera uses sensors within the camera to show the heat radiating from the pump. The brighter the color the hotter the temperature of the object. The camera must be set up to filter out the ambient heat from surrounding objects to ensure that the temperatures are accurate. The camera then takes a thermal image as well as a digital picture for reference.

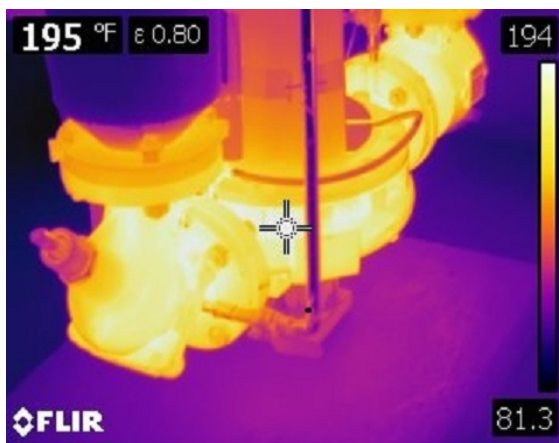
Bare heating pumps in the Boiler Room

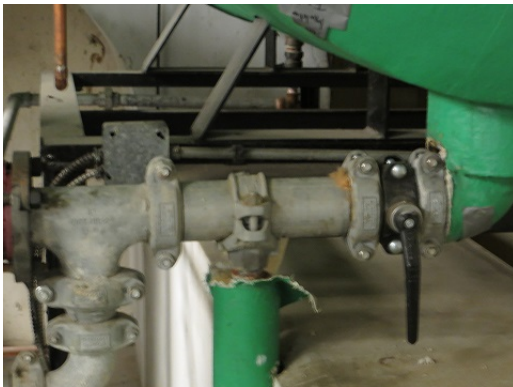
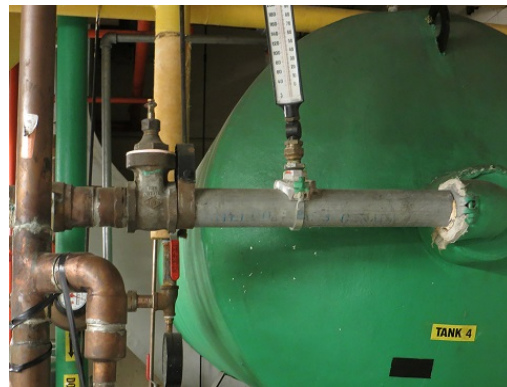
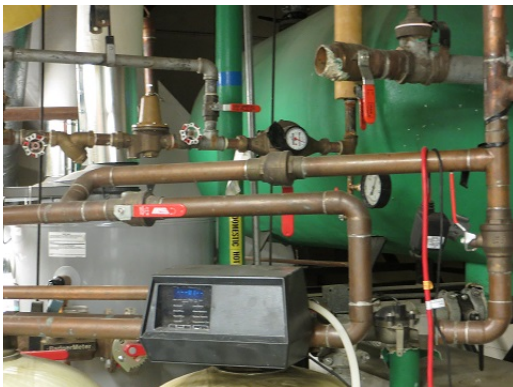
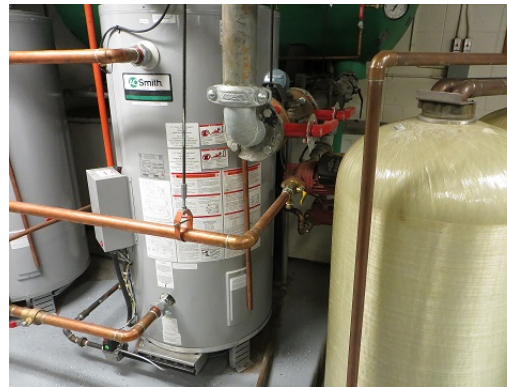
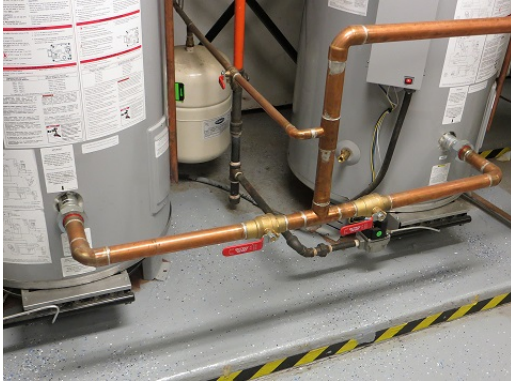
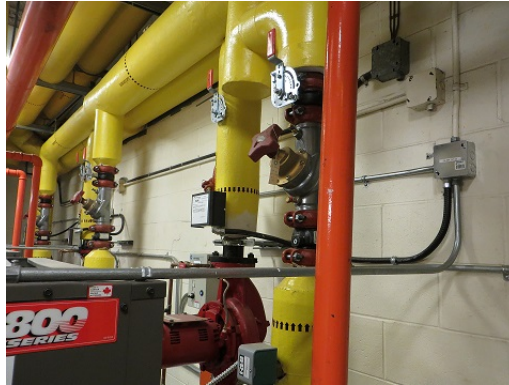
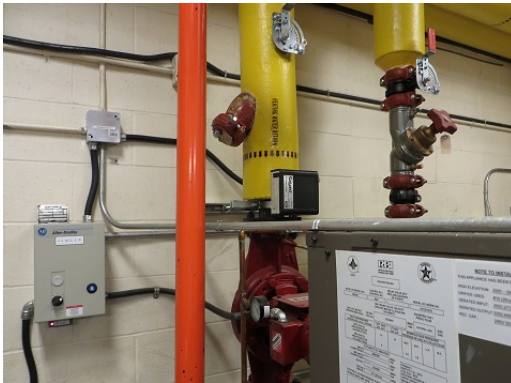
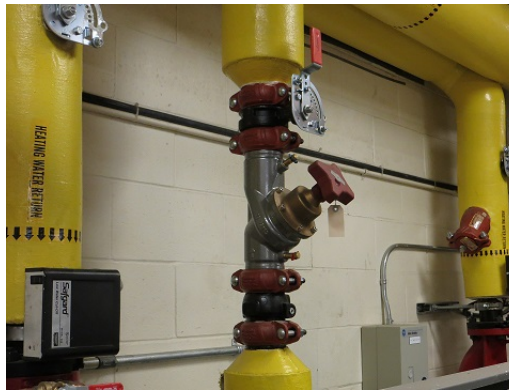
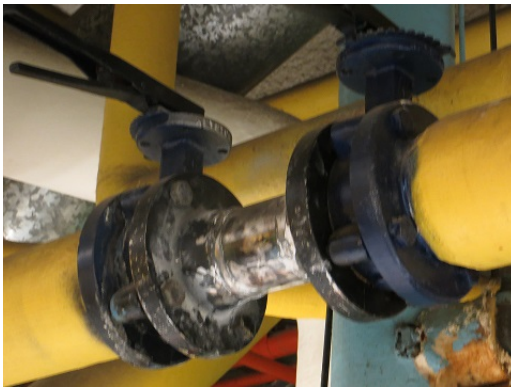
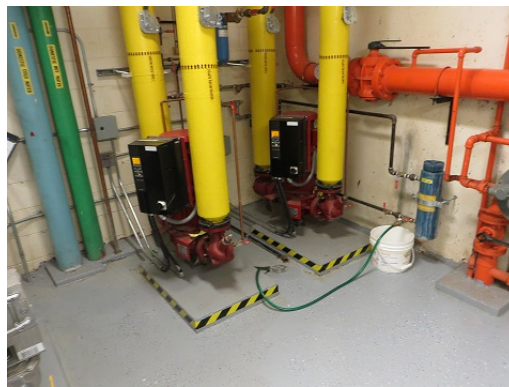
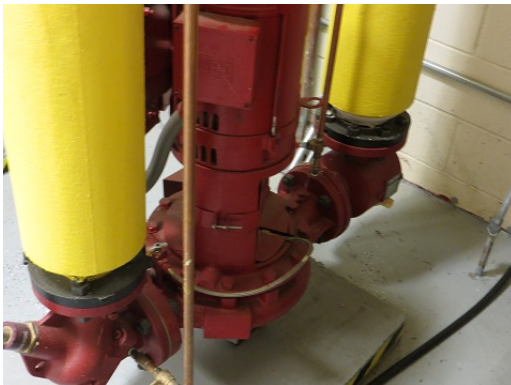
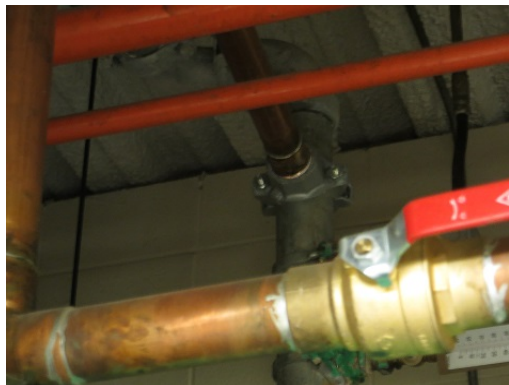
We have assessed the boiler room and found that the insulation applied to the mechanical systems is in good condition. However there are some instances where heating pumps, valves and piping remain without insulation applied and therefore, an opportunity to receive some savings is available. There has been recent maintenance work done in the Boiler Room and the piping to the domestic hot water tanks was replaced as well as the tanks, but insulation was not applied to the copper piping servicing the tanks which should have been included when the work was completed. **The boiler room comprises 95% of all items on the 3e spreadsheet.**

There are also control valves and motorized pumps which have been left exposed at the back of the boilers. These valves and pumps are a source of heat loss and the main reason why the boiler room is so warm. These pumps should be insulated and we would recommend that removable pads be used to ease maintenance. These types of insulating pads however need to be re-applied whenever work is done as insulation laying on the floor defeats its purpose.

We also recommend that best practices be followed on all insulation work new or retro fit, and that certified insulators do the work to ensure that best practices are followed. This report contains visual inspection of these systems utilizing thermo graphic analysis and conventional digital photographs for reference.

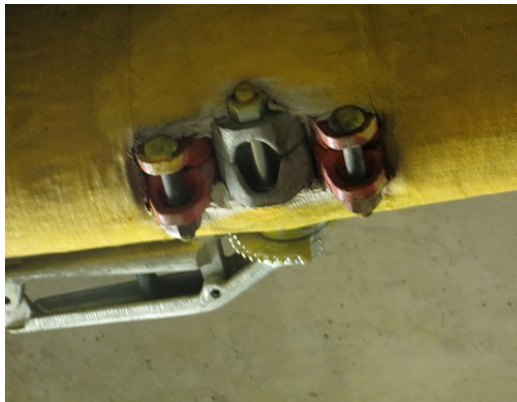
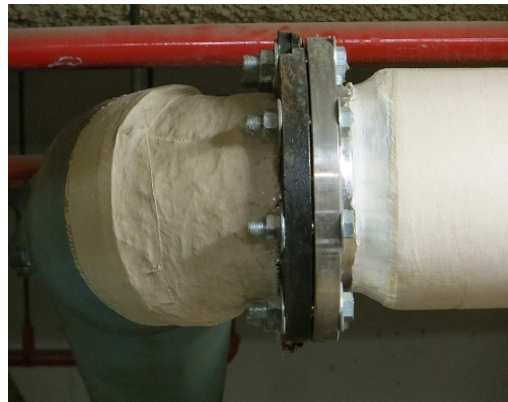
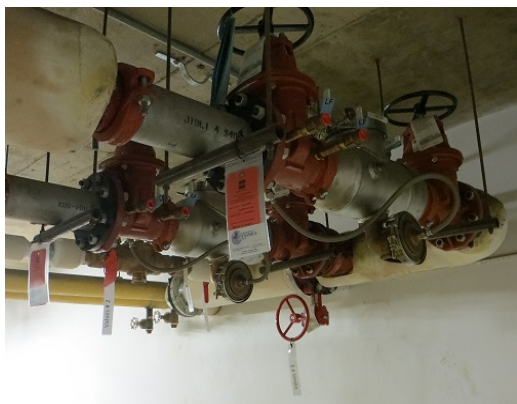
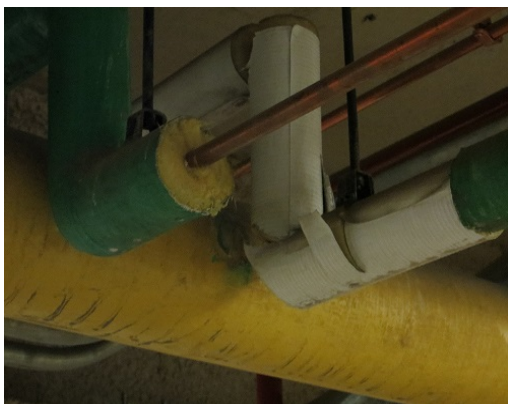
Parking Garage

Our walkthrough of the parking garage revealed that there are many areas where insulation has been removed for maintenance repairs and upgrade, but upon the completion of the work once again the insulation was not applied. We also observed that the original insulation applied was in good condition but we noticed that whoever did the original work did not cover the knuckles on the Victaulic fittings. This is very unusual as this practice compromises any attempt at having a vapor barrier that is integral on the domestic cold and chilled systems and a small amount of heat loss on the heating systems. This type of poor detail work can become a problem especially on cold and chilled systems as there is an opportunity for moisture to form on the piping and corrosion to take place.

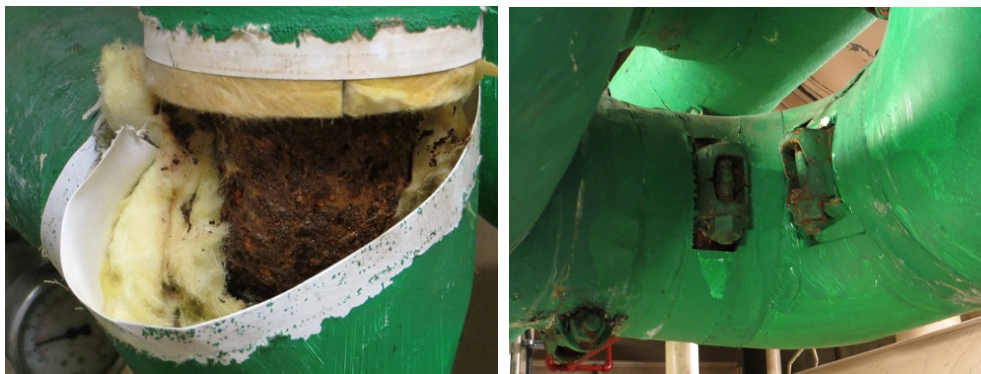
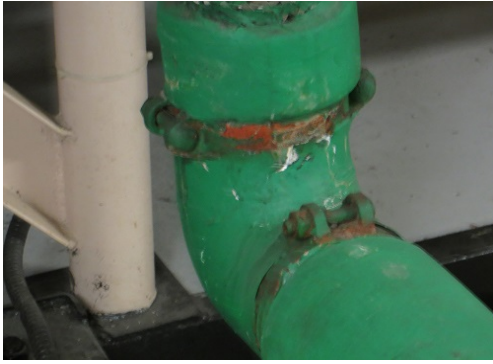
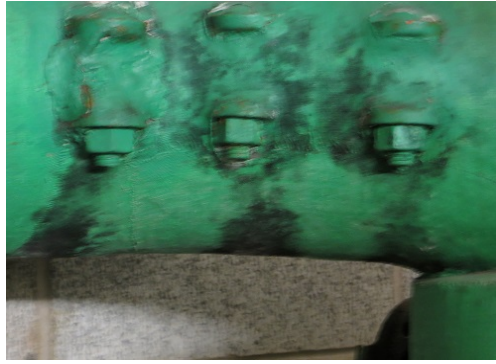
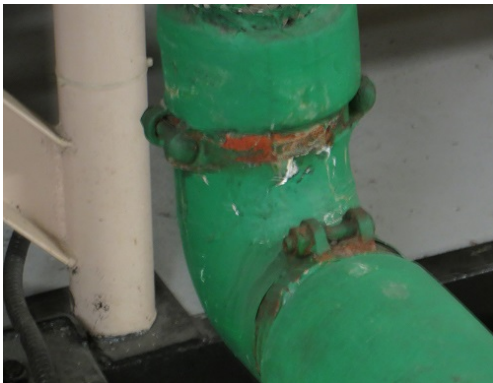
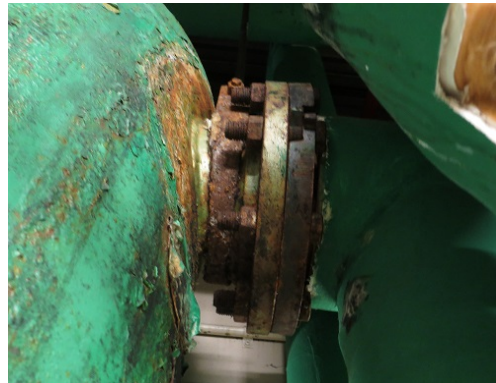
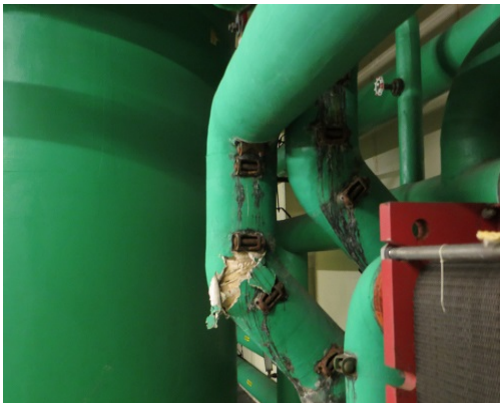
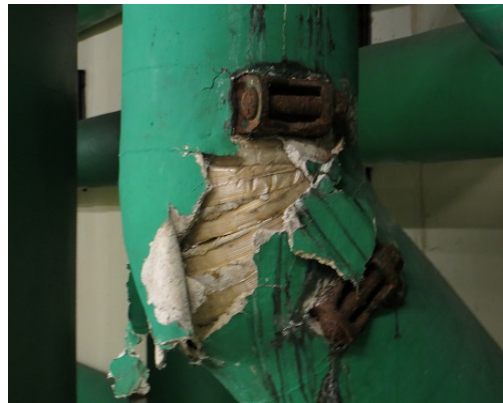
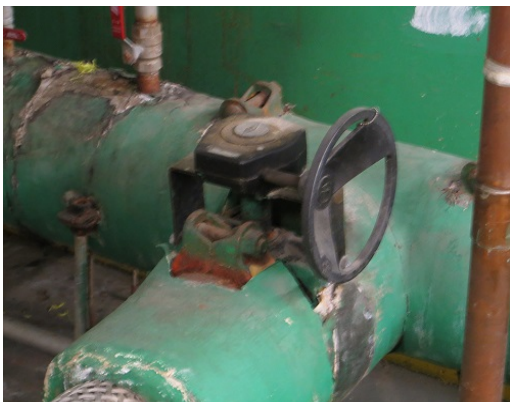
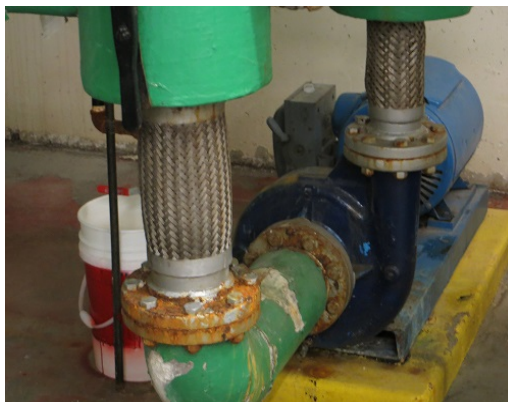
Penthouse Chilled Systems

We have inspected the chiller room on the parking garage level. The insulation applied to the chilled systems in fair condition, but there are many instances where insulation has been removed for maintenance and the upgrade of chillers and many other areas where there are bare knuckles on the Victaulic fittings. There are many areas where what appears to be black mold around these knuckles and other areas where the vapor barrier is compromised from poor insulation practices. We noticed that many elbows (PVC) were cracked or broken showing us that the insulation underneath was bare fiberglass with no integral vapor barrier. The contractor was intending that the PVC elbow would provide the vapor barrier, however, PVC is one component of an effective vapor barrier system and not a “stand alone” vapor barrier, especially as soon as there is damage to the PVC covering the vapor barrier is compromised. We did a physical count of just the exposed knuckles and noted that the count was eighty (80). Looking at pipe where there was no insulation corrosion was built up on the elbows and piping, insulation contractors must ensure a 100% vapor barrier to prevent the buildup of corrosion.

We walked through the two penthouse mechanical rooms to inspect the chilled and heating systems. We found that the insulation applied on the chilled systems was in the same state as the insulation found in the chiller room adjacent to the parking garage. We observed black mold forming at the Victaulic elbows and clamps as was the case in the other mechanical room and we also did a physical count of exposed Victaulic clamp ears and found that 140-160 knuckles exposed causing the vapor barrier to fail and consequently producing what appears to be black mold. The heating system was intact and with the exception of exposed unions, workmanship is good the system was intact.

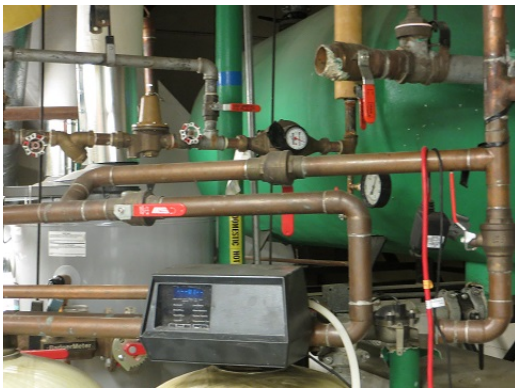
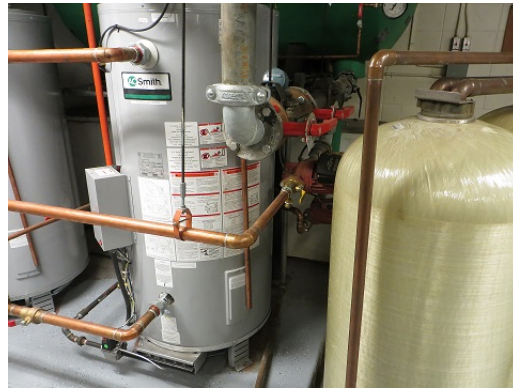
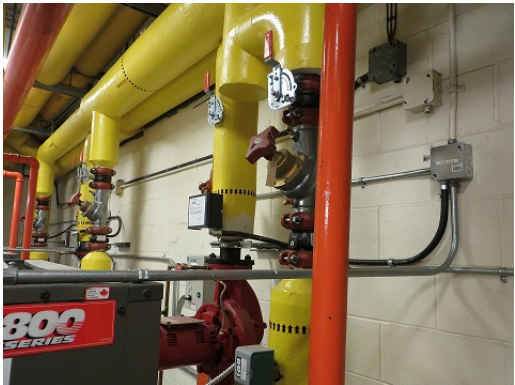
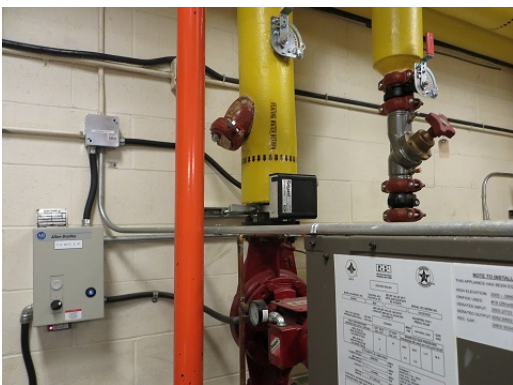
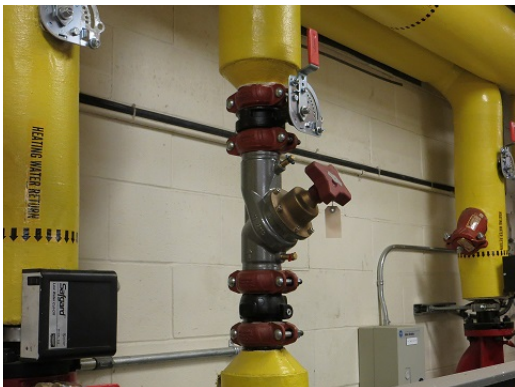
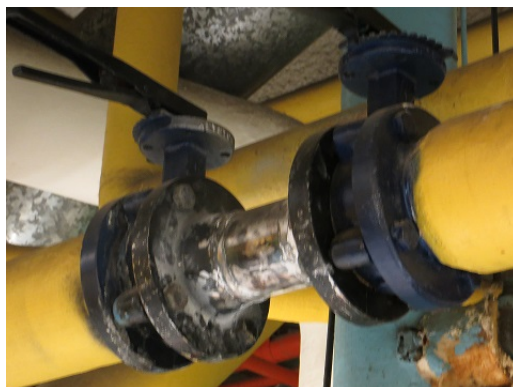
Personnel Protection

We also would like to address the hazards that the hot exposed items present to personnel. The boiler rooms and fan rooms generally are tightly packed with equipment and piping systems operating up to 121°C, the systems and equipment which are not insulated leave many opportunities for employees and maintenance personnel to come in contact with these surfaces which can burn skin. Properly insulated systems and equipment eliminate the possibility of individuals coming into contact with these hot surfaces and will prevent accidental burns which will add value by individuals not having claims and or lost time incidents.
