Mechanical Insulation Energy Audits

Energy Audit

For the Brownlee Building
10365 – 97 Street, Edmonton Alberta

April 5, 2016

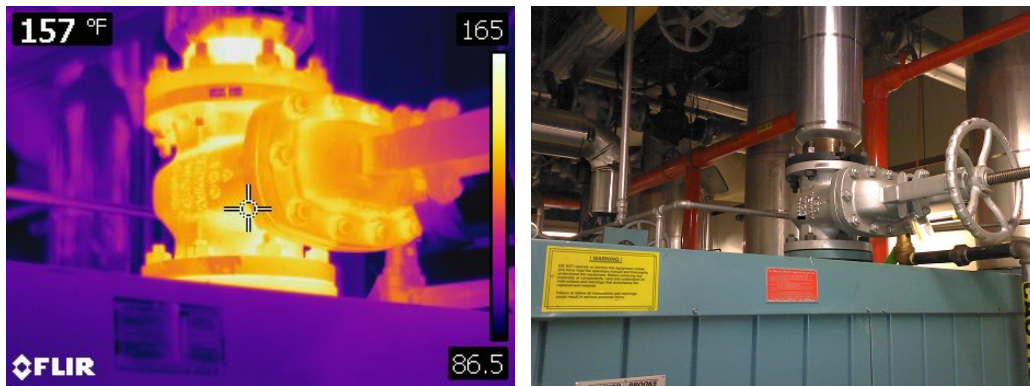
Exposed valves in the boiler room of the Brownlee Building as seen by the thermographic camera.

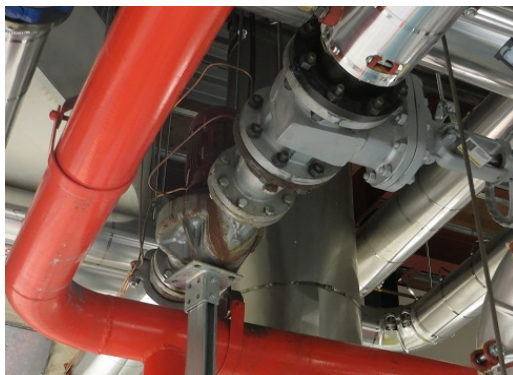
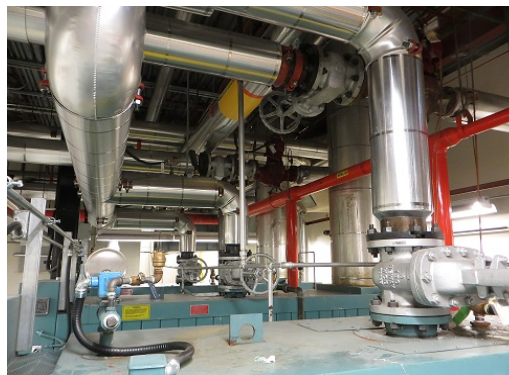
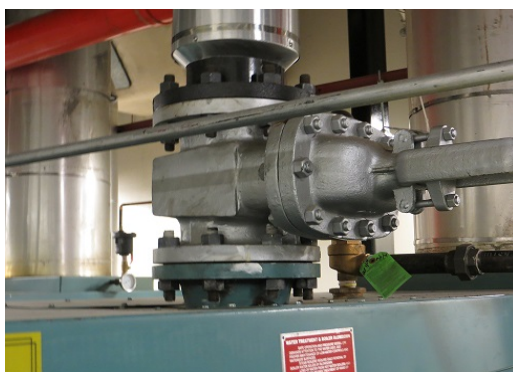
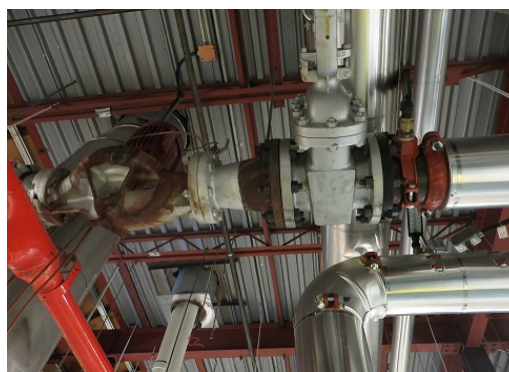
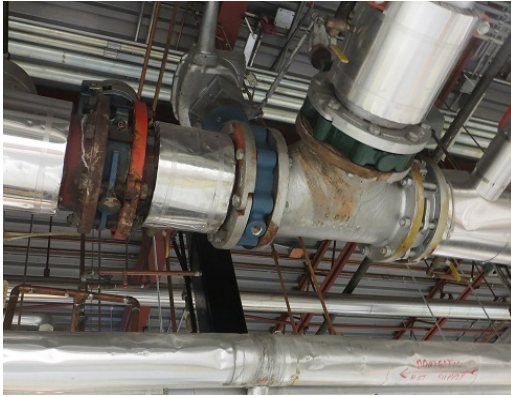
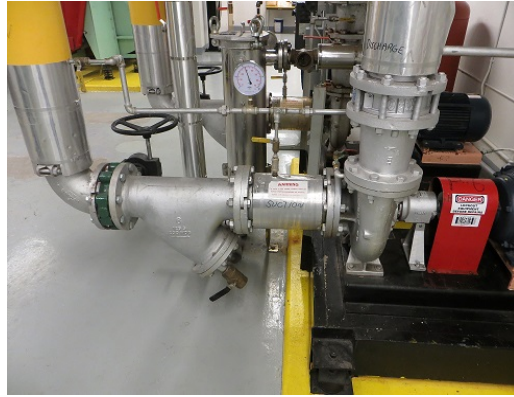
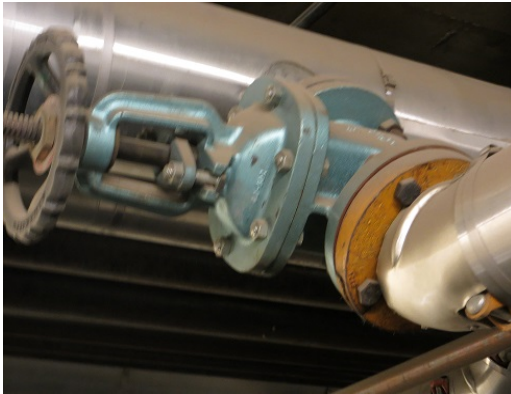
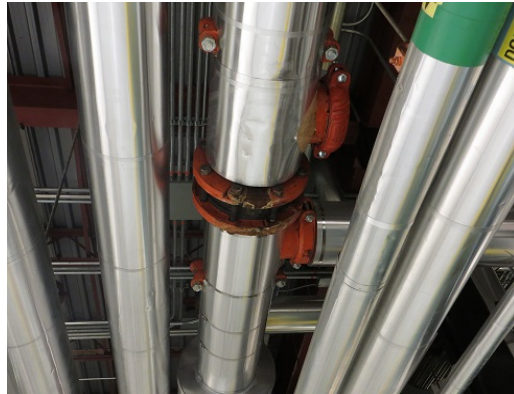
Boiler Room and Penthouse Fan Rooms

We have assessed the boiler room and found that the insulation applied to the mechanical systems is in good condition. However, there are some instances where pumps, valves and piping have no insulation applied and therefore, an opportunity to receive some savings is available. During the course of this inspection we counted at least (13) valves, (2) strainers, (6) pumps and a number of flanges and couplings as well as and other areas which should be insulated.

The workmanship of the existing insulation is in good condition but some bad practices were followed when these materials were installed. We observed that the metal cans (elbows) installed in the boiler room and in the adjacent fan rooms were cut open to allow the ears of the Victaulic clamps to be exposed rather than oversize the insulation materials to completely enclose the elbow. This practice was also done to some of the chilled system and the vapor barrier is compromised in these areas. There isn't a reason to not insulate valves, piping and or fittings but to achieve cost savings at the time of construction or a specification which allowed these practices to take place. We can now show that not insulating pipes hot or cold will cost money for the operation of the building and or repairs to equipment or piping. The report contains visual inspection of these systems utilizing thermographic analysis and conventional digital photographs for reference. **The boiler room comprises 90% of the items listed on the 3e spreadsheet.**

Upon consideration of all observed conditions and the information gathered from the 3EPlus program, we recommend that all areas identified within this report be insulated or repaired. We also recommend that **Best Practices** be followed when applying insulation to these items as any deviation from applying insulation will reduce any potential savings. For example, we know that the elimination of canvas can shorten the lifespan of fiberglass with an ASJ finish because of the lack of a protective cladding system. We also recommend using removable insulating pads where necessary or feasible. This will allow maintenance to take place by removing the insulation pad whenever maintenance needs to take place.

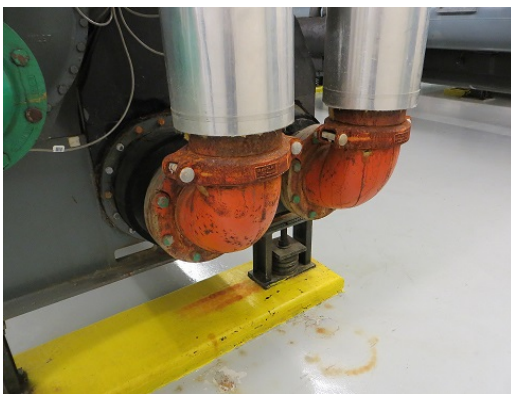
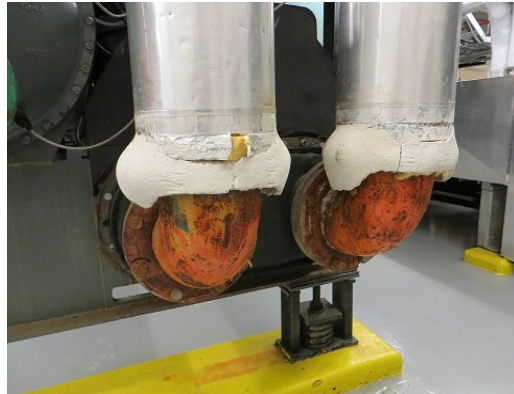
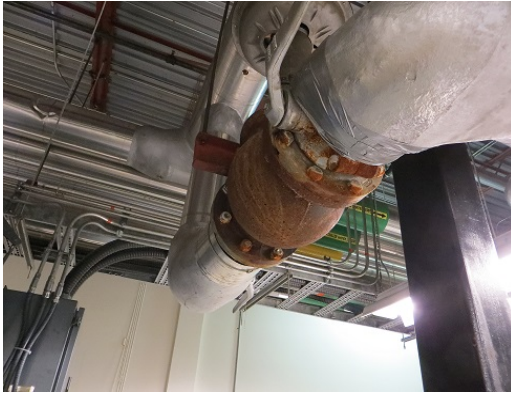
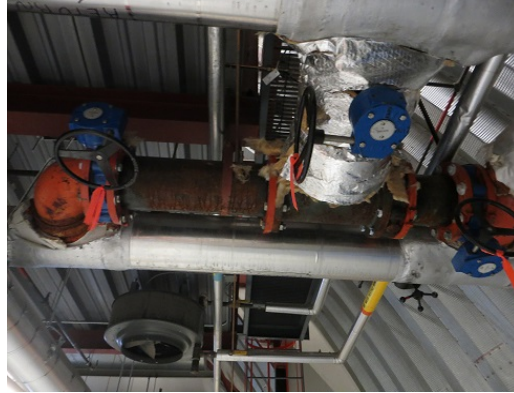
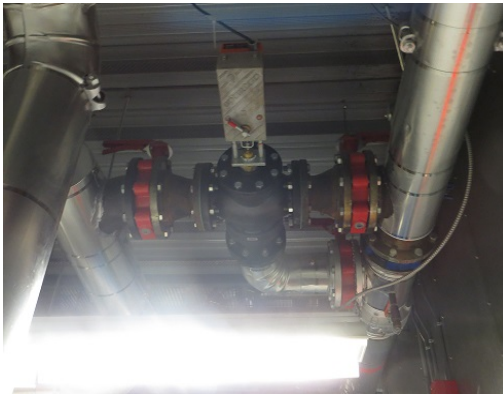
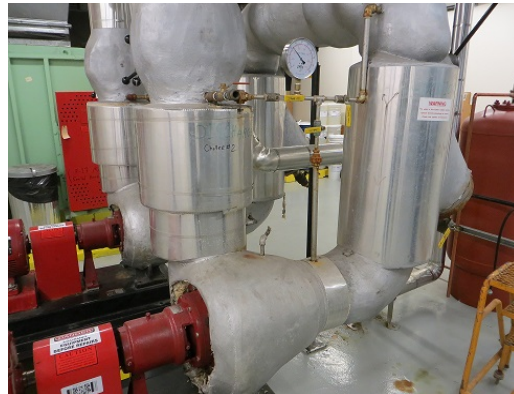
Chilled Piping

We have inspected the chilled mechanical piping and found most of the system was well insulated and the workmanship good. We have found areas where obvious maintenance has taken place and the insulation has yet to be applied in these areas. There were areas where oversize insulation was not applied to the Victaulic ears compromising the vapor barrier. At the time of inspection the chilled system was not operational and we could not confirm that the exposed piping, valves or pumps was condensing for lack of mechanical insulation.

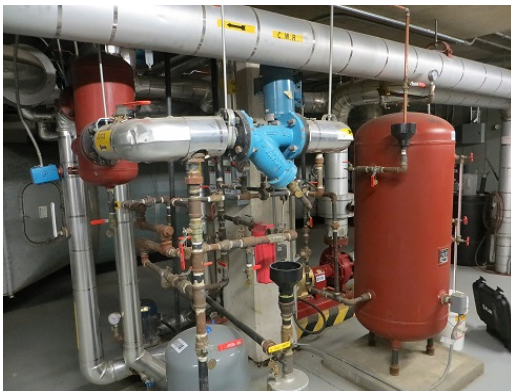
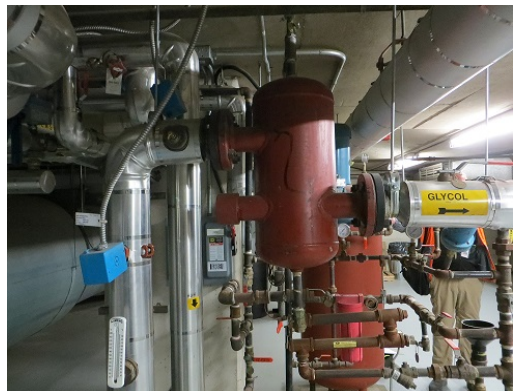
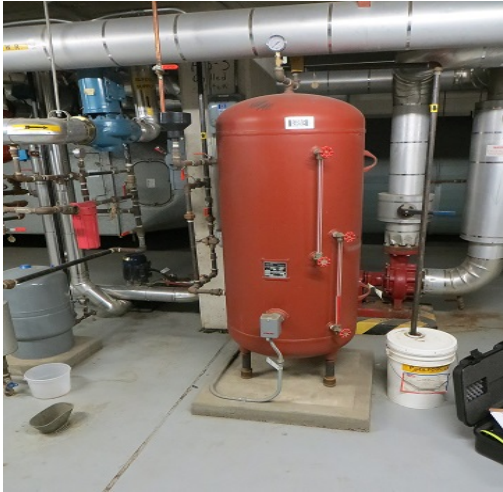
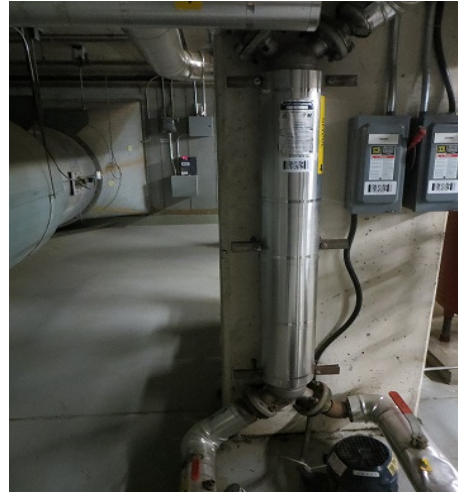
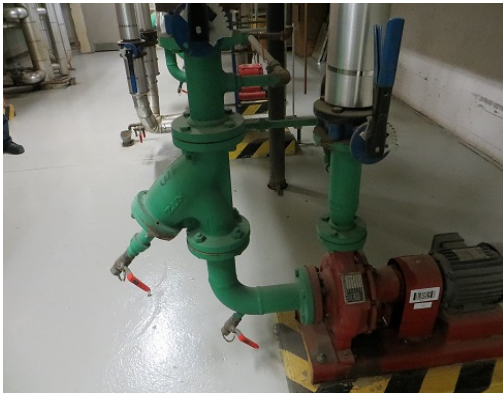
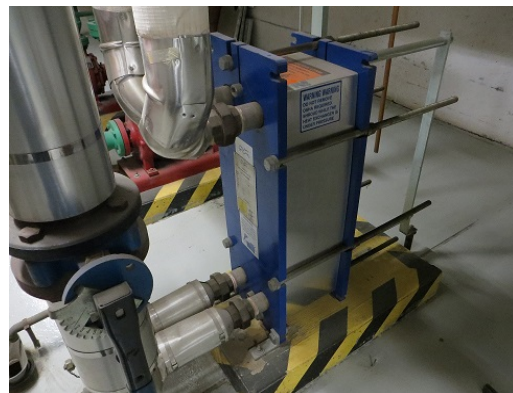
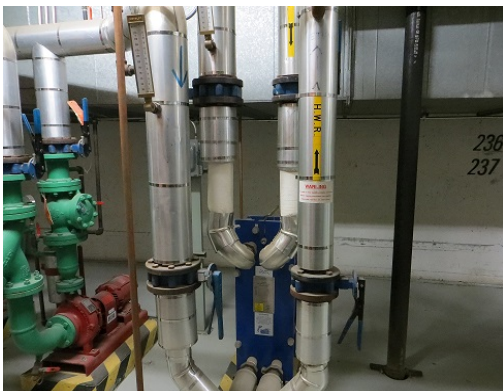
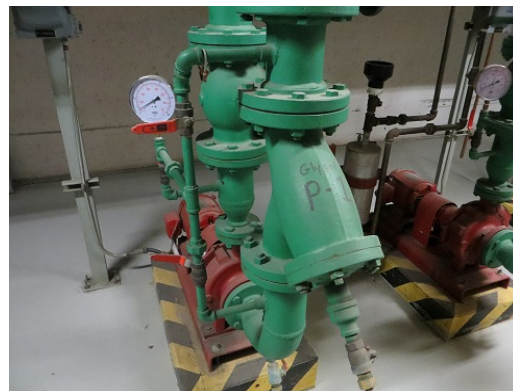
Mechanical Room in Parking Garage

We have inspected mechanical room AS-3 and found that there are valves, piping, pumps and a heat exchanger that have not been insulated. There are signs of maintenance that have been done and the mechanical insulation has not been repaired or replaced.

At the time of the inspection of this area both the heating system and cooling system were not active. The thermographic images which are in the appendix (Pictures) show very low temperatures for both cooling and heating. There are still many areas within this room and the connecting fan rooms on other levels of parking garage which have exposed piping and equipment that should be insulated to maximize efficiency.

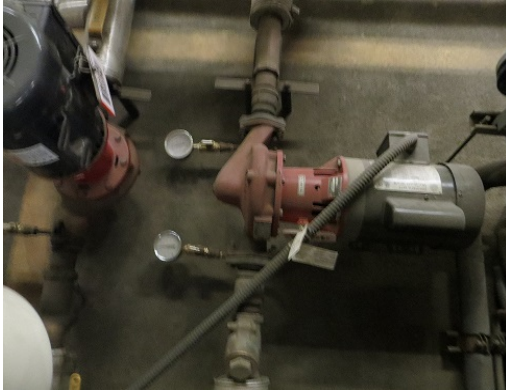
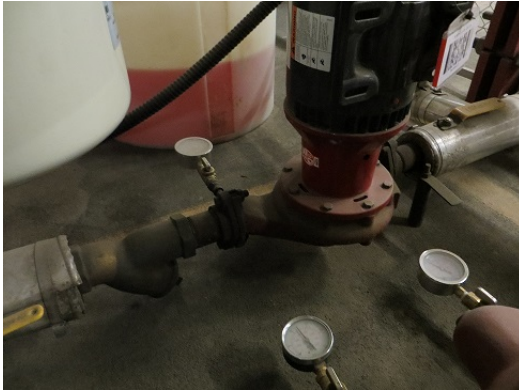
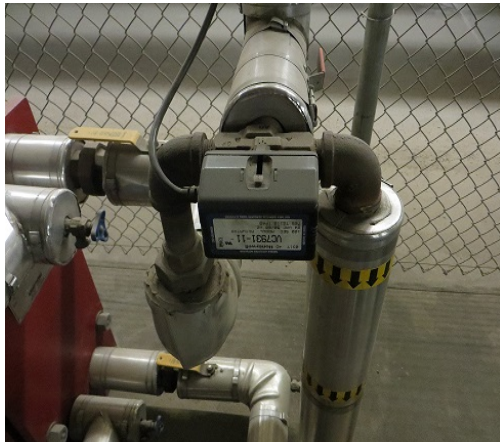
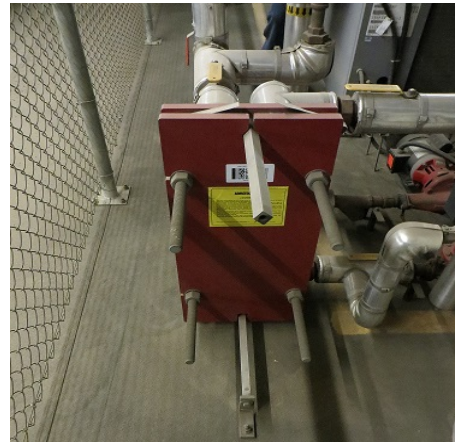
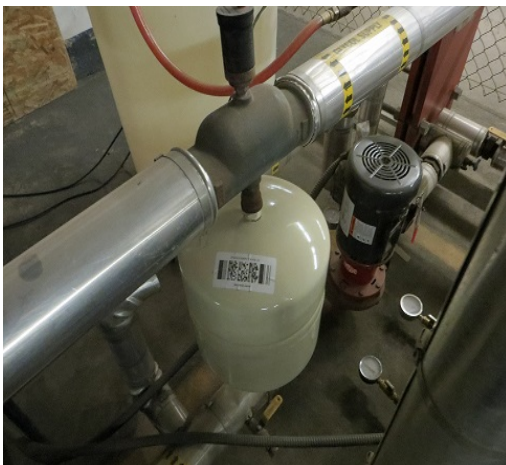
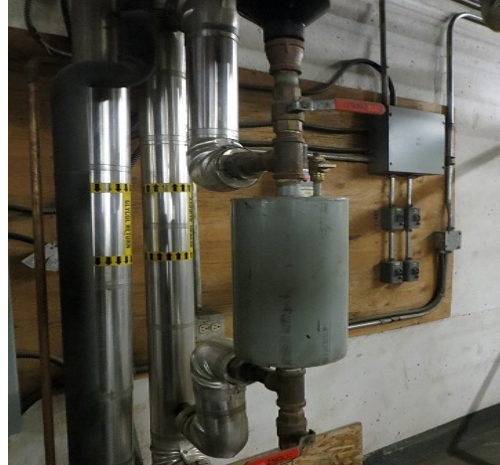
Parking Garage

The insulation materials applied to the piping in the parking garage is in good condition. The same application methods have been used in this space with various amounts of insulation not done or missing from maintenance work and possibly from specifications not requiring it. In our conversations with maintenance personnel their view is that the missing insulation on the heating side is helping to heat the space during the colder months.

Items missing insulation	in parking garage	
Elbows	2 inch	2
Elbows	6 inch	2
Valves	½ inch	8
Valves	¾ inch	10
Valves	1 inch	7
Victaulic Clamp Ears		29
Piping	1 inch	3 ft
Piping	½ inch	2 ft

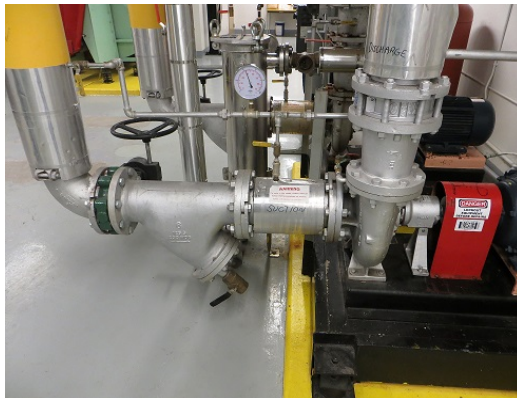
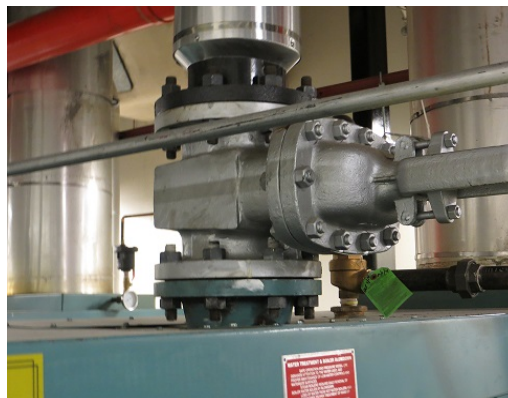
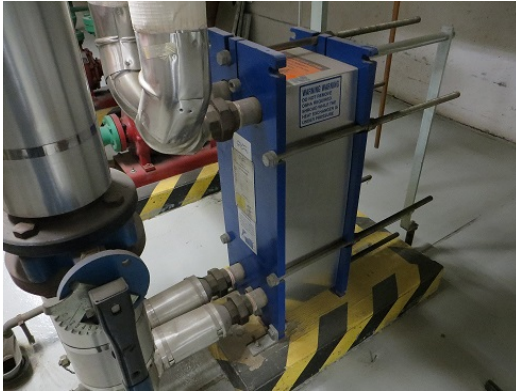
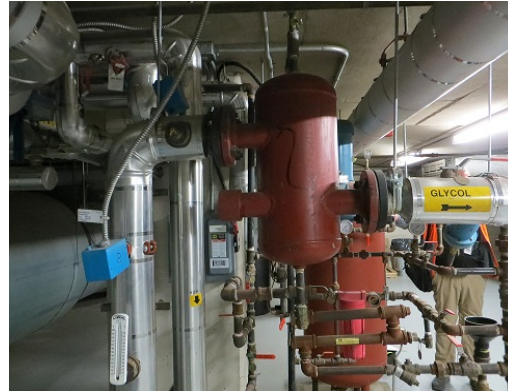
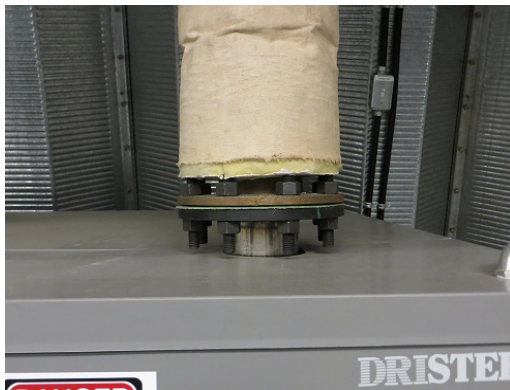
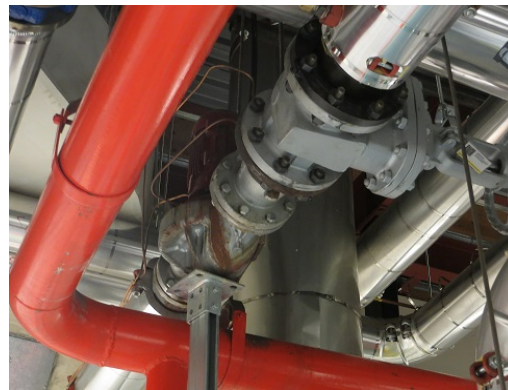
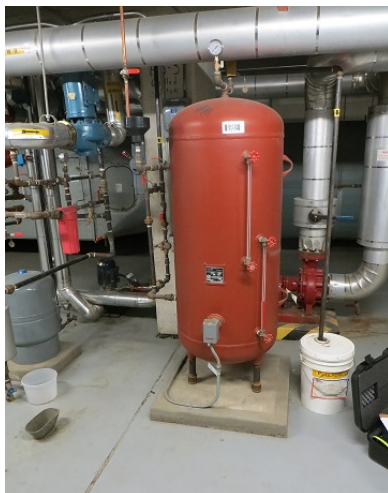
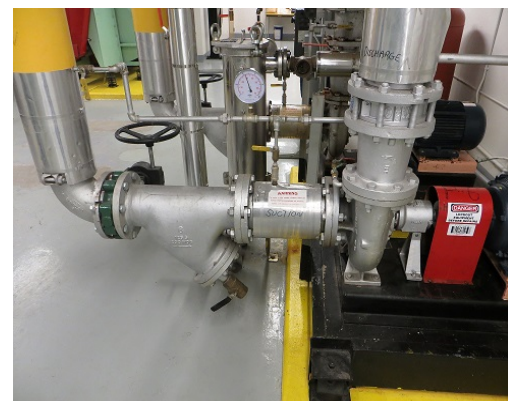
Personnel Protection

We also would like to address the hazards that the hot exposed items present to personnel. The boiler rooms and fan rooms generally are tightly packed with equipment and piping systems operating up to 121°C, the systems and equipment which are not insulated leave many opportunities for employees and maintenance personnel to come in contact with these surfaces which can burn skin. Properly insulated systems and equipment eliminate the possibility of individuals coming into contact with these hot surfaces and will prevent accidental burns which will add value by individuals not having claims and or lost time incidents.
