# SALAMANDER INSPECTIONS LTD

Mechanical Insulation Energy Audits

## Energy Audit

For Red Deer Provincial  
Building 4920 – 45 Street  
Red Deer, Alberta

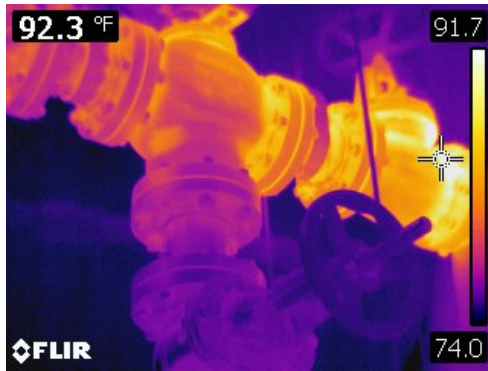
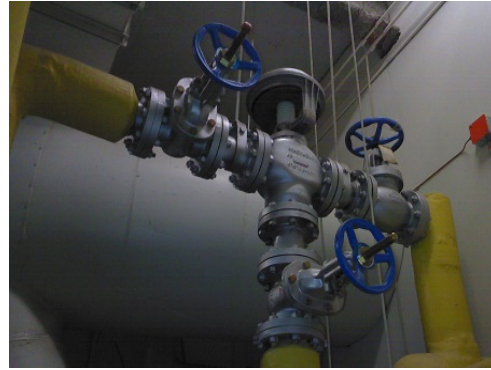
Bare heating valves in the Red Deer Provincial Building fan room.

This three way control valve, as photographed by the FLIR camera uses sensors within the camera to show the heat radiating from the valve. The brighter the color the hotter the temperature of the object. The camera must be set up to filter out the ambient heat from surrounding objects to ensure that the temperatures are accurate. The camera then takes a thermal image as well as a digital picture for reference.

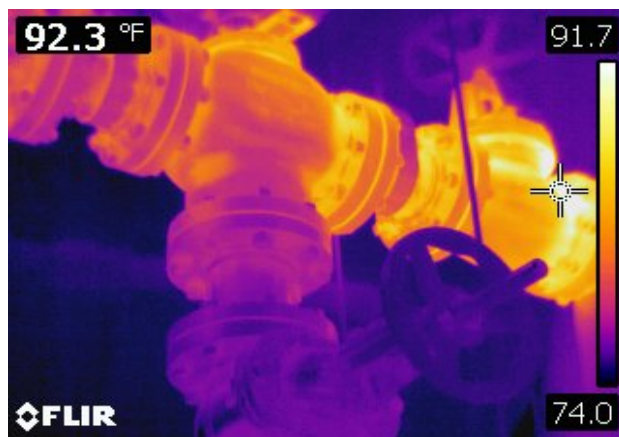
There are some areas where pumps, valves and piping remain without insulation applied.

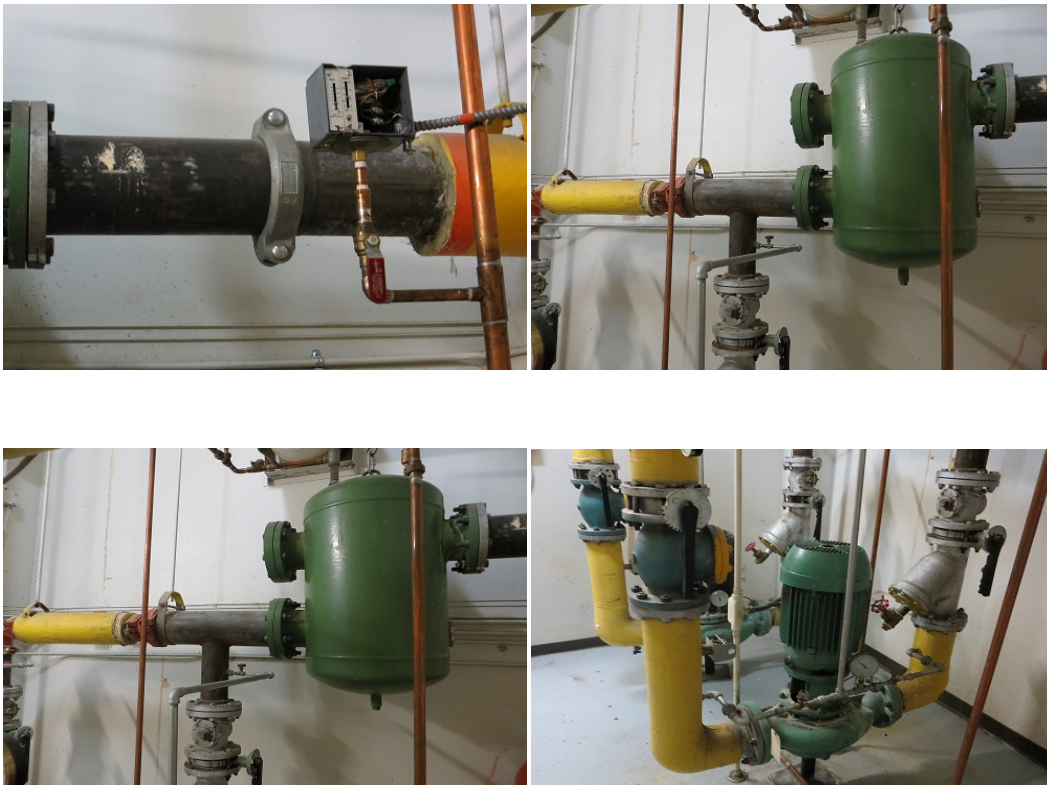
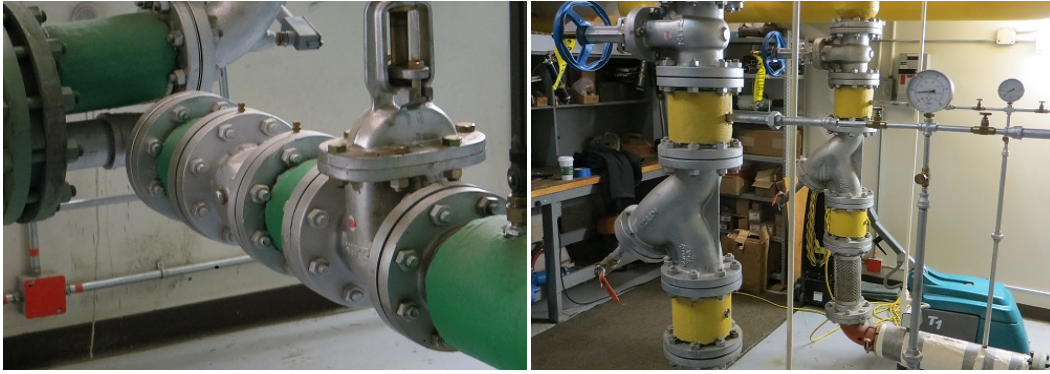
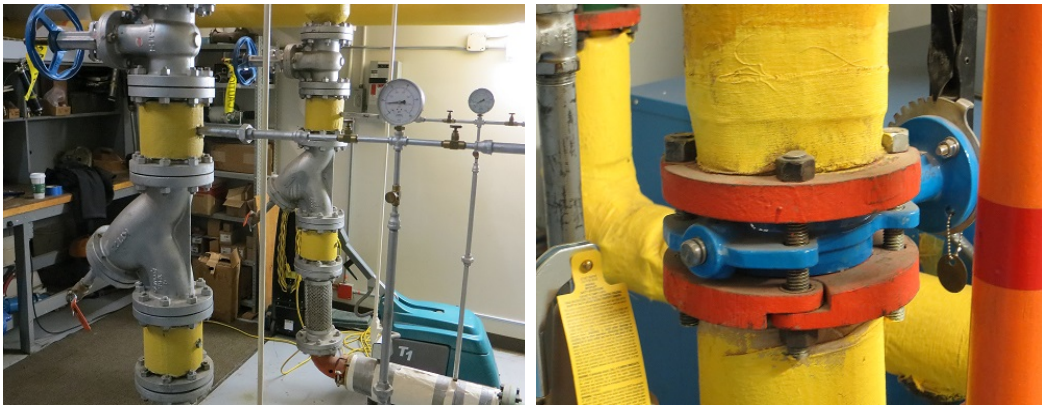
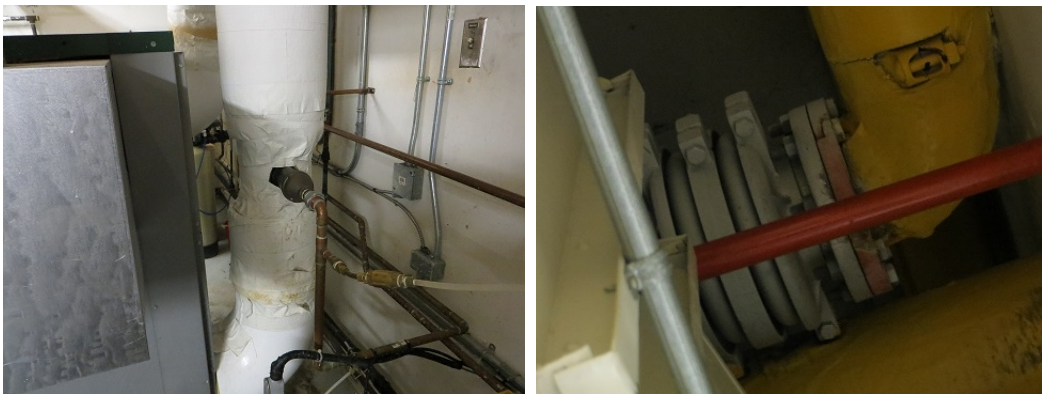
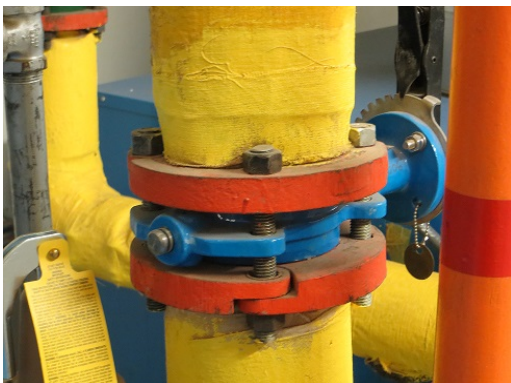
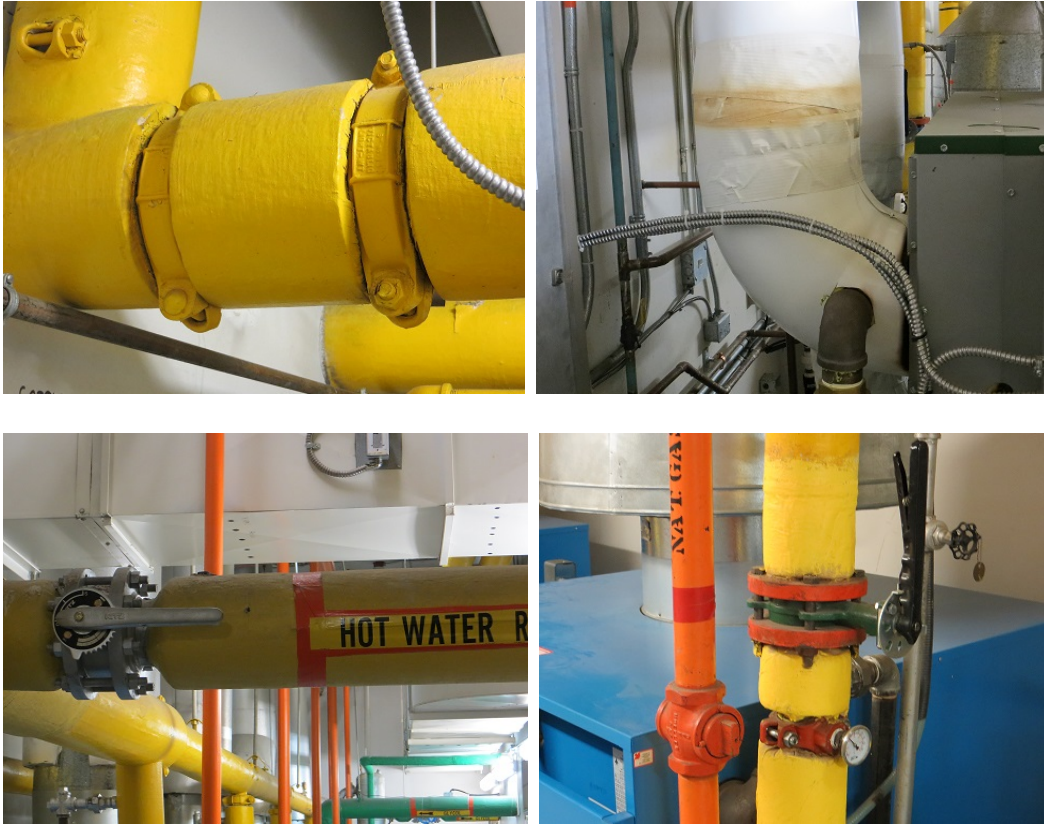
## Boiler Room and Fan Room

We have assessed the boiler room and found that the insulation applied to the mechanical systems is in good condition. However, there are some instances where pumps, valves and piping have no insulation applied and therefore, an opportunity to receive some savings is available. During the course of this inspection we counted at least (19) four inch valves, (4) strainers, a number of flanges and couplings as well as numerous other areas which should be insulated. **The boiler room and fan room comprise 95% of the items listed on the 3e spreadsheet.**

The workmanship of the existing insulation is in fair to good condition but some bad practices were followed when these materials were installed. There isn't a reason to not insulate valves, piping and or fittings but to achieve cost savings at the time of construction or a specification which allowed these practices to take place. We can now show that not insulating pipes hot or cold will cost money for the operation of the building and or repairs to equipment or piping. The report contains visual inspection of these systems utilizing thermographic analysis and conventional digital photographs for reference.

Upon consideration of all observed conditions and the information gathered from the 3EPlus program, we recommend that all areas identified within this report be insulated or repaired. We also recommend that **Best Practices** be followed when applying insulation to these items as any deviation from applying insulation will reduce any potential savings. For example, we know that the elimination of canvas can shorten the lifespan of fiberglass with an ASJ finish because of the lack of a protective cladding system. We also recommend using removable insulating pads where necessary or feasible. This will allow maintenance to take place by removing the insulation pad whenever maintenance needs to take place.

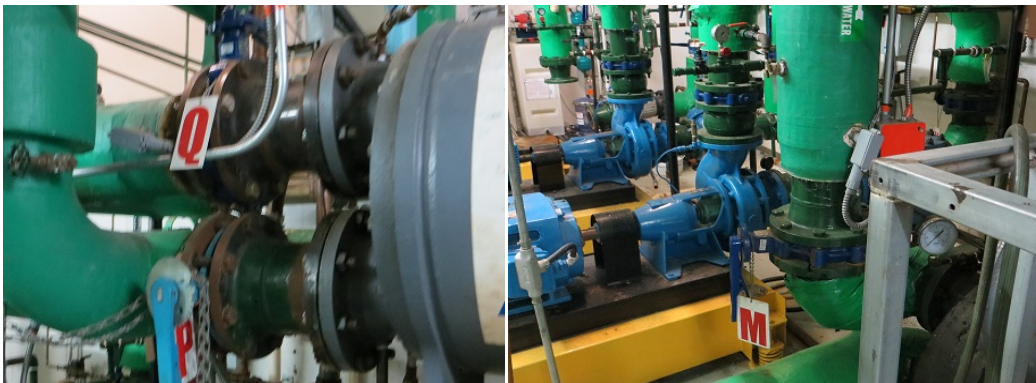
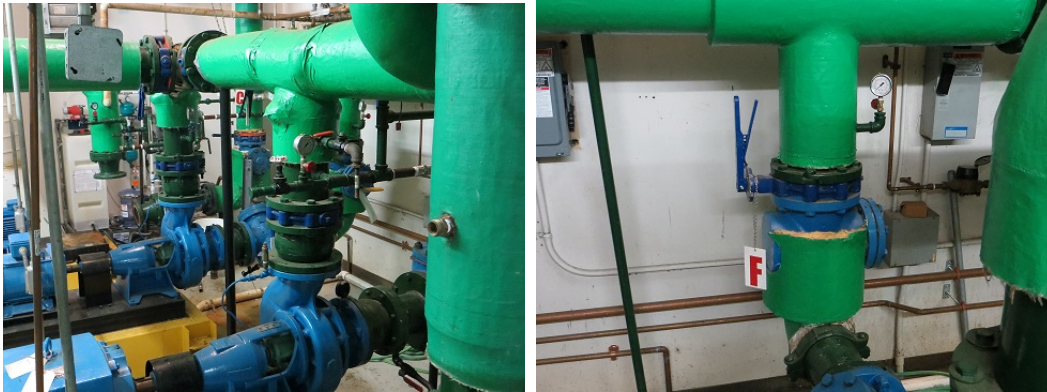
## Chiller Room

We have inspected the chiller mechanical room and found the same experience of missing insulation on the valves, pumps and damaged or degraded pipe covering. The bare valves and equipment are painted and show no evidence of rust or corrosion at this time. The fact that there is not a 100% vapor barrier may require further investigation as to whether there is rust or corrosion underneath existing insulation. At the time of inspection the chilled system was not operational and we could not confirm that the exposed piping, valves or pumps could condensate for lack of mechanical insulation.

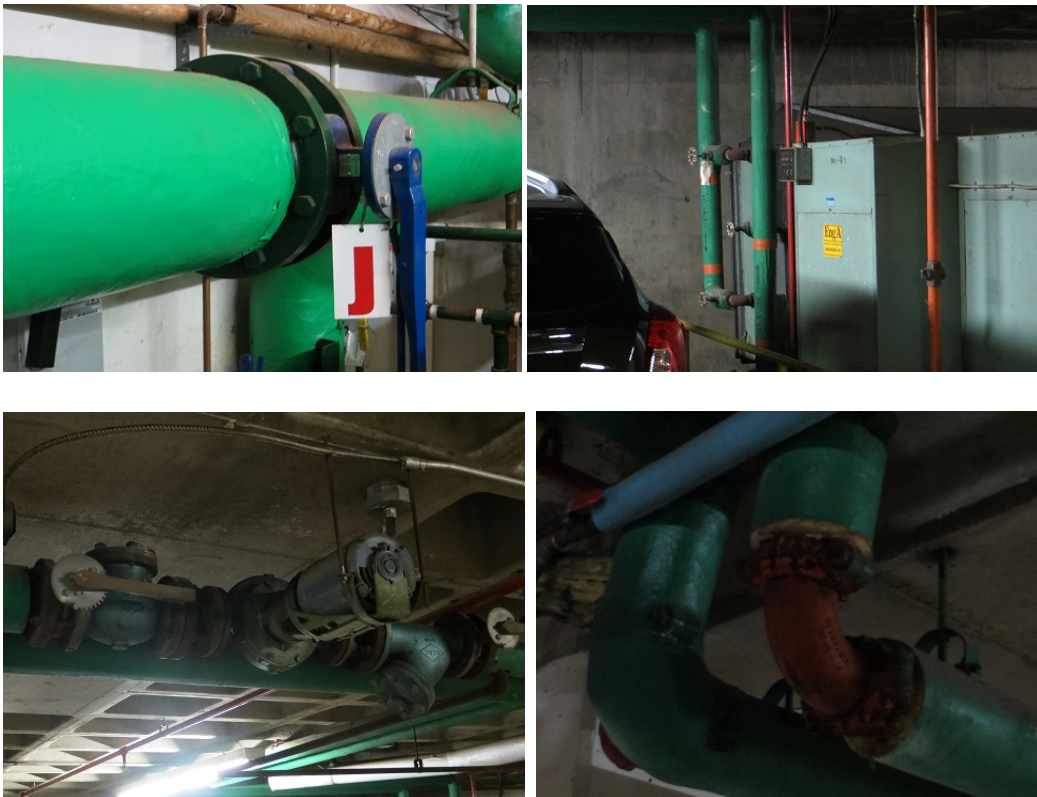
## Parking Garage

The insulation materials applied to the piping in the parking garage is in good condition. The same application methods have been used in this space with various amounts of insulation not done or missing from maintenance work. In our conversations with maintenance personnel their view is that the missing insulation on the heating side is helping to heat the space during the colder months.

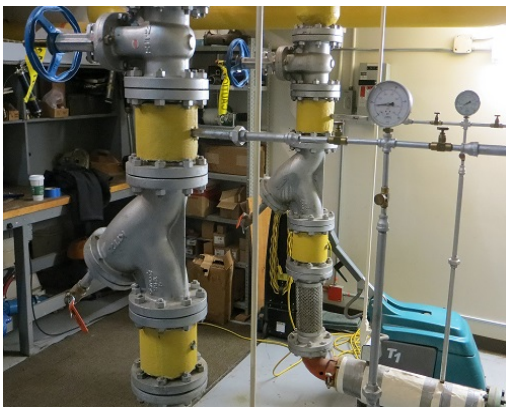
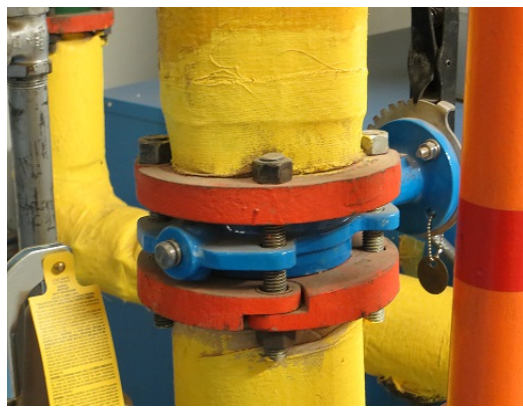
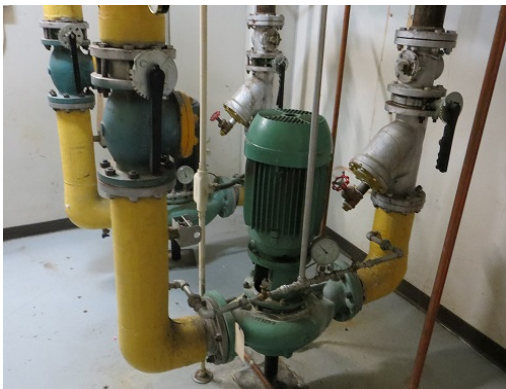
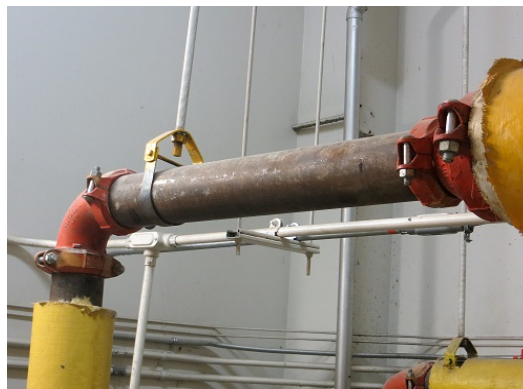
## Personnel Protection

We also would like to address the hazards that the hot exposed items present to personnel. The boiler rooms and fan rooms generally are tightly packed with equipment and piping systems operating up to 121C, the systems and equipment which are not insulated leave many opportunities for employees and maintenance personnel to come in contact with these surfaces which can burn skin. Properly insulated systems and equipment eliminate the possibility of individuals coming into contact with these hot surfaces and will prevent accidental burns which will add value by individuals not having claims and or lost time incidents.
