Mechanical Insulation Energy Audits

Energy Audit

For Reynolds Museum
6246 – 40 Avenue
Wetaskiwin, Alberta

April 12, 2016

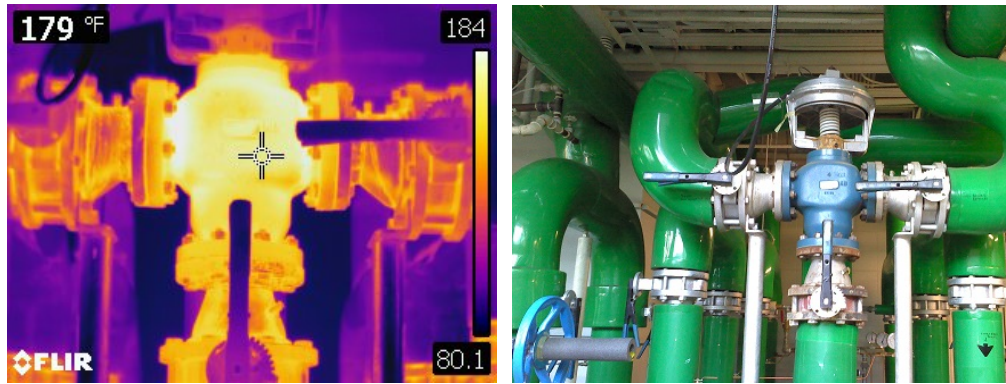
Bare heating valves in the boiler room of the Reynolds Museum

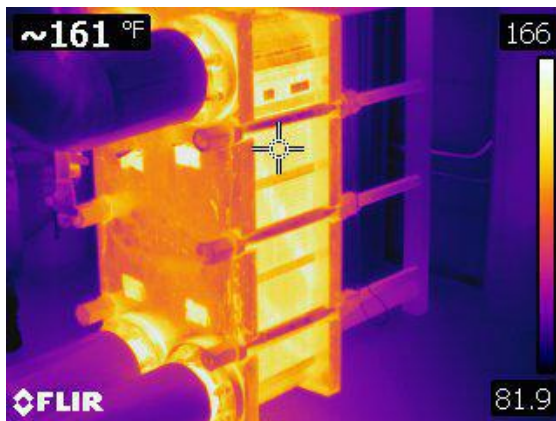
There are some areas where pumps, valves, heat exchanger and piping remain without insulation applied.

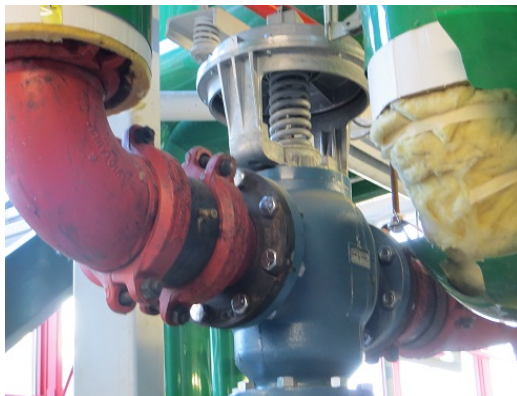
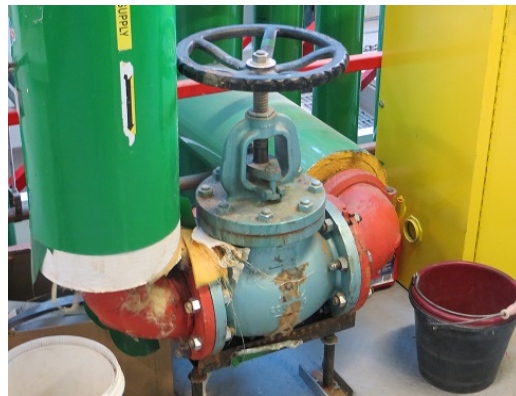
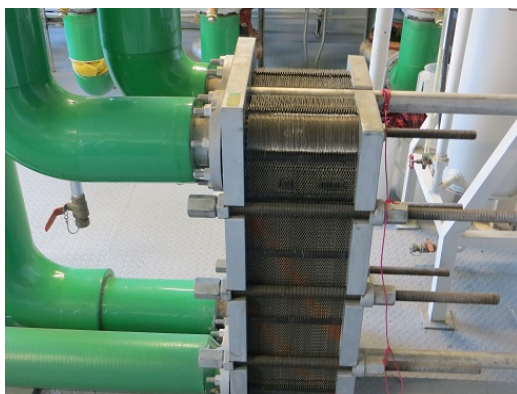
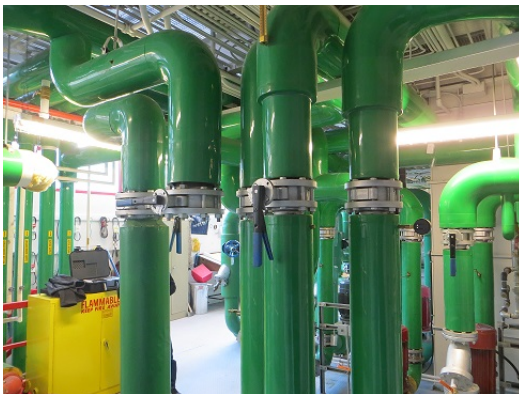
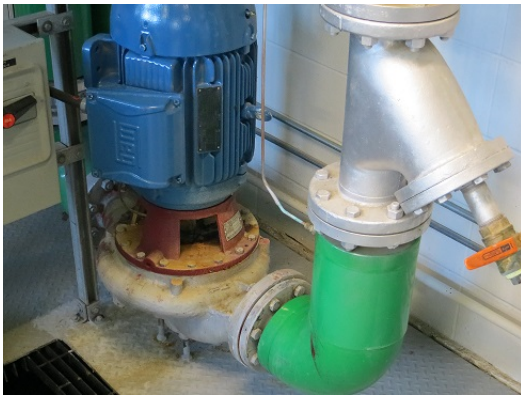
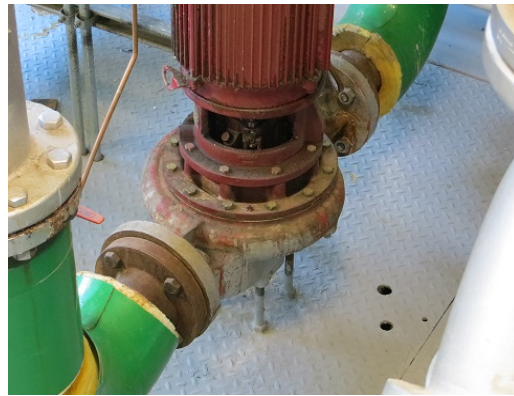
Boiler Room and Fan Room

We have assessed the boiler room and found that the insulation applied to the mechanical systems is in good condition. However, there are some instances where pumps, valves and piping have no insulation applied and therefore, an opportunity to receive some savings is available. During the course of this inspection we counted at least (37) valves, (7) strainers, (10) pumps with numerous other areas which need to be insulated. We also note that the current thickness of applied insulation is 1 ½ wall which meets current best practices and ASHRAE 90.1 (2010). **The boiler room comprises 99% of the items listed on the 3e spreadsheet.**

The workmanship of the existing insulation is very good but there are some bad practices that were followed when these materials were installed. There isn't a reason to not insulate valves, pumps, flanges and or fittings but to achieve cost savings at the time of construction or a specification which allowed these practices to take place. We can now show that not insulating pipes hot or cold will cost money for the operation of the building and or repairs to equipment and piping. The report contains visual inspection of these systems utilizing thermographic analysis and conventional digital photographs for reference.

Upon consideration of all observed conditions and the information gathered from the 3EPlus program, we recommend that all areas identified within this report be insulated or repaired. We also recommend that **Best Practices** be followed when applying insulation to these items as any deviation from applying insulation will reduce any potential savings. For example, we know that the elimination of canvas can shorten the lifespan of fiberglass with an ASJ finish because of the lack of a protective cladding system. We also recommend using removable insulating pads where necessary or feasible. This will allow maintenance to take place by removing the insulation pad whenever maintenance needs to take place.

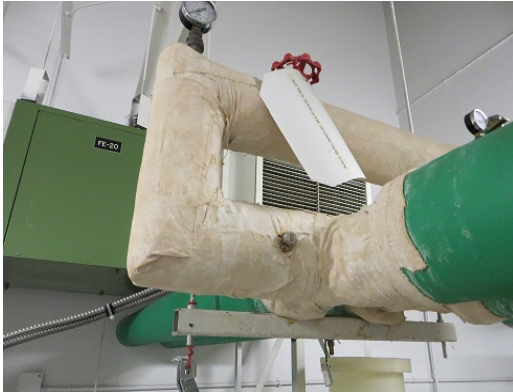
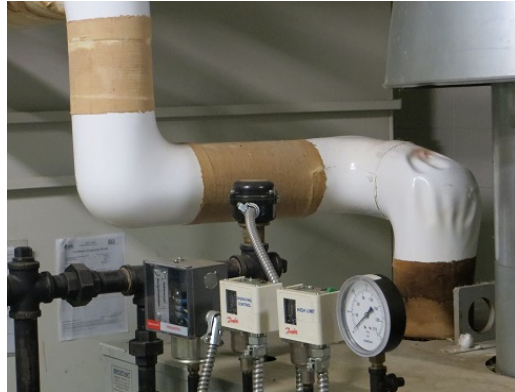
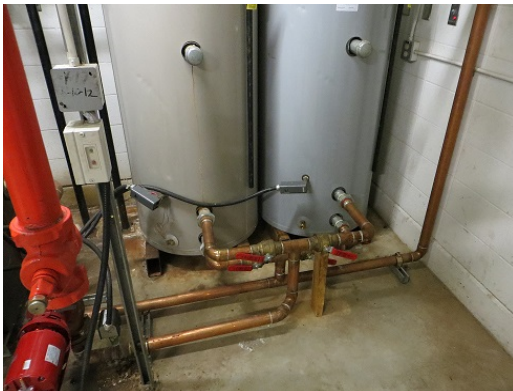
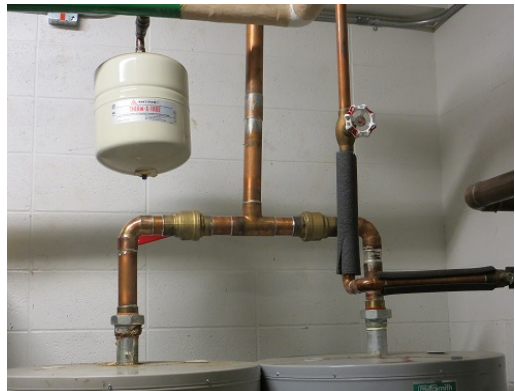
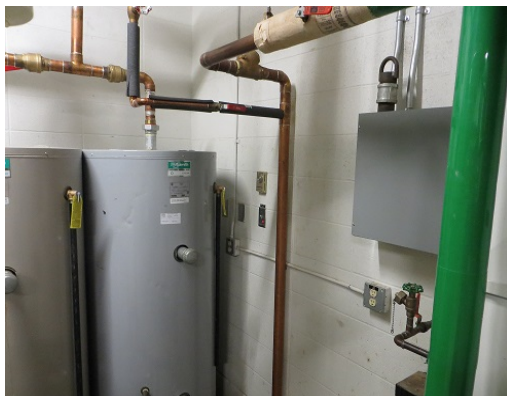
Fan Room

We have inspected the mechanical fan room and found the same experience of missing insulation on the valves, pumps and poorly insulated piping that was not insulated with respect to the original specification. The picture below shows clearly that there is no insulation under the PVC elbow and the elbow is melting from the heat. The copper from the hot water tanks also requires insulation and in its current state poses a possible burning hazard.

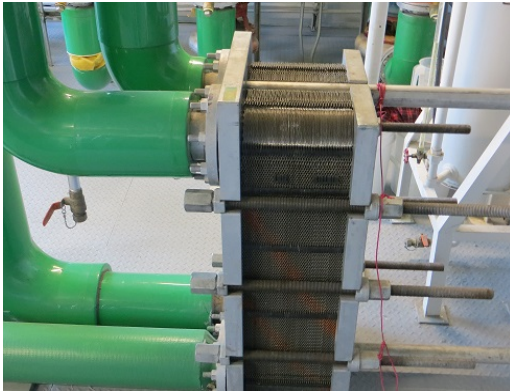
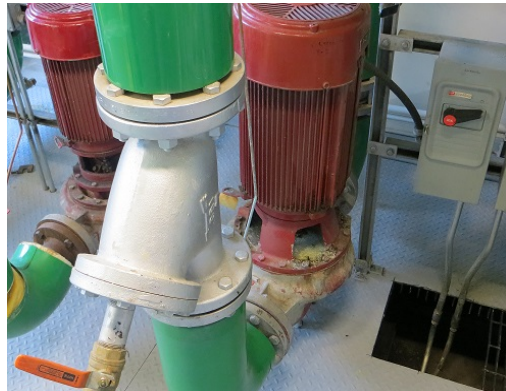
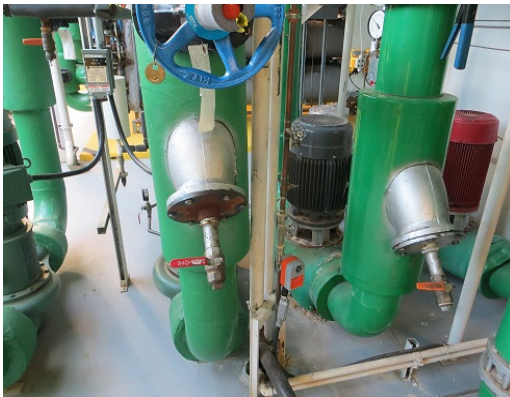
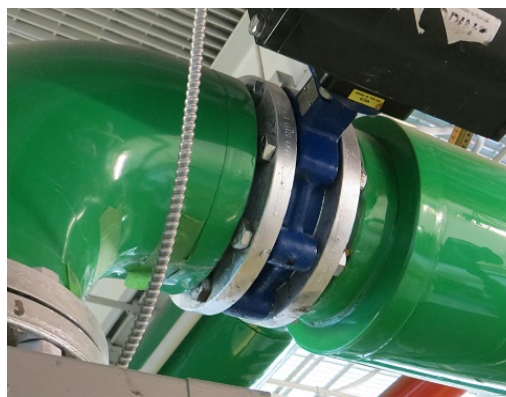
Personnel Protection

We also would like to address the hazards that the hot exposed items present to personnel. The boiler rooms and fan rooms generally are tightly packed with equipment and piping systems operating up to 121 C, the systems and equipment which are not insulated leave many opportunities for employees and maintenance personnel to come in contact with these surfaces which can burn skin. Properly insulated systems and equipment eliminate the possibility of individuals coming into contact with these hot surfaces and will prevent accidental burns which will add value by individuals not having claims and or lost time incidents.
