# SALAMANDER INSPECTIONS LTD

## Energy Audit

For Royal Tyrell Museum  
1500 – Dinosaur Trail  
Drumheller, Alberta

April 14, 2016

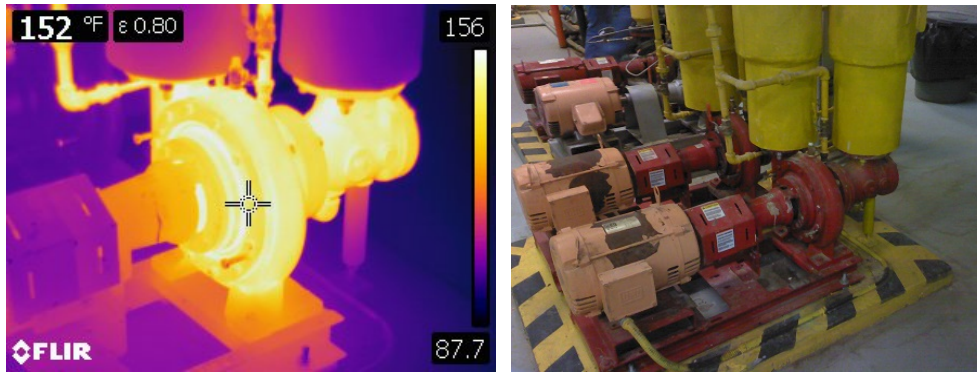
Heating pumps located in the Boiler Room of the Royal Tyrell Museum

This heating pump, as photographed by the FLIR camera uses sensors within the camera to show the heat radiating from the valve. The brighter the color the hotter the temperature of the object. The camera must be set up to filter out the ambient heat from surrounding objects to ensure that the temperatures are accurate. The camera then takes a thermal image as well as a digital picture for reference.

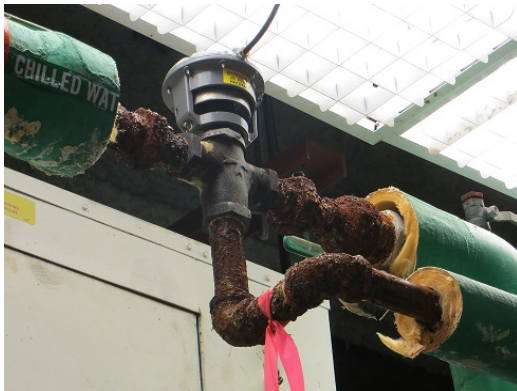
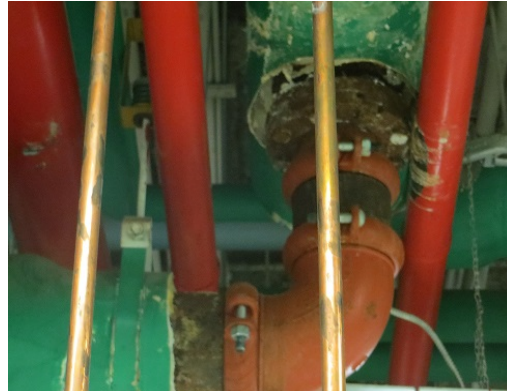
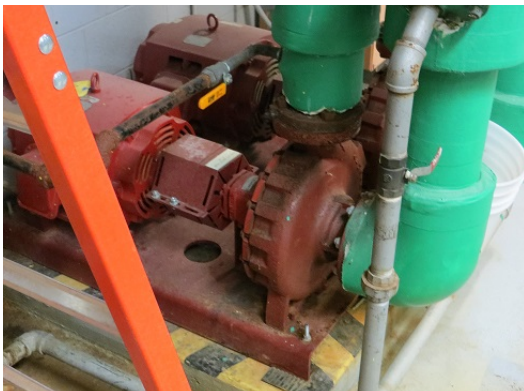
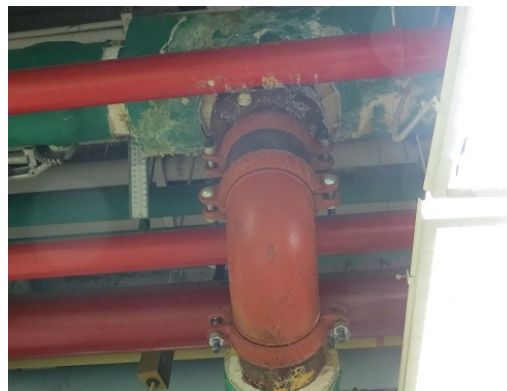
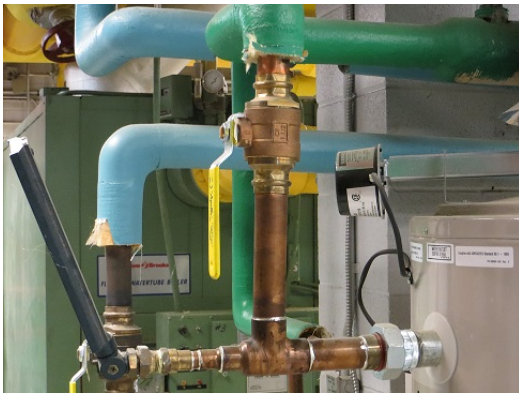
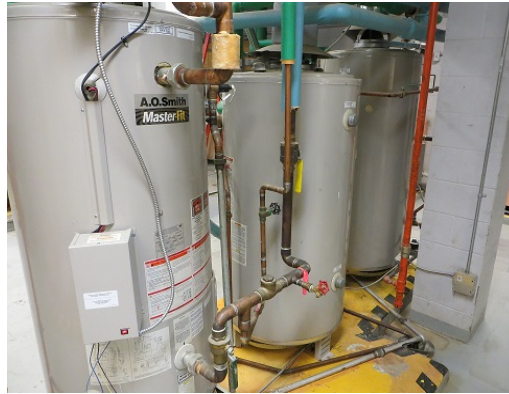
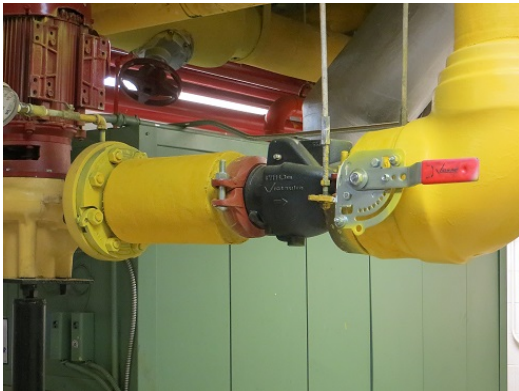
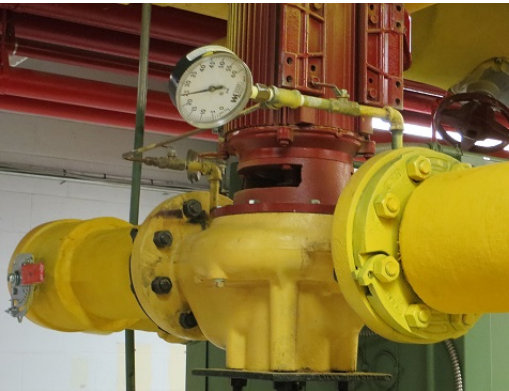
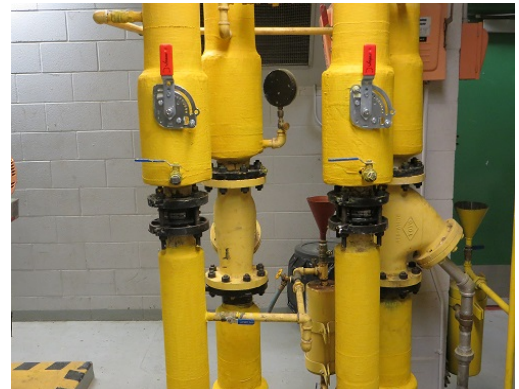
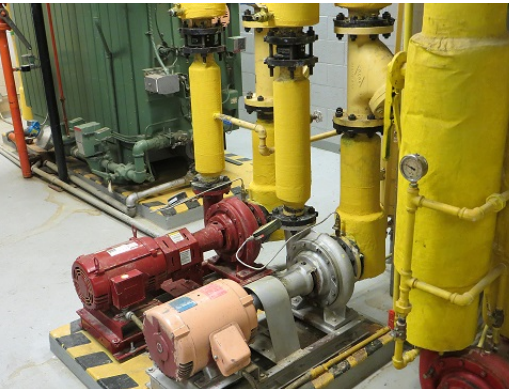
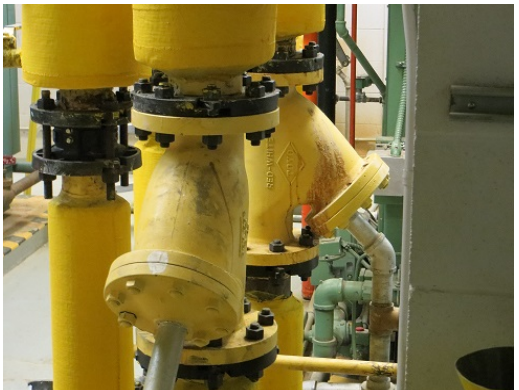
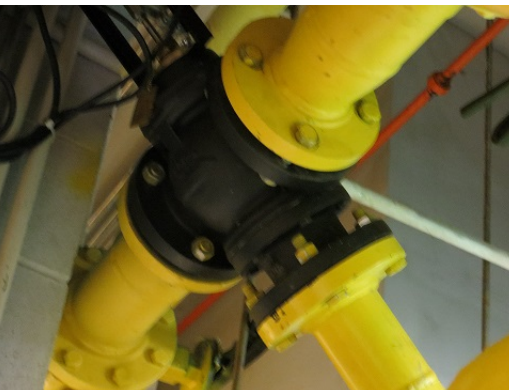
## Boiler Room

We have assessed the boiler room and found that the insulation applied to the mechanical systems is in good condition. However, there are some instances where pumps, valves and piping have no insulation applied and therefore, an opportunity to receive some savings is available. During the course of this inspection we counted at least (22) valves, (7) strainers, (10) pumps with numerous other areas which need to be insulated. There are areas where the pipe covering has broken down from leaks in the system or another means. This pipe covering has now some amount of which appears to be black mold forming on the cladding. **This boiler room comprises 98% of items contained on the 3e spreadsheet.**

The workmanship of the existing insulation is good but there are some bad practices that were followed when these materials were installed. There isn't a reason to not insulate valves, pumps, flanges and or fittings but to achieve cost savings at the time of construction or a specification which allowed these practices to take place. When maintenance has taken place there is evidence that insulation materials are not being replaced such as the piping off the domestic hot water tanks. We can now show that not insulating pipes hot or cold will cost money for the operation of the building and or repairs to equipment and piping. The report contains visual inspection of these systems utilizing thermographic analysis and conventional digital photographs for reference.

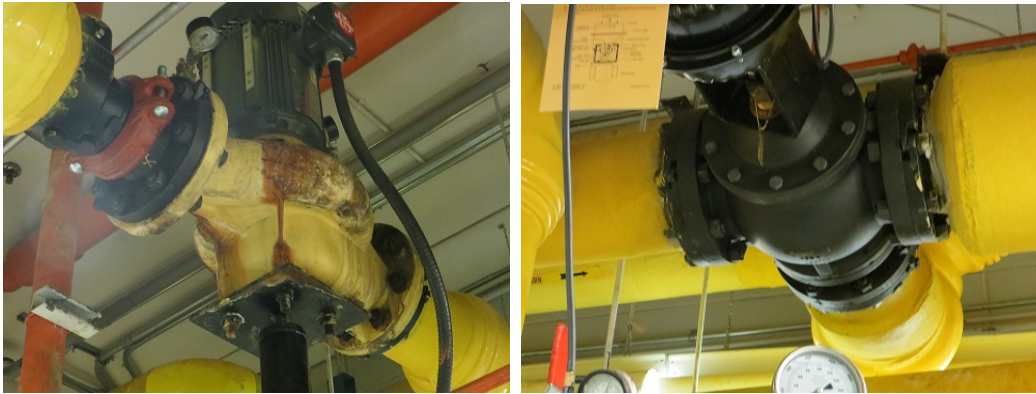
### **Condenser Water Piping**

During the inspection of the boiler room we noticed that the condenser water piping was not insulated. This type of system normally runs between 21 C and 32 C so we feel that there are savings to be had by insulating this system but ASHRAE 90.1 – 2010 suggests that insulating would be unnecessary because of the temperature range. If the temperature of this system goes above 40°C we would recommend insulating this system.

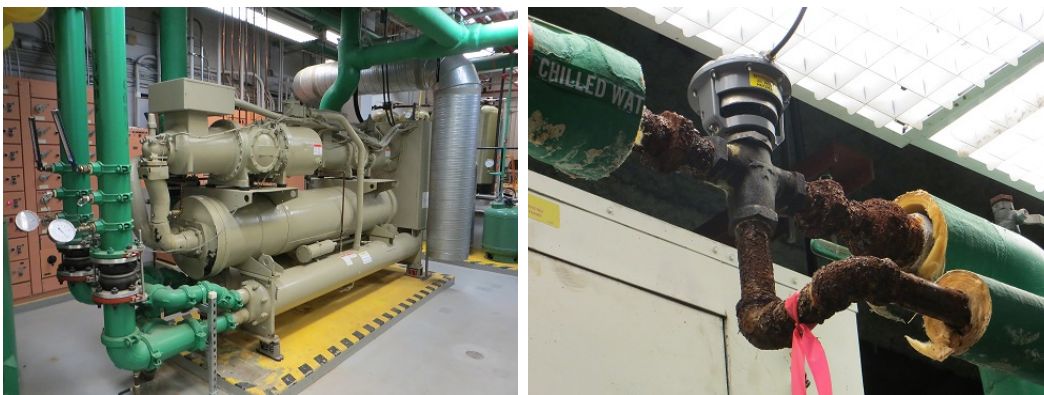
### **Chilled System**

Upon inspection of the chilled system within the boiler room we found 30 plus areas where what appears to be black mold on the surface of the canvas cladding. We have also seen there are areas where the insulation has been missing for some time and the piping has become corroded and will probably need to be replaced. It is our opinion that any area where the vapor barrier has been compromised that further inspection is done to ascertain the condition of the piping.

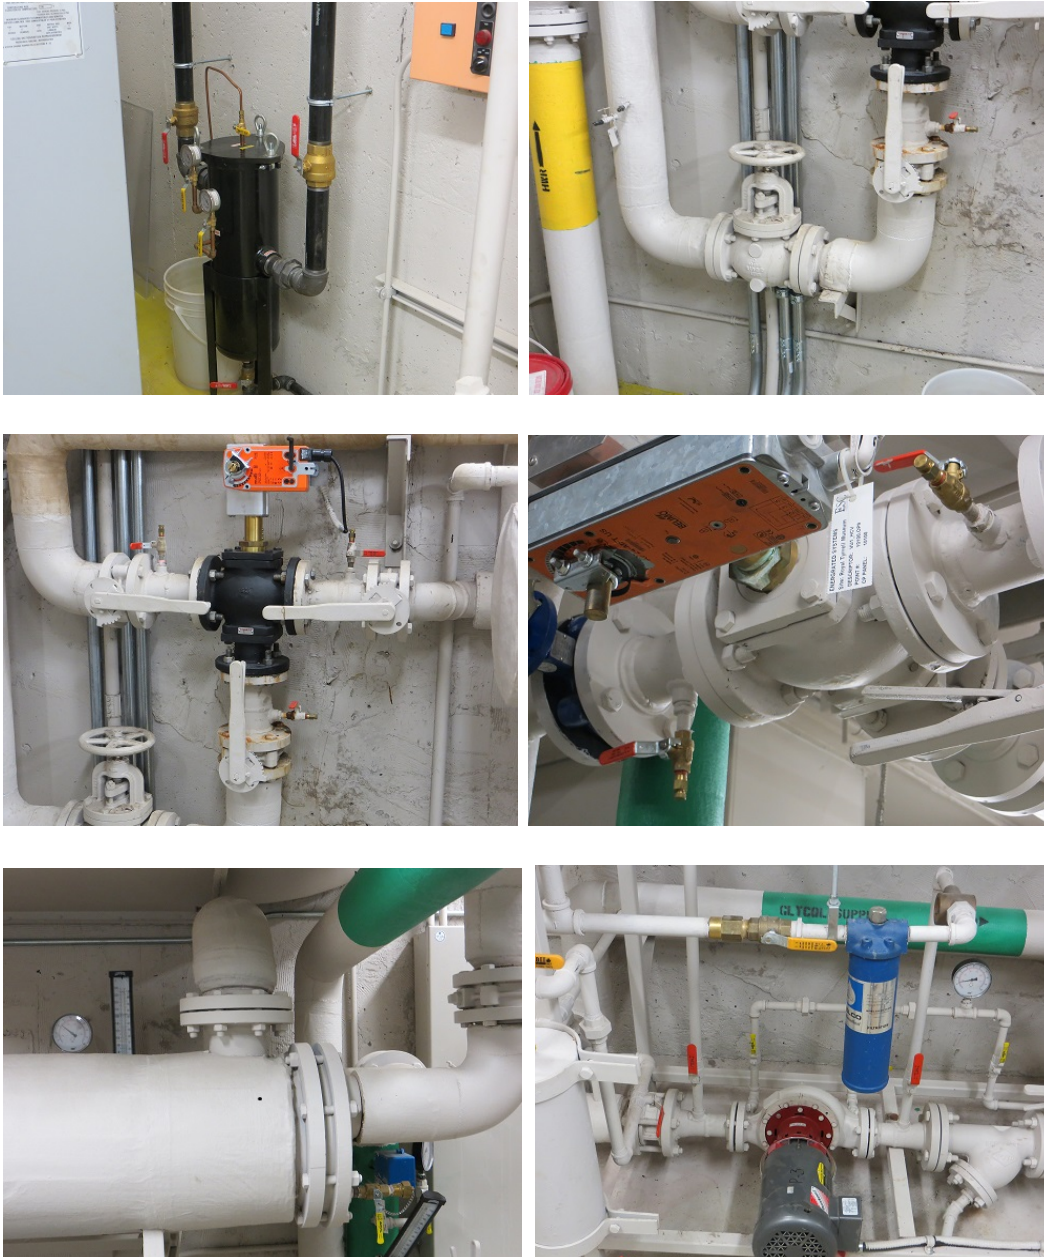
## Fan Room – 244.0

We have inspected the mechanical fan room and found the same experience of missing insulation on the valves, pumps and newly installed piping in fan room 244.0. The pictures show the valves, piping and heat exchanger head without insulation.

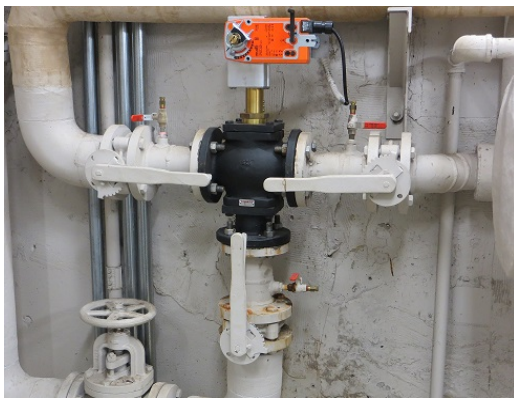
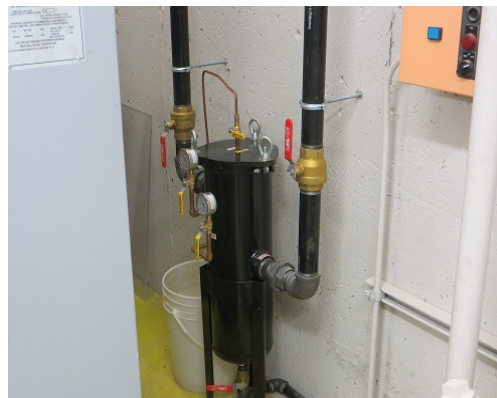
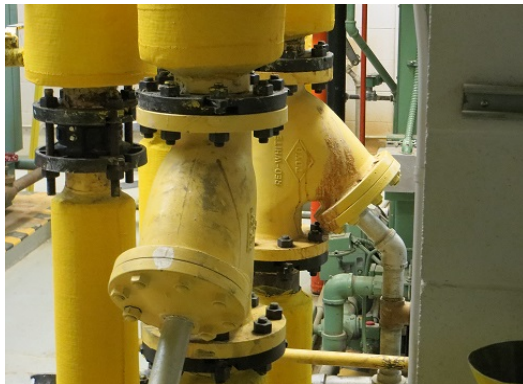
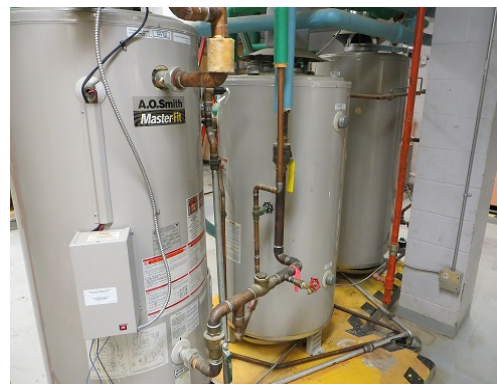
## Personnel Protection

We also would like to address the hazards that the hot exposed items present to personnel. The boiler rooms and fan rooms generally are tightly packed with equipment and piping systems operating up to 121°C, the systems and equipment which are not insulated leave many opportunities for employees and maintenance personnel to come in contact with these surfaces which can burn skin. Properly insulated systems and equipment eliminate the possibility of individuals coming into contact with these hot surfaces and will prevent accidental burns which will add value by individuals not having claims and or lost time incidents.
