PAVEMENT MANAGEMENT PILOT

UPWP Task 5.32
June 30, 2020

North Florida TPO Pavement Management Pilot

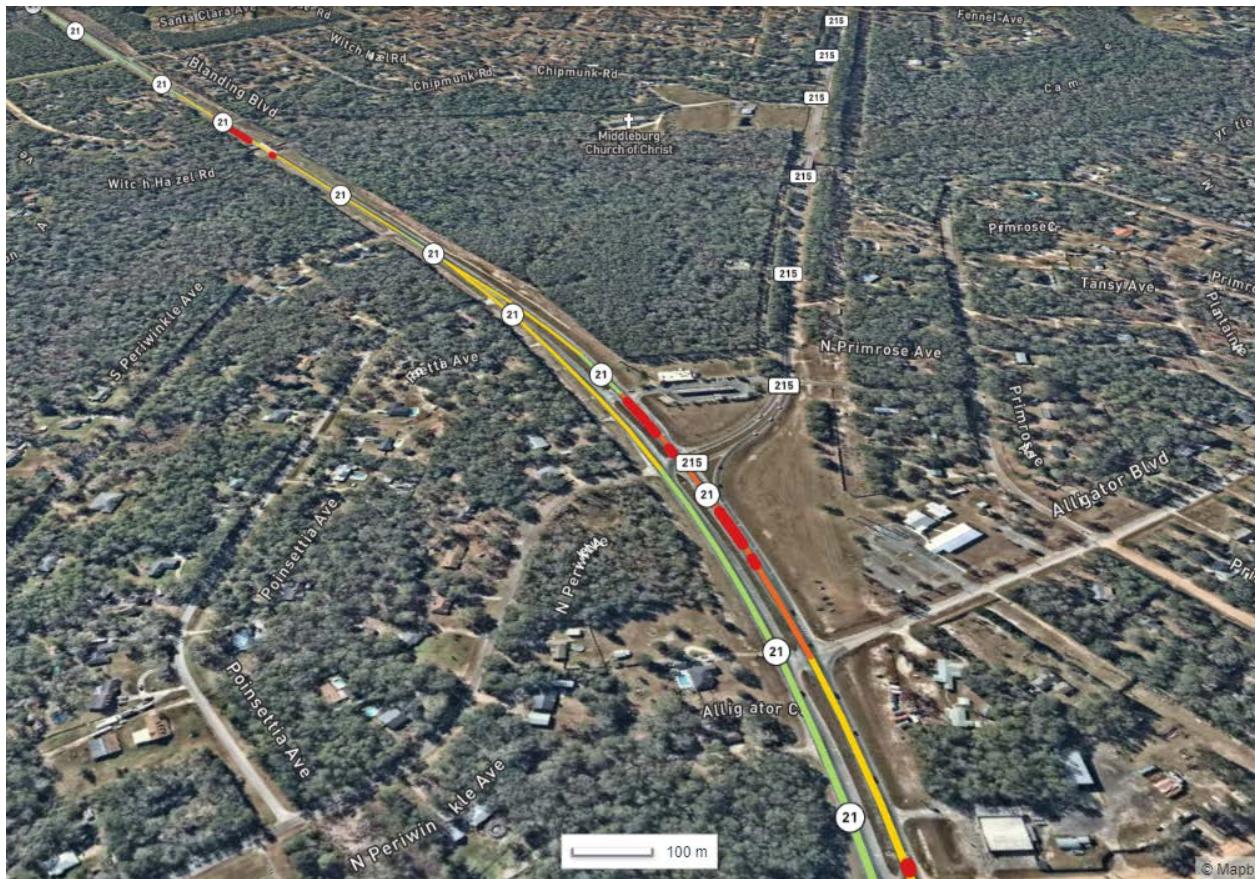
Figure 11. SR 21 Intersection with CR 215

There were two areas where pavement distress was rated as significant in the left (southbound lanes). The segment where the distress occurs is shown in Figure 11. A photo taken during the data collection located between Peppergrass Street and Halpern Street as shown in Figure 13.

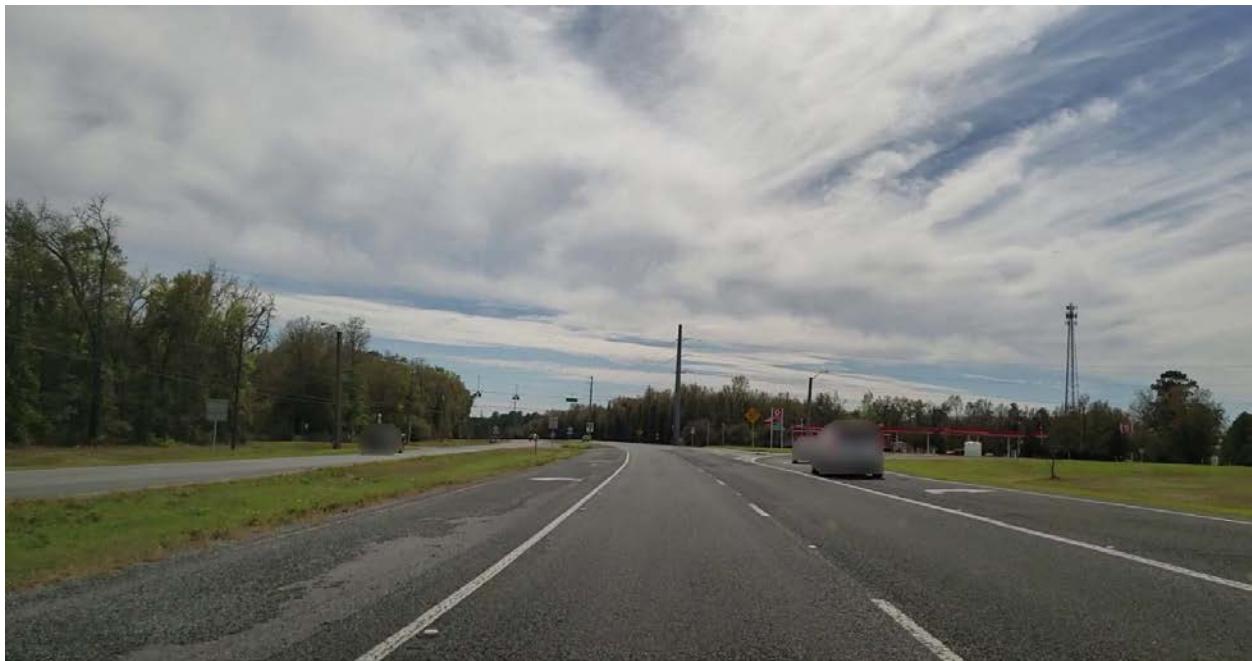
Figure 12. Pavement Distress Near the Intersection of CR 215

The segment of SR 21 from SR 16 to Halperns Way was rated as deficient (weighted average of three segments is 2.09) by RoadBotics, but not FDOT.

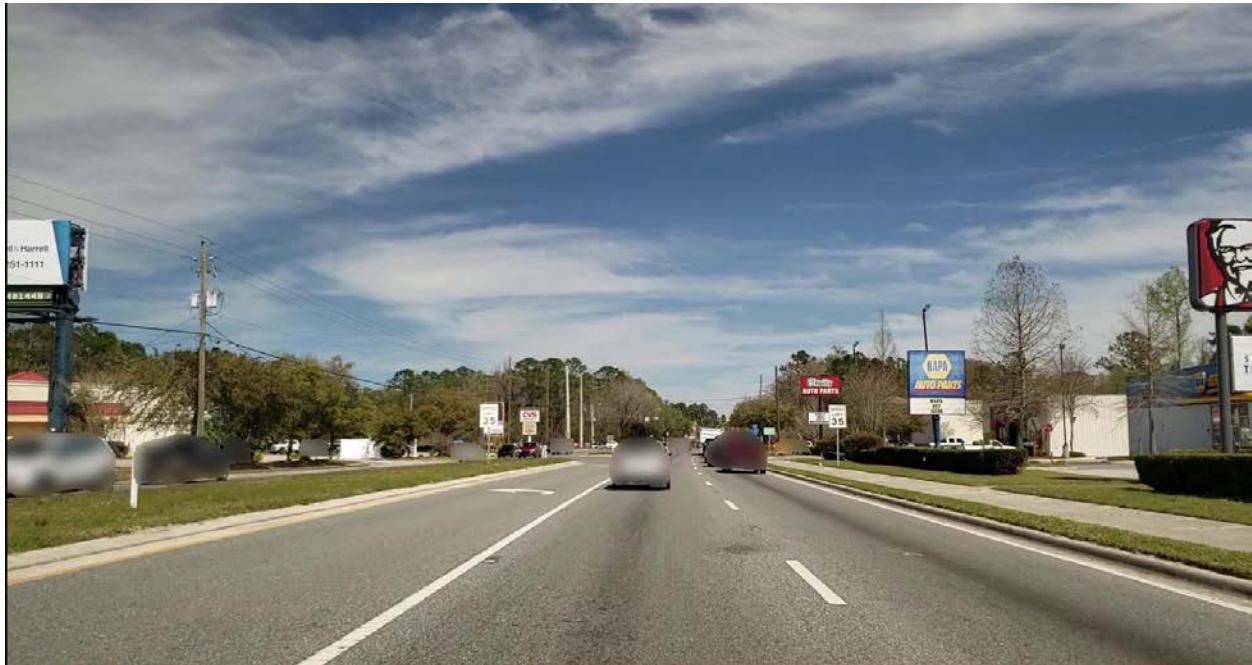
Figure 15. Raveling between Halperns Way and CR 218 (northbound)

The segment of SR 21 between Halperns Way and CR 218 was rated deficient by FDOT but not RoadBotics. Review of the photos made during the data collection raveling and oxidation was occurring such as shown in Figure 14. Significant deterioration was also observed at the intersection with CR 218 as shown in Figure 15.

There was one segment of SR 21 where the FDOT ratings reflect the need for resurfacing and RoadBotics did not. The distress caused by oxidation and some raveling was not detected as accurately as other forms of cracking.

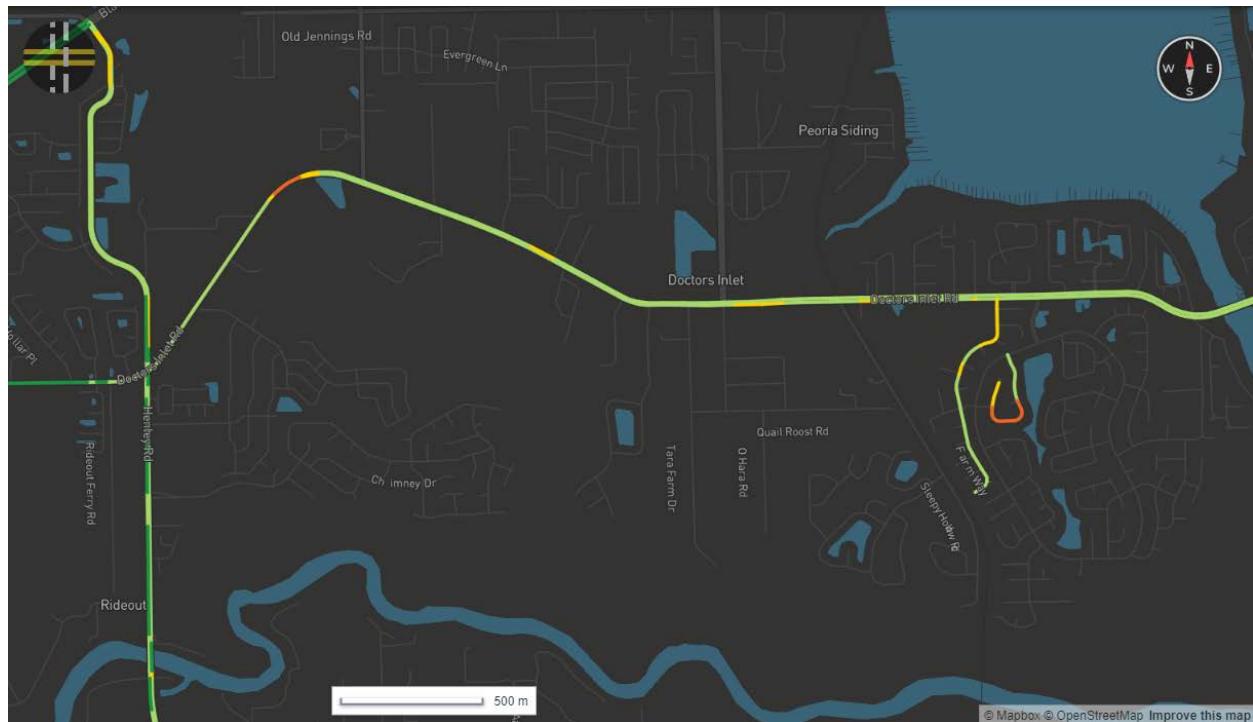
Figure 17. CR 220 from College Drive to Dr. Inlet Bridge

Similar to the issues discussed in the comparison of the FDOT and RoadBotics ratings, the segment length selected has a significant impact of the rating on a segment basis. Figure 16 shows an area with significant pavement distress near the Little Black Creek. When viewing the pavement distress in this area as shown on Figure 17, there is significant oxidation and cracking. Along other segments of the corridor oxidation, patching and other indicators of distress were not identified. The higher pavement rating from RoadBotics is likely a combination of the corridor length vs. areas identified in the software as deficient plus the lack of consideration of oxidation.

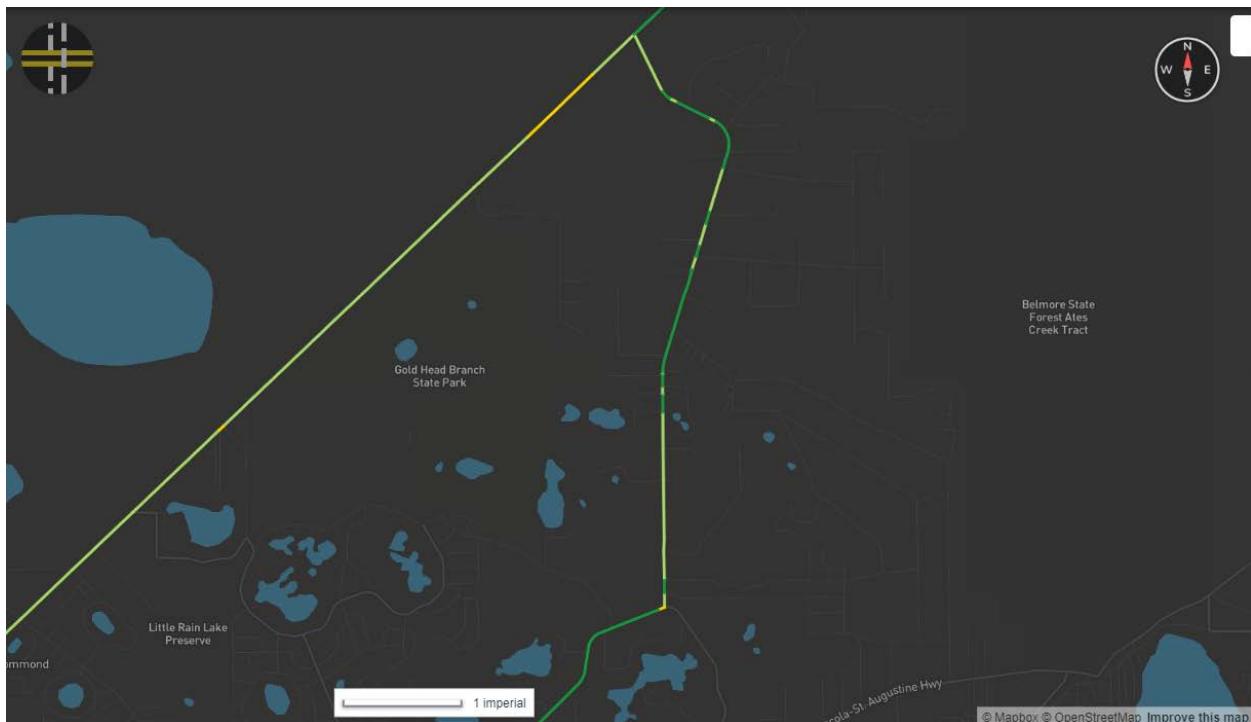
Figure 20. CR 315C from CR 214 to SR 21

CR 315 is a rural roadway with shoulders. It has also experienced distress due to oxidation. There are spot locations along the corridor RoadBotics identified as deficient, but relative to the overall length of the corridor, they were not sufficiently long enough to lower the effective pavement rating. The location identified as deficient is shown in Figure 20.
