Major Power Plant in Turkey Protects Stack and Facility Equipment with ChemLine® Coatings

ChemLINE®
CASE STUDY

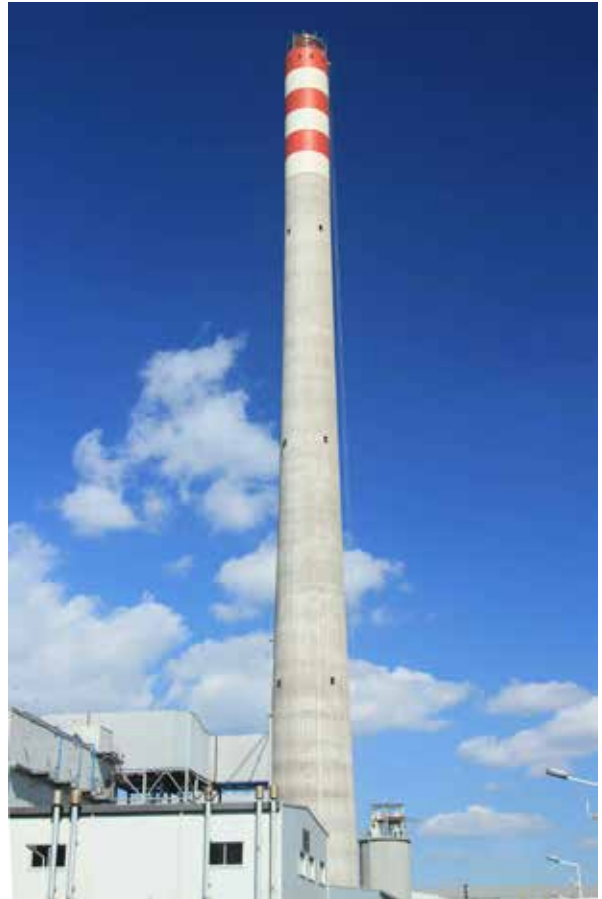
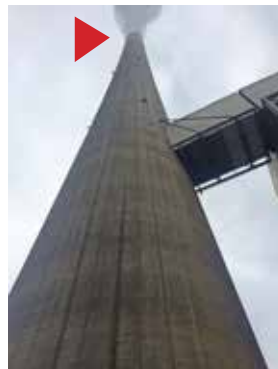
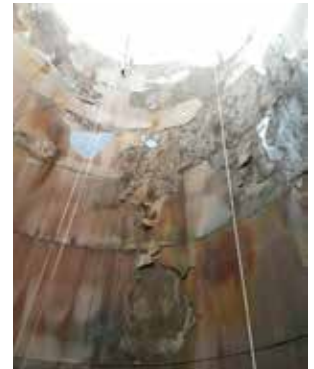
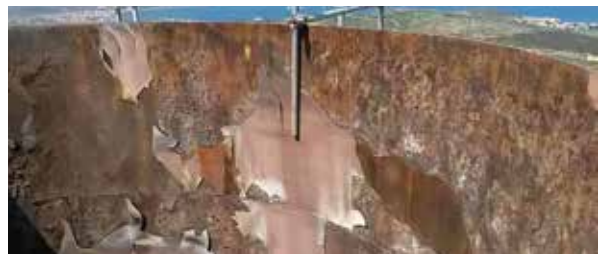
One of the largest thermal coal-fired power plants in Turkey had a serious coatings corrosion problem on the inside of their 180-meter carbon steel stack, at the height of 170 meters. They had previously lined this area with a vinyl ester coating, however it did not even last 10 months before serious de-lamination problems occurred (as shown in photos below).

When plant personnel discovered coating de-lamination problems inside the stack (shown by red arrow in photo), they asked if ChemLine® could also handle these severe conditions, where a mixture of different chemicals — 70.295% Nitrogen, 12.858% Water, .005% Sulfate, 11.769% Carbon Dioxide, and 5.07% Oxygen — operate in temperatures of 140°F/60°C and at times reaching 233°F/112°C.

After reviewing the extensive project reference list from MarineLine Turkiye for similar projects, including coatings work done for EREN ENERGY and others, the power plant contracted for ChemLine® lining within the stack.

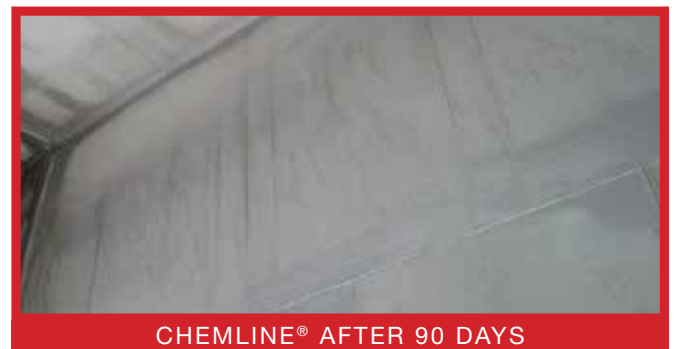
90 Day Followup

After 90 days of operation, the power plant stopped production to check the condition of the ChemLine® coating. The inspection showed the coating in near-perfect condition (as shown in this 90-day inspection photo of a close-up of the stack tunnel presented in the photo area above). The customer is pleased with the result and will conduct a through review after one year of service, with plans for future ChemLine® protective coating projects.

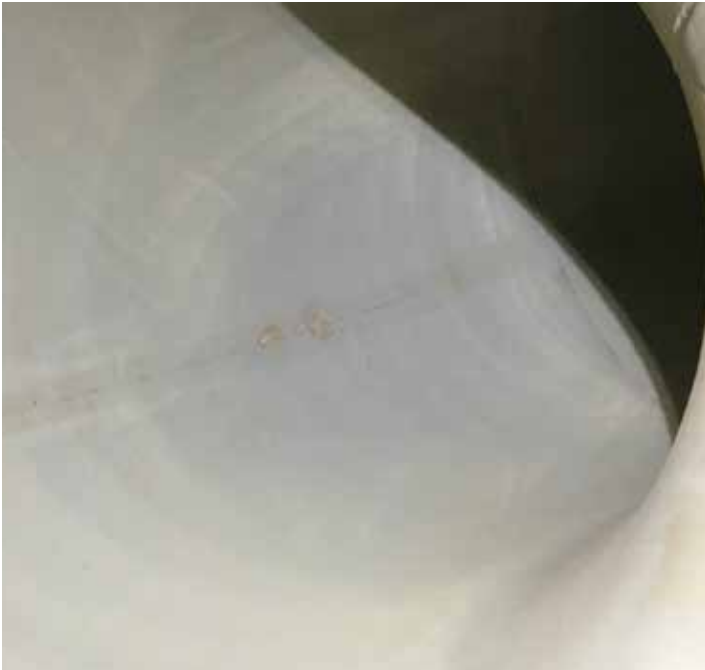
CONDENSER LINE AFTER 1 YEAR CHEMLINE® SERVICE

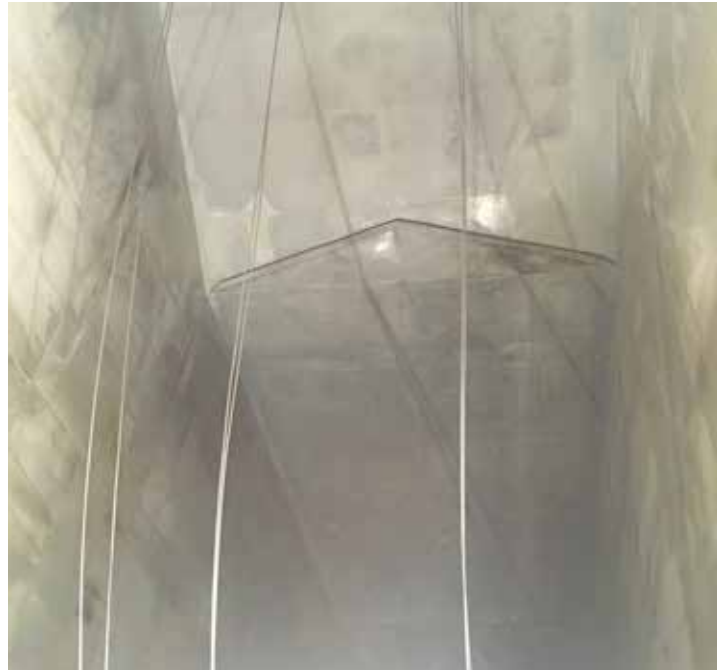
FGD UNIT AFTER 1 YEAR CHEMLINE® SERVICE

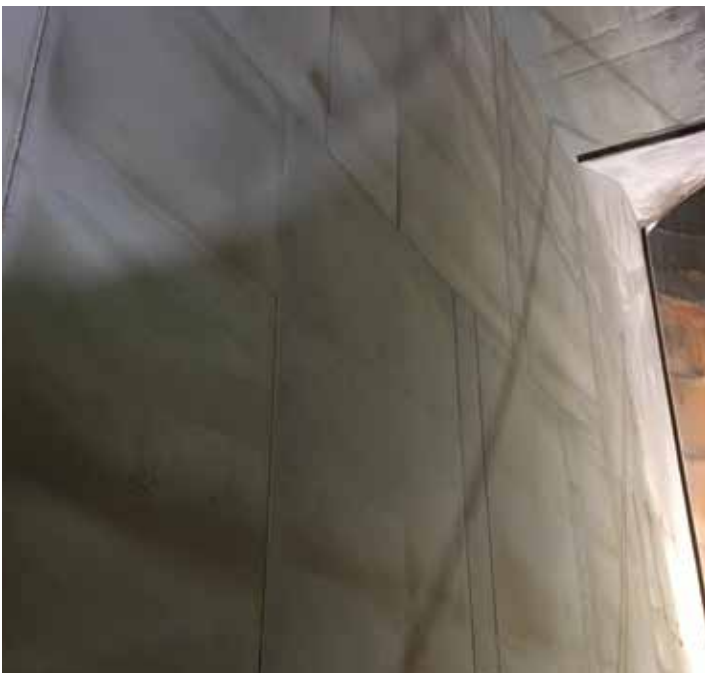
FGD UNIT AFTER 1 YEAR CHEMLINE® SERVICE

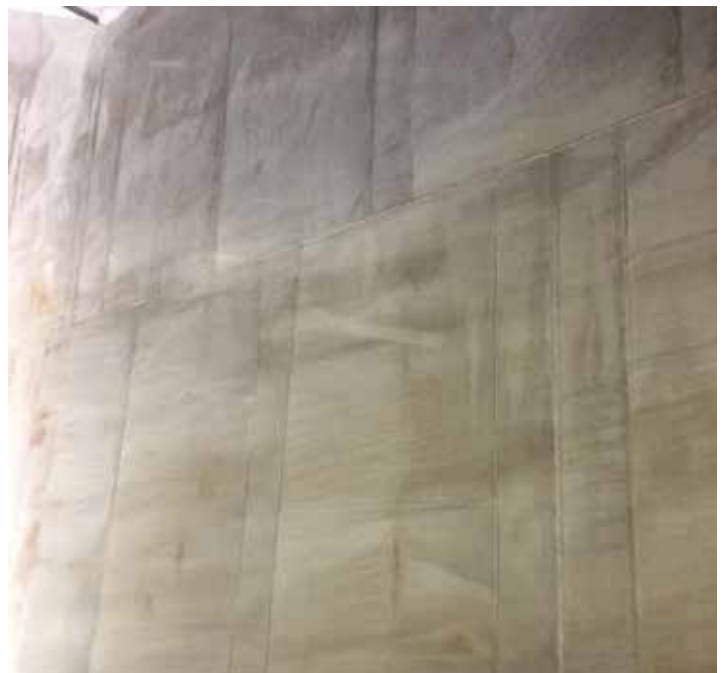
FGD UNIT AFTER 1 YEAR CHEMLINE® SERVICE

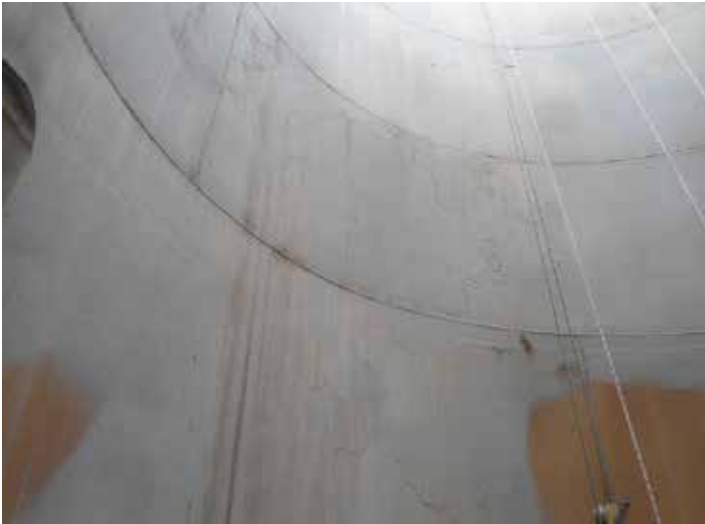
The ChemLine[®] coating in the stack was also inspected after 1 year of service, with no problems found. The rust shown at the top of the stack is rust stain

from the manifolds, and not any corrosion effect.

STACK AFTER 1 YEAR CHEMLINE[®] SERVICE

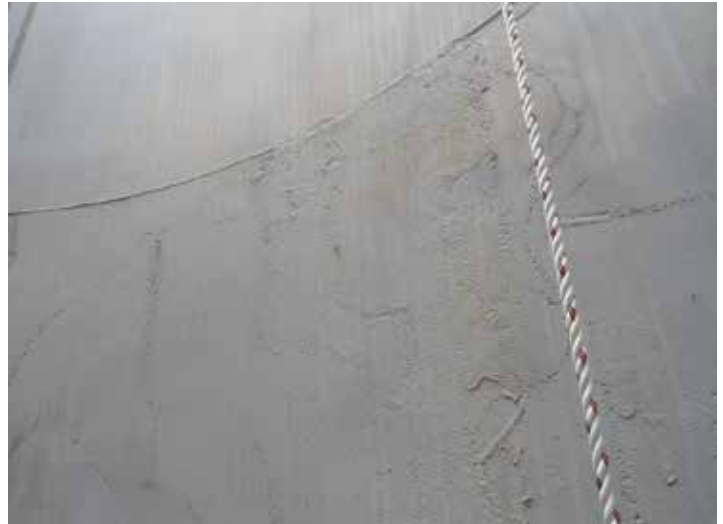
STACK AFTER 1 YEAR CHEMLINE[®] SERVICE

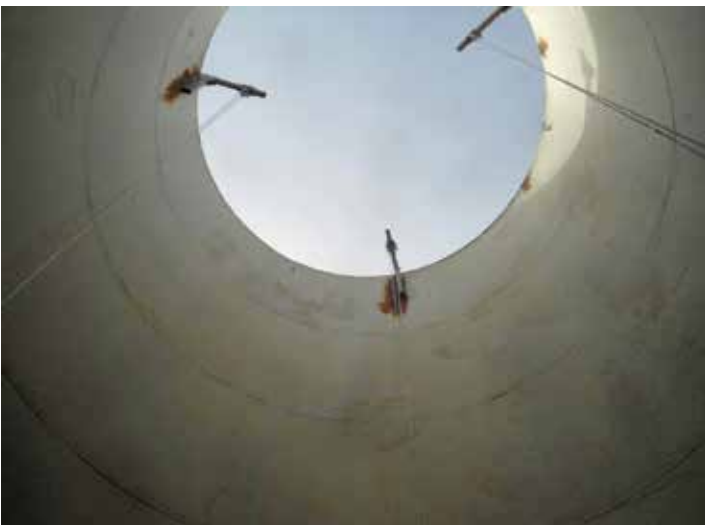
STACK AFTER 1 YEAR CHEMLINE[®] SERVICE

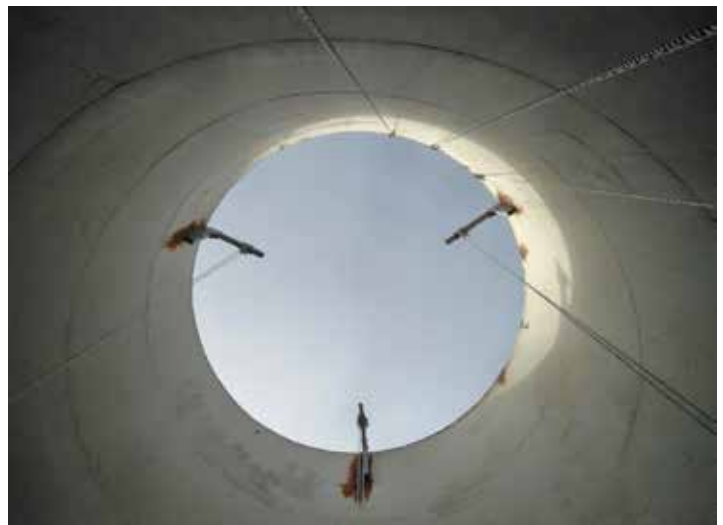
STACK AFTER 1 YEAR CHEMLINE[®] SERVICE
