## Encircle Sample Report

Water

159 North Lake Drive, Waterloo, Ontario

## Claim Summary

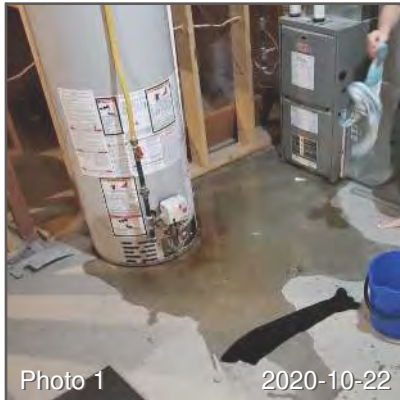
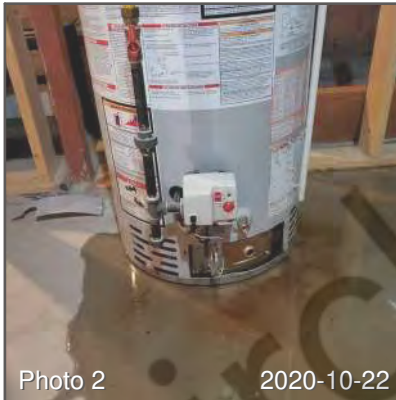
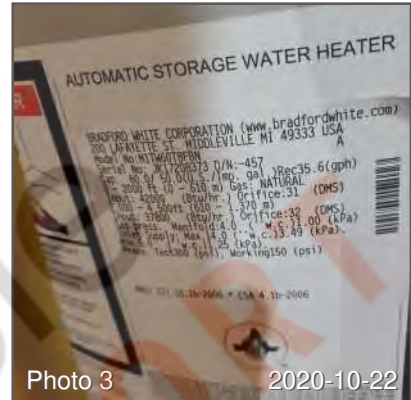
Cause of loss was determined to be a faulty water heater in the basement of the client's home. Upon arrival water the heater was continuing to rapidly expel water onto the basement floor saturating the immediate surrounding area.

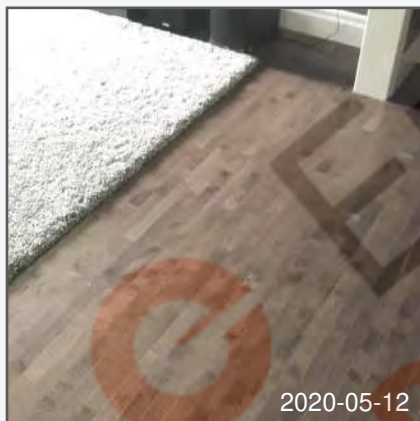
### Preexisting damage to floor

Initial walkthrough noted significant scratching/wear and tear on living room hardwood floor. Damage featured in attached picture.
