TURBINE OVERSPEED TRIP PROTECTION

Charles R. Rutan

Lyondell/Equistar Chemicals, LP

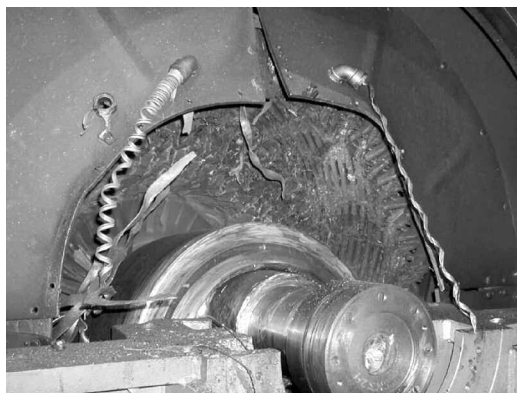
Figure 14. Generator.

A 22 Megawatt, 3600 rpm unit oversped to at least 5400 rpm as a result of the disk and bolt, from an upstream extraction nonreturn valve, became loose and moved into a position that resulted in the nonreturn valve sticking open (Figures 14, 15, and 16).
