Example Aerial Inspection Surveys and Reports

Activity: Aerial Inspection of Flare Stack and Tip

SURVEY EXCERPT 1: JUNE 30, 2016

SURVEY EXCERPT 2: OCTOBER 18, 2012

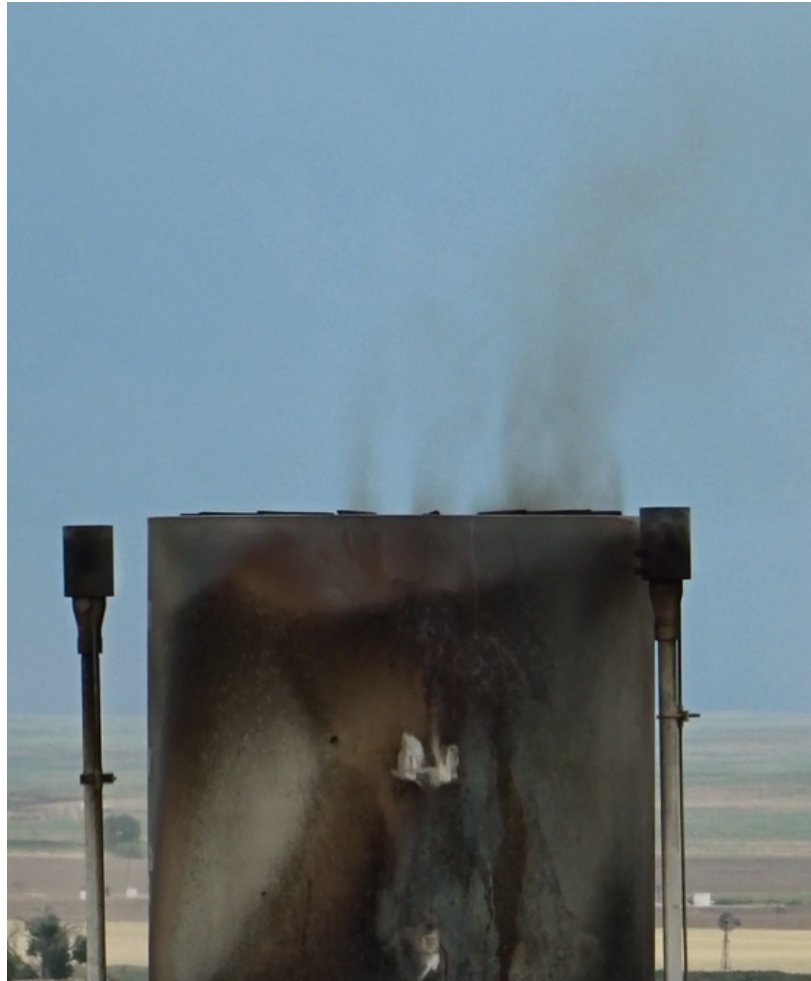
Figure 1: Problematic smoke emanating directly from gas riser exit. No visible flame present

1. Existing Flare Tip Design
 - a. Cause of Smoking
 - i. The smoking observed by [REDACTED] at turndown rates is the result of internal burning. Internal burning is detected in the drone inspection video looking down into the flare tips vanes and further confirmed by the smoke emitted from the flare tip vanes, rather than the end of the flame itself. This smoking is not due to insufficient of assist air from the fan.
 - ii. Smoking resultant from insufficient assist air would be emitted from a visible flame and would initiate from the end of the flame.

- iii. The existing flare tip design promotes internal burning during most average wind events. During the inspection [REDACTED] attended, any wind over 10-12 MPH caused the combustion to stabilize inside the flare tip and emit smoke from the downwind flare tip vanes. The long vanes of the existing flare tip promote a chimney effect to be established during low flow conditions. [REDACTED] air-assisted flare tips utilize short vanes that allow the wind to dominate at turndown cases to push the flame out of the tip. [REDACTED] design does not promote the formation of a draft to feed internal combustion.

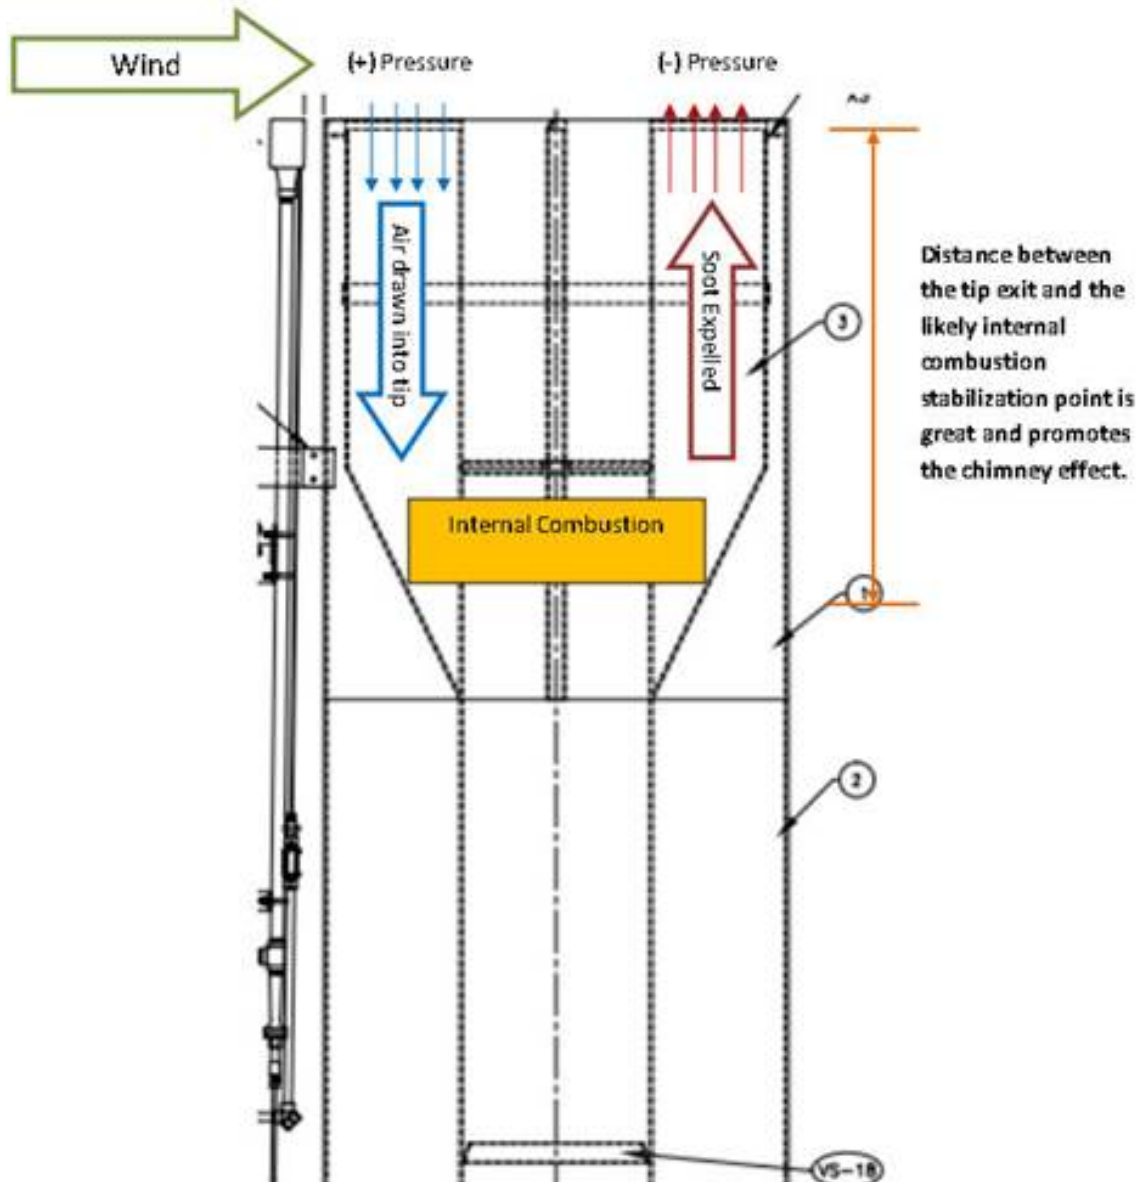
Figure 2: Existing Tip Burning Propensity

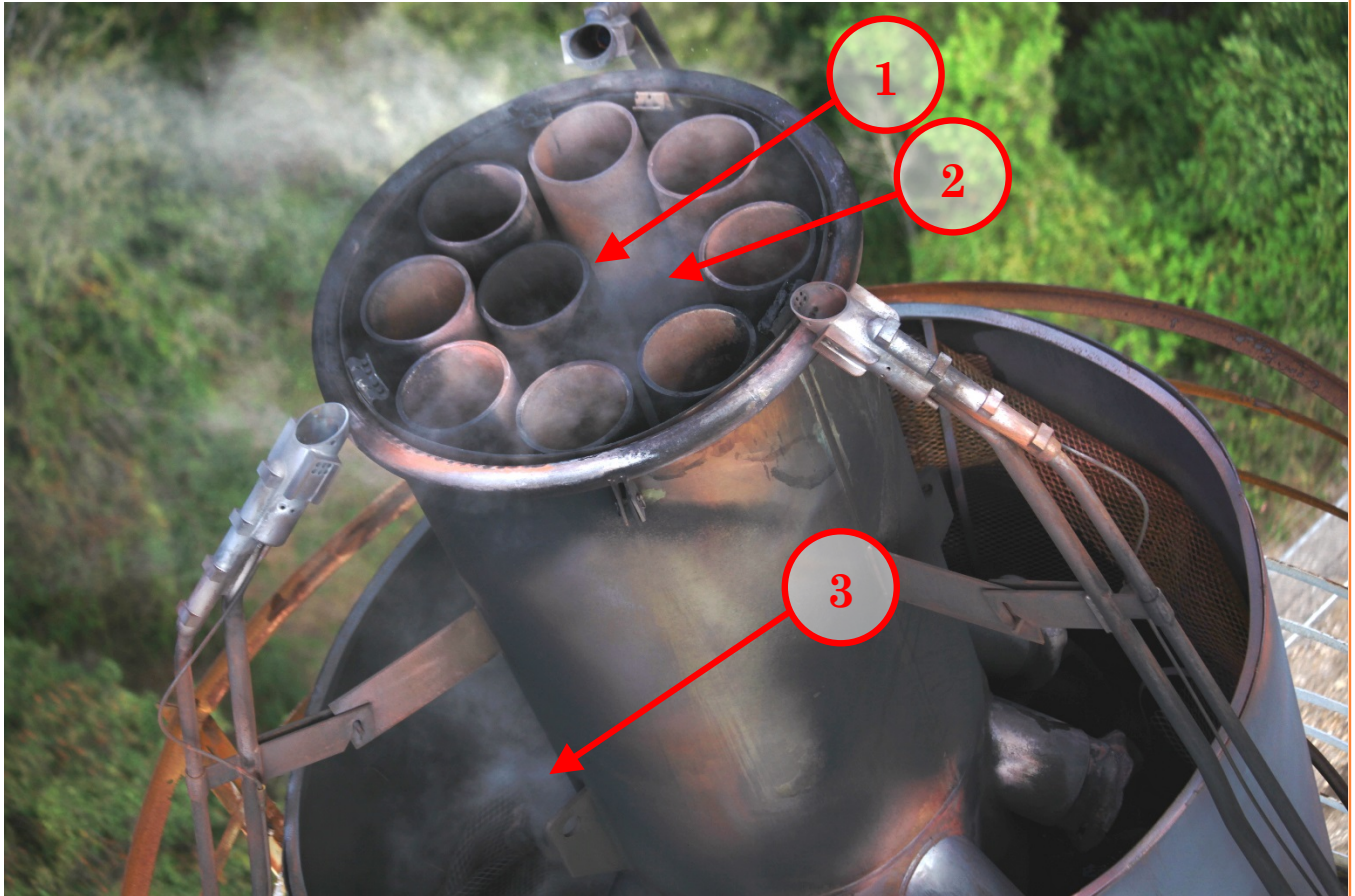
1. The displacement of the center steam-air tube is significant. The connection of the steam tube to the barrel wall tends to be easily damaged by flame impingement. The transition of the tube as it penetrates the barrel at an angle to its final vertical trajectory is often made with a mitered weld, and this can also be susceptible to rapid damage in a capping or reverse-firing event. Knowing the delicate nature of this assembly, the displacement of the center tube is consistent with a break in one of these welds, not merely bending or sagging.
2. The most troublesome evidence of damage is the steam condensate apparently emanating from the flare tip barrel, not the steam injection tubes. Normal steam

The above observations lead to the conclusion that there is a significant weld break either in the steam tube miter or the barrel penetration. In either case, flare gas may now combust in an unintended manner with certain impacts such as unknown flame stability, rapid degradation to the flare tip assembly, and likely damage to nearby equipment such as the platform and derrick assembly.

The assumption reported earlier is that no significant deformation is recognized as a result of the survey, and the tip has the possibility of remaining in service. Based on the below observations, Zeeco assess the equipment to have damage that necessitates its urgent repair or replacement:

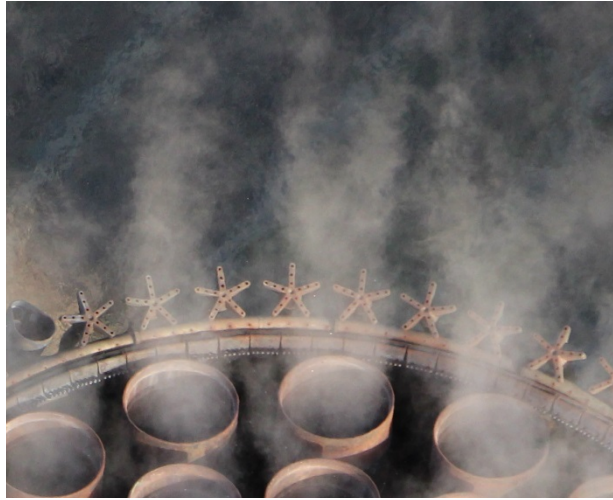
Instead, the steam pattern from the tip is ill-defined. The appearance, in conjunction with the evidence from the first point, is that a break in the tube is leaking steam and induced air into the flare tip barrel. This is reason for the urgency; flare gas and air can now exchange and mix somewhere other than the flare tip exit. Combustion can occur deep inside the tip and rapidly degrade the assembly, or worse flare gas can exit the steam tube and combust in the muffler in an uncontrolled manner.

3. In its original design condition, the steam injected into the lower tubes flows in its entirety into the inlet venturi and through the tube. No steam is released into the muffler. The steam observed in the muffler area is either coming from a) a break, leak or misalignment of the steam injection assembly, or b) a break or penetration of the inner steam tube at the shell penetration or miter. Considering the observations made in the above points 1 and 2, it is assumed the condensate in the muffler is a result of a compromise to the steam inner tube. As mentioned before, combustion can occur deep inside the tip and rapidly degrade the assembly, or worse flare gas can exit the steam tube and combust in the muffler in an uncontrolled manner
