OSU Parking Garage Restored in Two Weeks

Chamberlin restored the Monroe Street parking garage at Oklahoma State University.

The Oklahoma State University (OSU) Monroe Street parking garage was first built in 2008. Located at the corner of Monroe Street and Hall of Fame Avenue, it is near the hub for the OSU transit system which allows students to easily get around campus and the City of Stillwater.

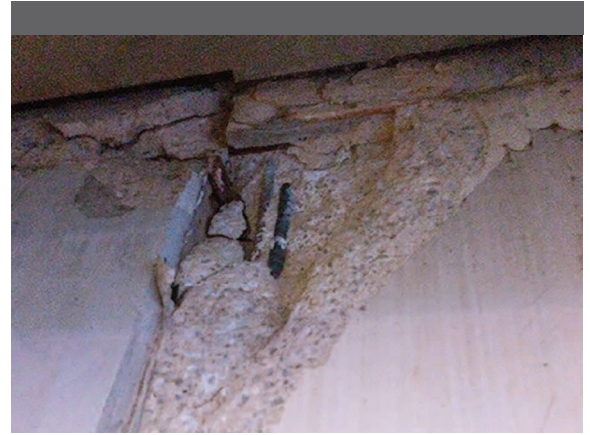
Sections of the garage walls, vertical beams and columns had severely deteriorated over time. The concrete was chipped, broken off and worn down to the rebar in some places. Using hand grinders, the Chamberlin crew first cut out the damaged areas in squares and removed the old concrete. Then, using a BASF grout, they filled in those areas bringing the grout flush with the existing concrete for a smooth finish. This not only improved the facility aesthetically, but also prevented the concrete in those damaged areas from continuing to crack and break off.

The concrete in the parking garage had sustained extensive corrosion and damage.

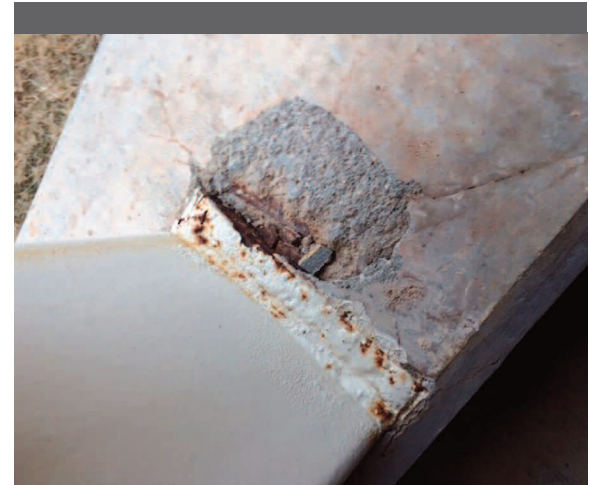
Steel support beams were embedded into the pony walls of the Monroe Street garage during original construction. Movement in the garage over time caused cracking and spalling around this embed. While routing the embed repairs, Chamberlin crew members discovered another concern. The rebar surrounding the damaged concrete in

the walls was partially rusted. If left untreated, the rust will continue to spread and cover the rebar entirely. If that happens, the rebar could fail and cause structural damage to the pony walls.

While performing embed repairs, rust was discovered on the rebar.

To address this issue, the Chamberlin crew removed not only enough concrete to repair the damaged areas, but continued demolishing until all of the rusted rebar was exposed. They then removed the rust and applied a coat of rust inhibitor to the rebar before filling the areas back in, completing the embed repairs.

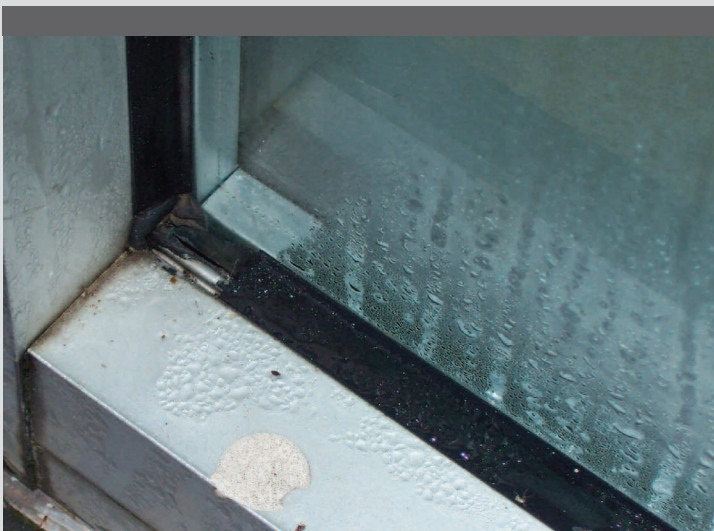
Figure 1: Short gasket at corner of frame

Water infiltration typically occurs at preformed gaskets due to either shrinkage (resulting from weathering/aging) or improper installation. Improper installation can result in gaps and/or openings between adjoining gaskets that occur at the corners of the sill and jamb intersections. During the installation of the gaskets, adjoining gaskets might not be properly mitered at the adjoining corner or the two adjoining gaskets might be “pulled/stretched” into their original end-to-end positions and then shrink back (“re-coil/relax”) to their original length.

As a result of these actions, a relatively large gap ($\frac{1}{4}$ inch to $\frac{1}{2}$ inch) can occur at the corners of the sill and jamb intersections, which can allow an excessive amount of water to migrate into the internal network of

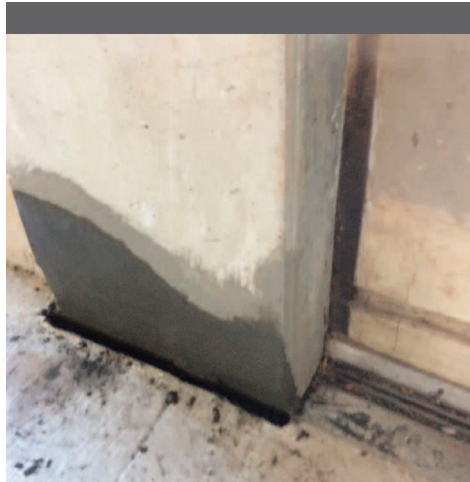
This picture shows an area of concrete patched on a column during the curing process.

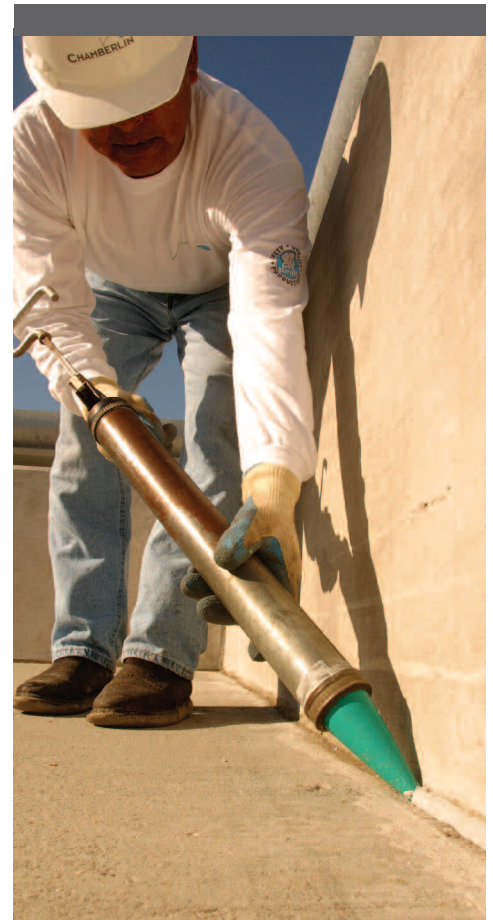
Installation of parking garage joint sealants.

Sealant was used to repair the cracking in the concrete slab. Since the cracks were initially caused by structural shifting, the Chamberlin crew first cut the cracks open with a grinder to achieve the correct width-to-depth ratio for the sealant to have optimal movement in the future. Tremco Dymeric 240FC was chosen for this scope, which is a cost-effective urethane caulking useful for keeping moisture out without being too rigid. The same material was also well suited to replace the failed joints on the vertical precast panels.

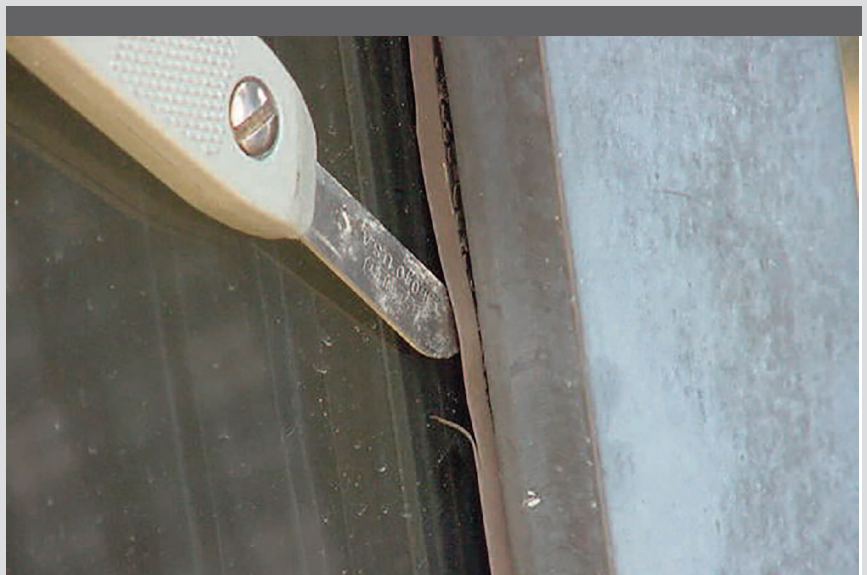
Figure 2: Loose gasket

the assembly (Figure 1). The gaskets are traditionally composed of EPDM rubber that, upon exposure and aging, will begin to shrink and develop crazing/cracking of the gasket surface. This shrinkage and development of cracks (particularly along the outer, thinner edges of the gasket) can result in a loss of compression between the gasket and the glass, which can then allow moisture migration into the assembly (Figure 2). Therefore, the purpose of the wet seal is to completely conceal the gasket with the new sealant.

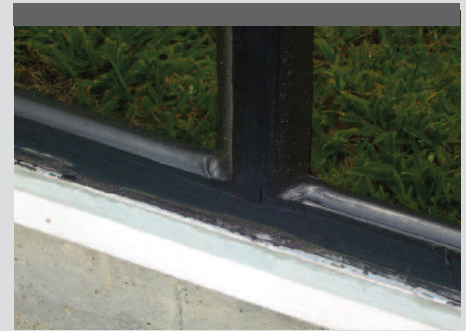
Figure 5: Lock-strip wet sealed

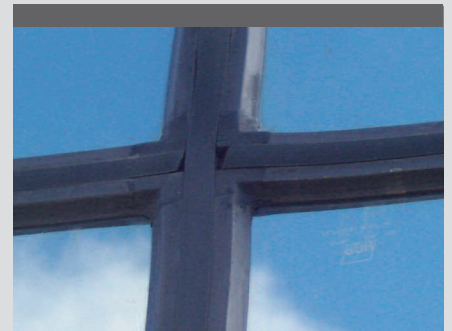
Figure 6: Lock-strip gasket corner

Similar to other preformed gasket systems, lock-strip gasketed systems become vulnerable as the outer edge of the gasket or lip of the gasket loses pressure on the glass, resulting in avenues for moisture migration into the glazing pocket and manifesting as leakage in the interior at joints in the gaskets. Wet sealing of these assemblies can include injecting sealant behind the lip of the gasket and allowing the sealant to exude out to be tooled flush. Sealant is then applied in a cap bead centered over the lip or outer edge of the gasket and adhered to the gasket and the glass (Figure 5). Sealant is also applied over the gasket intersections at the corners of the four glass units, and any gasket joint that may occur in vertical or horizontal runs of the assembly (Figures 6 and 7). Mock-ups using the proposed sealant should be performed to test for compatibility issues and adhesion properties. In the past, polyurethane sealants were commonly used for this application, due to their ability to bond readily to the gaskets. However, due to their organic-based compound, this type of sealant weathered and became hardened in a relatively short timeframe (i.e., 5-7 years) and made future sealant remedial work (removal) more exhaustive.

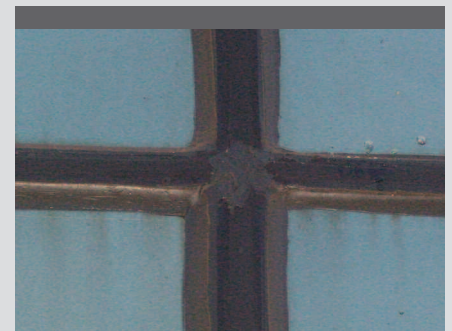
Figure 7: Wet seal of lock-strip gasket
