Preserving an Austin Historical Landmark

The Driskill Hotel repaired and restored balconies on Sixth Street.

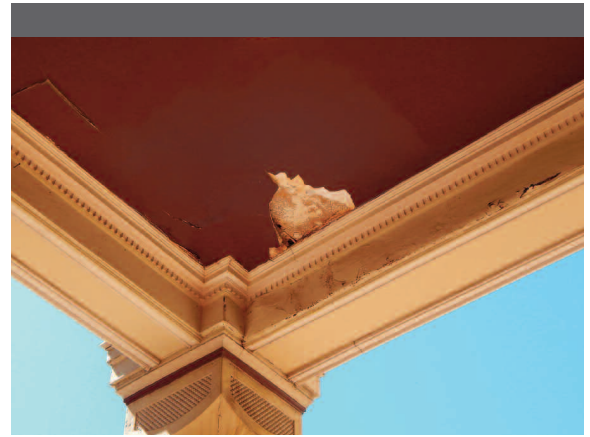
Building Consultants, Ltd. conducted a thorough building envelope investigation to uncover the extent of water damage. It was apparent the soffits were compromised, however the investigation identified other areas that needed repair as well. The consultant cut holes into the soffit to observe the structural integrity and concluded the joists were heavily damaged and needed to be replaced. The same conclusion was reached for the extensively deteriorated decks on all four balconies.

An original soffit depicting water intrusion.

Once the waterproofing was complete, a three-inch concrete slab with an eighth-inch slope per foot was poured and leveled. The crew then installed plaster and sheathing at the soffits, an intricate crown molding and trim on the balustrades, and copper flashing around the perimeter of the balconies.

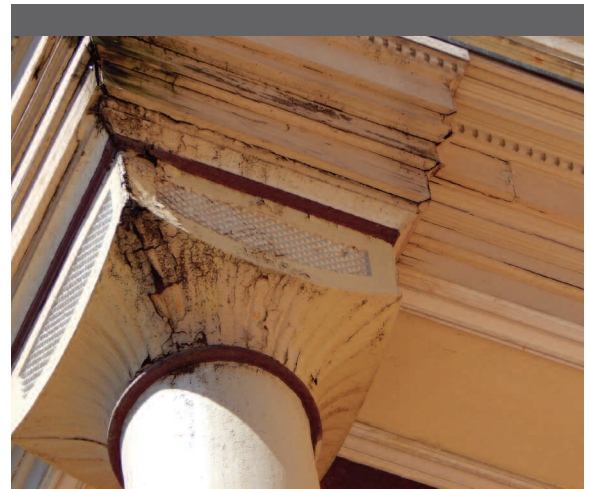
Water damage to an original balustrade.

Blue Diamond Steel was enlisted to restore the existing balustrades. During the initial evaluation, abnormally large cracks in the cast iron were observed and some sections were discovered to be unlevel by as much as half an inch. The cause of this damage became clear when the floor under the concrete was discovered to be rotten, compromising the substrate on which the balustrades rely.

The Chamberlin project management team corresponded with an architect to discuss preserving the existing cast iron balustrades. To maintain the historical value of the hotel, the architect recommended the balustrades be removed, repaired and reinstalled instead of replaced.

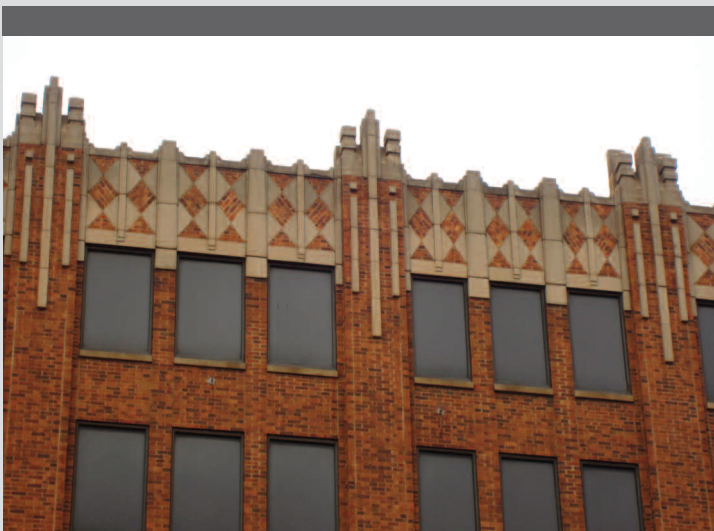
Figure 1: Brick and cast stone capitals and spandrels that were salvaged and reinstalled as an interior architectural feature in the new construction.

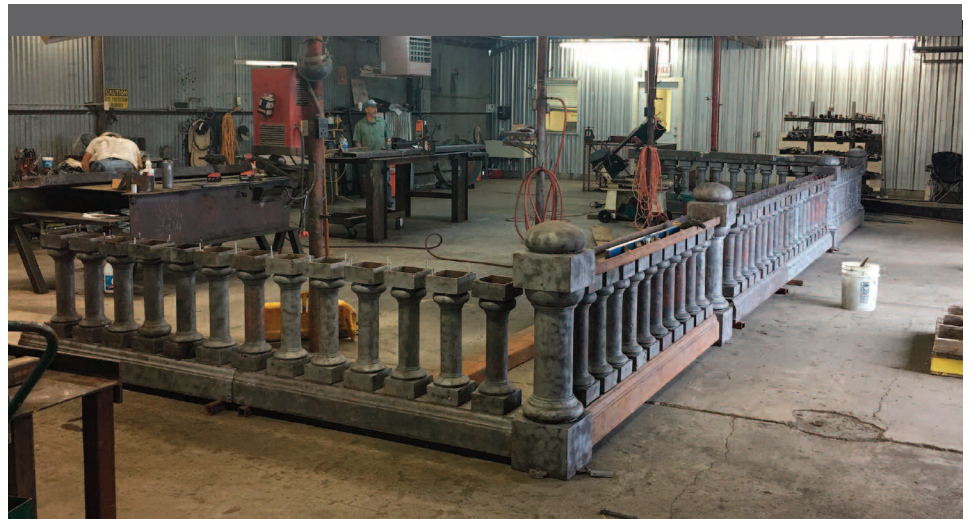
The balustrades were sandblasted to remove the paint and expose cracks before welding.

The balustrades were removed by crane and transported to the Blue Diamond Steel facility in New Braunfels, Texas, for repairs. They were sandblasted to remove multiple layers of paint and expose the cracks. Then, the paint chips were tested for lead. The paint that contained lead was placed in barrels and properly disposed.

Knowing that cast iron is extremely brittle, the balustrades were placed in a charcoal oven for three hours until the temperature reached approximately 500 degrees. This process helps to prevent any further breakage during the welding phase. After the balustrades were welded, they continued to rest in the oven until the coals cooled to a safe temperature before the balustrades could be removed. For those sections of the balustrades that were too badly cracked or missing pieces, new balustrades were fabricated.

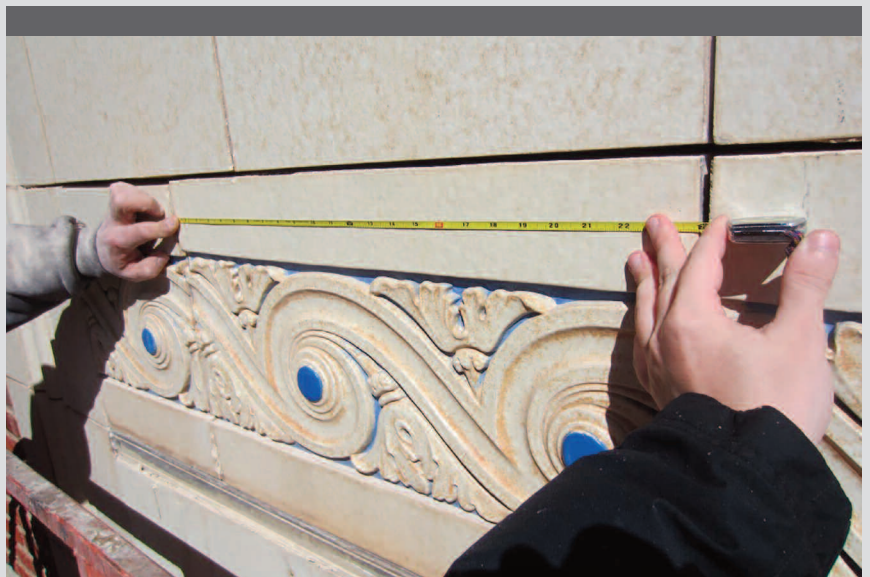
Figure 2: Measurements of the polychromatic terra cotta units and total quantities were made to determine the available quantity for the reinstallation.

In addition to the quantity and sizes of the units, the design team also needed to understand the condition of the elements being retained. For example, the cast stone frieze elements only required cleaning to maintain their historic appearance. However, the terra cotta had varying degrees of distress and damage that needed to be repaired. Discussions with the architect about the final appearance of repairs and the acceptable size of unrepaired areas were important to establish a baseline level of repair.

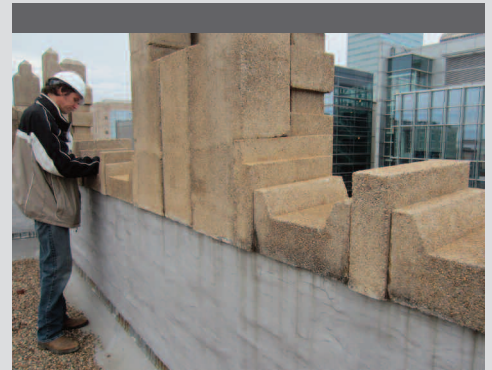
Figure 4: Measurements were made of the brick and cast stone capitals.

capitals were simply stacked with little to no connection between the units, and the cast stone frieze elements were laid in the masonry with no significant ties that needed to be cut. Removal of these items was anticipated to be straight forward with no projected loss of materials.

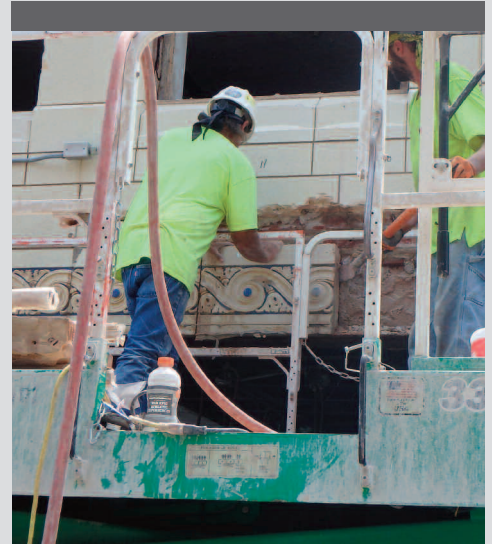
Figure 5: Frequent visits to the site allowed for opportunities to observe and provide alternate strategy for removal of the terra cotta.

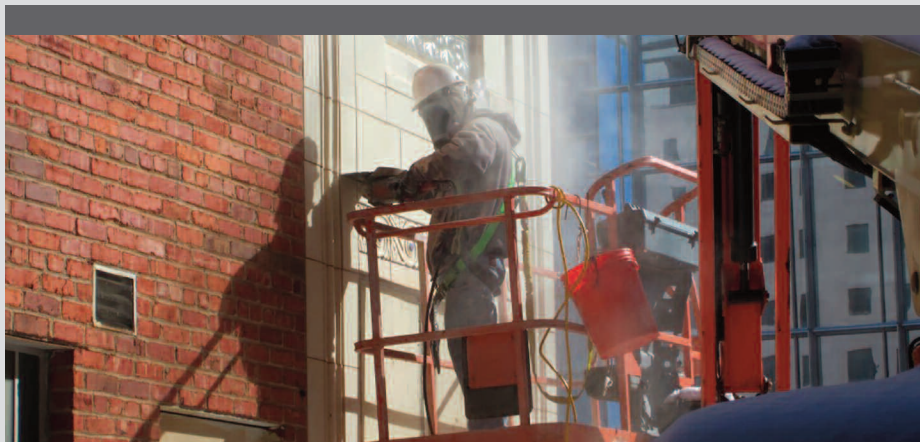
In contrast, for the terra cotta frieze, it was critical to locate the quantity of anchors, determine the strength of the bedding and fill mortar and identify which units could be sacrificed to achieve access. During the investigation, it was found that the mortar behind the terra cotta was concrete and that two heavy ties per unit were embedded into this mortar and the back-up wall. It was also discovered that the frieze was seated into the web of a beam header which would complicate removal. In this case, since the frieze units were the only ones to be salvaged, the ashlar units above the frieze were sacrificed to provide adequate access for removal.

Figure 3: Selective removal and exploratory openings during the investigation were used to determine the type of connection of the terra cotta to the back-up wall.

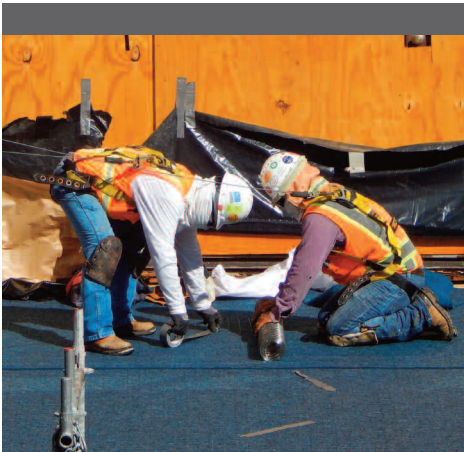
The Chamberlin crew preparing for Electronic Leak Detection (ELD) testing on the waterproofing membrane.

fasteners. Electronic Leak Detection (ELD) testing was then performed to check for membrane water tightness.

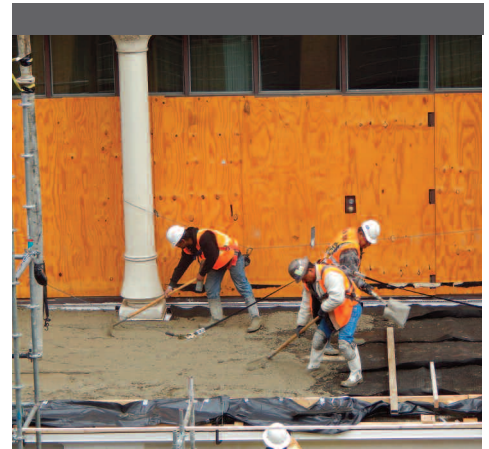
Leveling concrete on the new balcony as it is being poured.

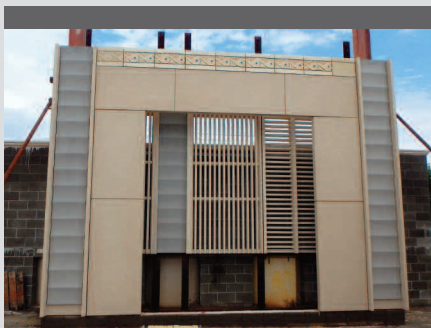
Figure 6: Full scale mock-up of the terra cotta frieze installed into the GFRC panel (note that the end pieces were recreated units being reviewed for acceptance in the final installation).
