CHAMBERLIN

NEWSLETTER

Restoring The Buckingham Balconies

WINTER 2018

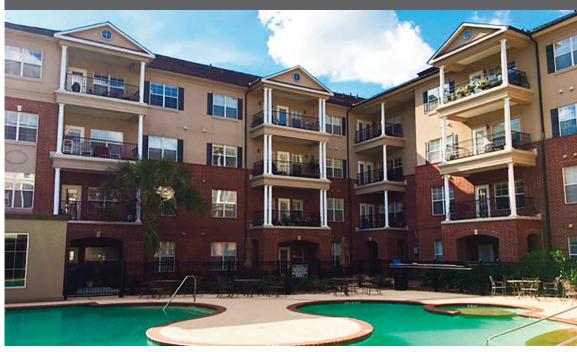
One hundred and forty-four balconies were restored at The Buckingham senior living community in Houston, Texas, to remedy water infiltration.

The Buckingham is a four-story senior living community located in the center of Houston, Texas. This establishment encompasses over 200 residences, with a balcony attached to each exterior unit. Due to unknown issues during original construction, the waterproofing and flashing details installed on the balconies failed, allowing water infiltration that caused extensive damage over the years. The framing members were deteriorated, and the plywood decks rotted, with many requiring complete demolition and rebuild. A nearly two-year-long project kicked off to fully restore and waterproof 144 balconies at The Buckingham.

After demolition, Chamberlin repaired and replaced damaged framing and columns, as well as installing new through-wall flashing. Next, new wooden decking was installed with an eighth-of-an-inch drop per foot to create the proper drainage slope. Then a W.R. Grace Bituthene 3000 sheet waterproofing system was applied and covered with a Wausau paver system. Finally, metal retaining flashing was installed.

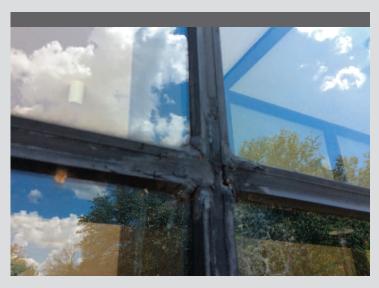
Figure 1: Lock-strip gasket in need of repair. Photo courtesy of Chamberlin Roofing & Waterproofing.

Remedial options are available for lock-strip gasket facades that focus on preserving and maintaining the primary elements and appearance of the system from simple remediation efforts, such as the installation of exterior "wet-seals" to limit air and water infiltration, to complete replacement and reglazing. (Fig.1 and Fig. 2)

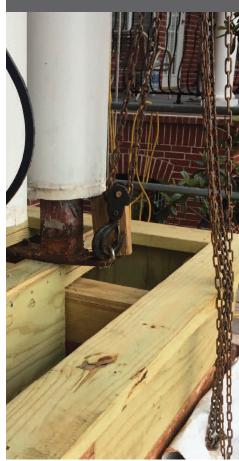
Chamberlin devised a hoist system to hold the columns in place while repairing the decking beneath.

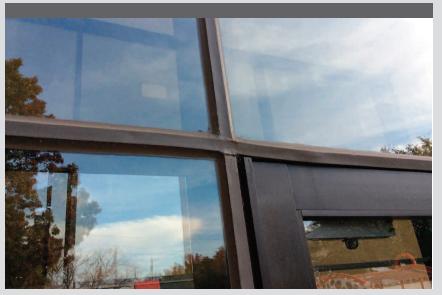
Figure 2: Repaired lock-strip gasket. Photo courtesy of Chamberlin Roofing & Waterproofing.

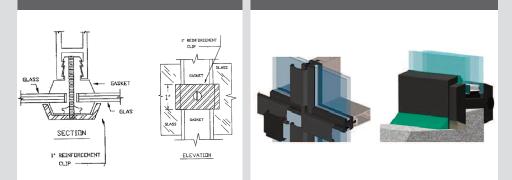
Figure 3: Retaining clips for lock-strip gasket. Diagram and image courtesy of Griffith Rubber Mills.

To provide structural support of the existing system, a remediation may include installation of retaining clips at exterior horizontal and vertical lock-strip gaskets. The addition of mechanically attached retaining clips will help to ensure structural performance of the system as deteriorated gaskets may not exhibit the same performance characteristics as originally designed. This is especially important at corner zones and locations anticipated to have significant wind exposure. (Fig. 3)

The use of reinforcement clips results in an increase in the resistance of the gasket to roll off the frame. The use of one clip per side provides substantially higher load capacity and still greater capacity is obtained using two clips per side.
