2021 Audi e-tron quattro

Weak Key Fob – Failure to Recognize

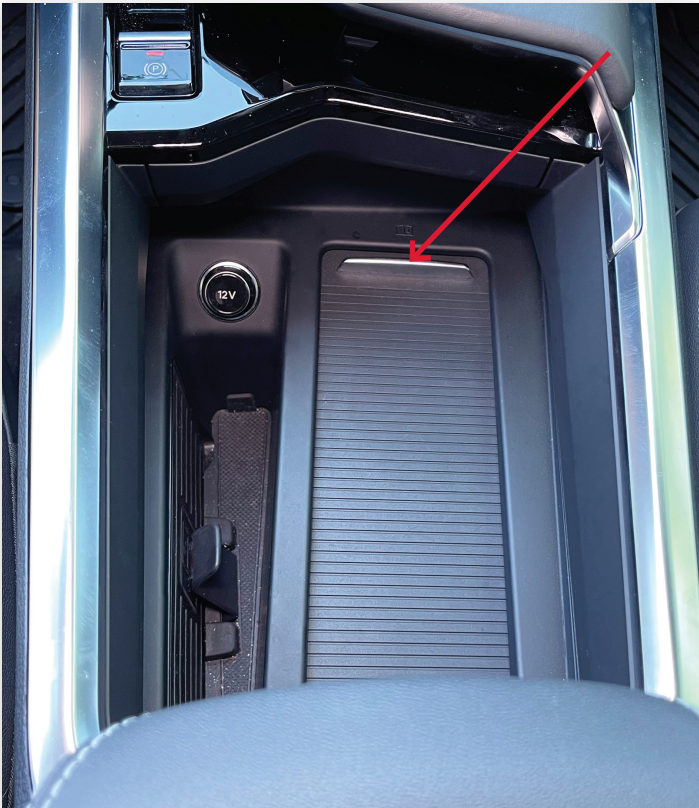
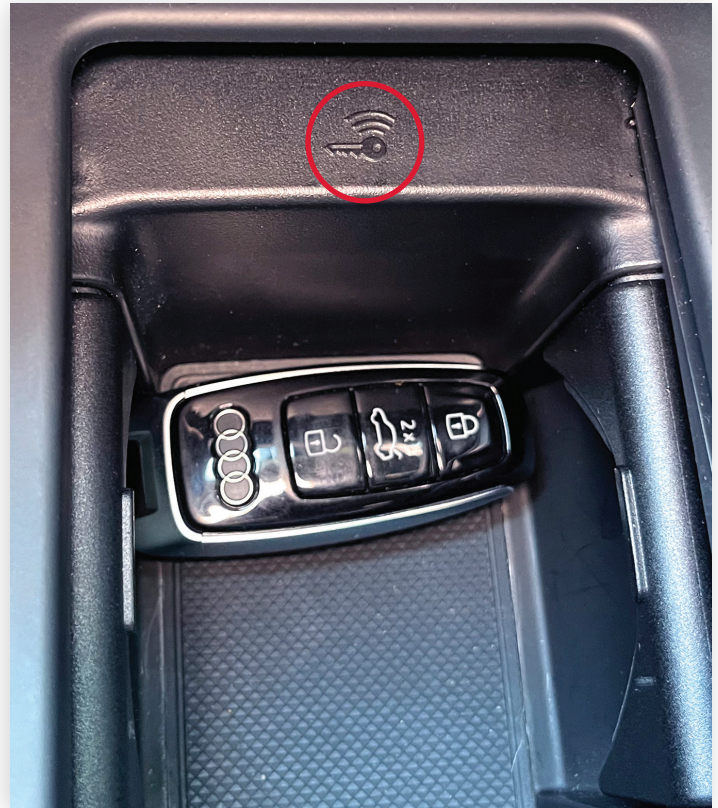
When e-tron quattro proximity Key Fob Batteries become weak the vehicle may have difficulty acknowledging its presence and not start.

Placing Fob in the designated area will aid in starting the vehicle.

The designated area in e-tron quattro is in the front cup holder in the center console.

Immediately replace the weak Key Fob Battery
