2021 Ford Mustang Mach-E

Weak Key Fob – Failure to Recognize

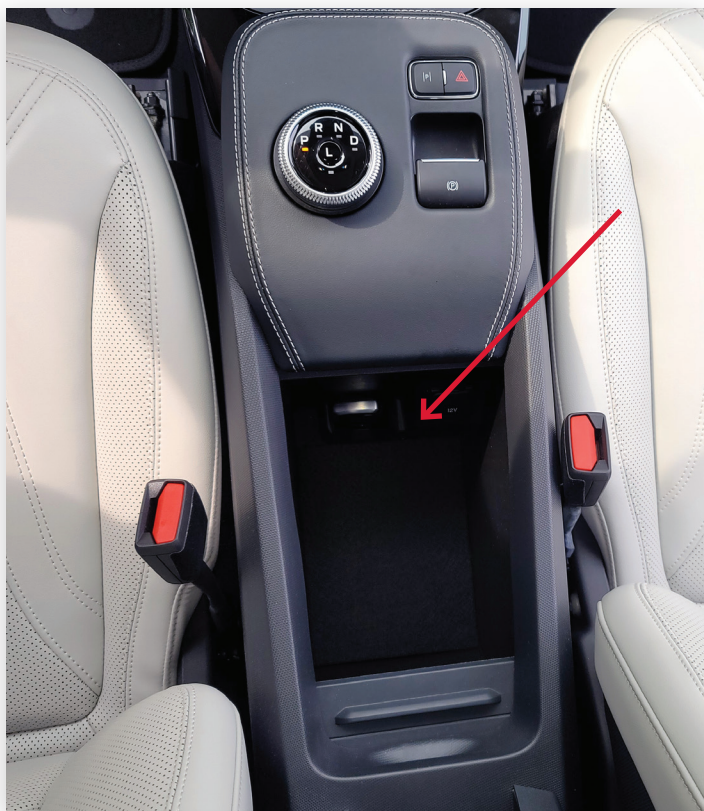
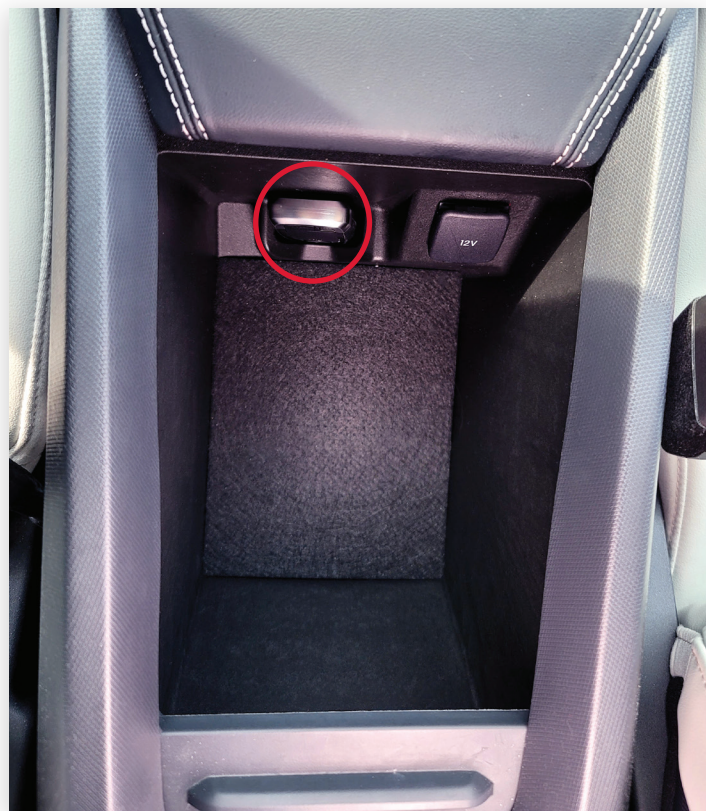
When Mach-E proximity key fob batteries become weak the vehicle may have difficulty acknowledging its presence and not start.

Placing the fob in the designated area will aid in starting the vehicle.

The designated area in Mach-E is in on the front wall of the center console.

Immediately replace the weak key fob battery
