Energy Audit

Saanich Peninsula Hospital 2166 Mt. Newton X Road Saanichton, B.C. V8M 2B2

Executive Summary

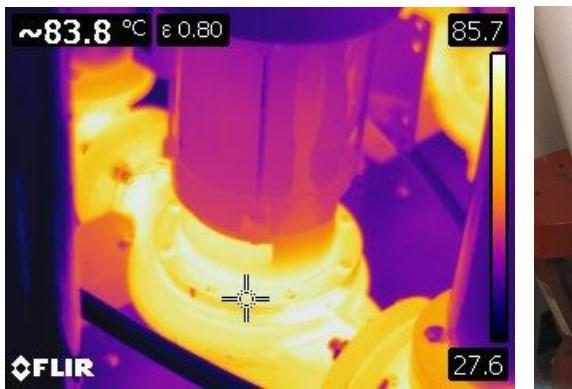
Figure 3 This thermographic image of an exposed motorized heating pump at 83° C or 181° F.

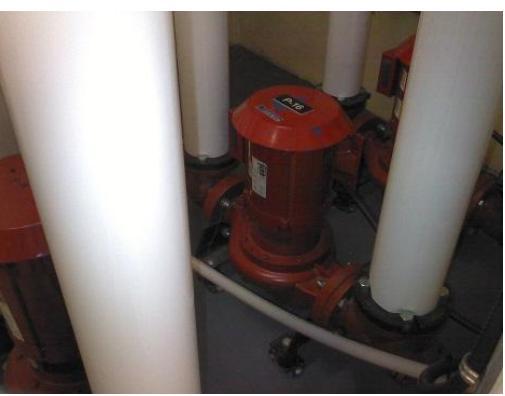
Figure 4 This is a conventional photo of the same pump. There is also an exposed strainer and control valve.

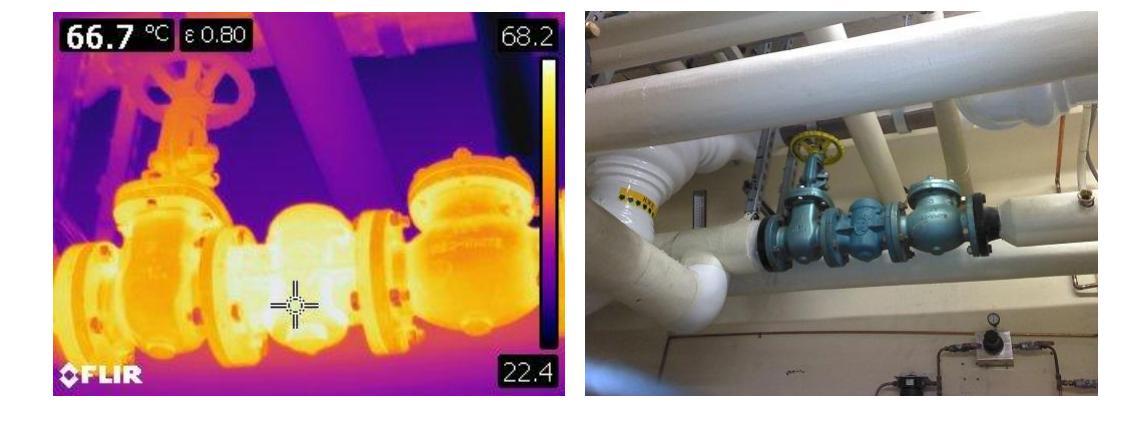
Figure 5 This Thermographic image of a HWR supply valve assembly at 66° C or 152° F.

Figure 6 This conventional photo shows the same valve assembly. This assembly should be insulated for cost savings purposes.

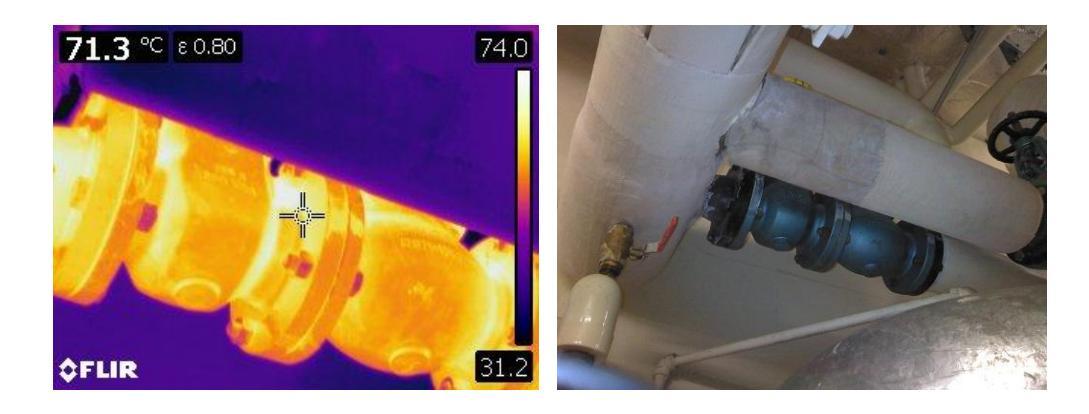
Figure 7 This is a thermographic image of another set of valves at 71° C or 161° F.

Figure 8 This is a conventional photo of the same valve assembly and a further valve in the picture.

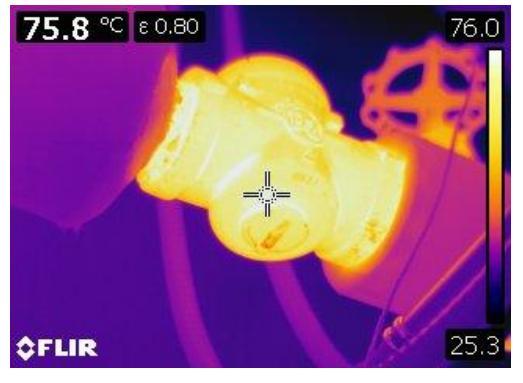
Figure 9 This is a thermographic image of a backflow preventer at 76° C or 168°F.

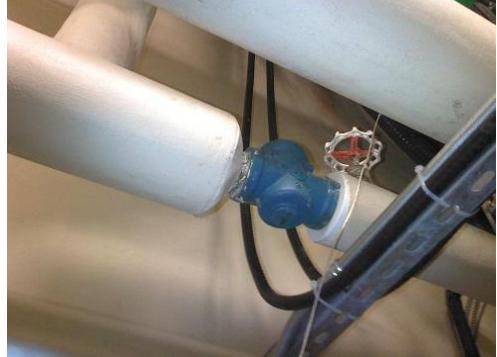
Figure 10 This is the conventional image of the same bare backflow preventer in the boiler room.

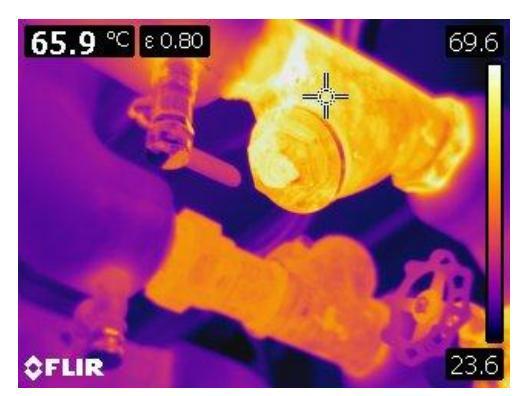
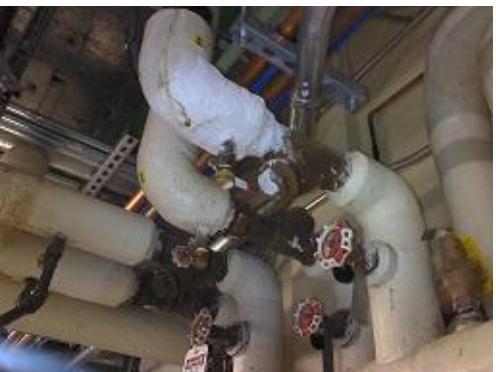
Figure 13 Thermographic image of non insulated fittings on the pre heat from a heat exchanger at 66° C or 150°F.

Figure14 This is a conventional image of the same valves and fittings.

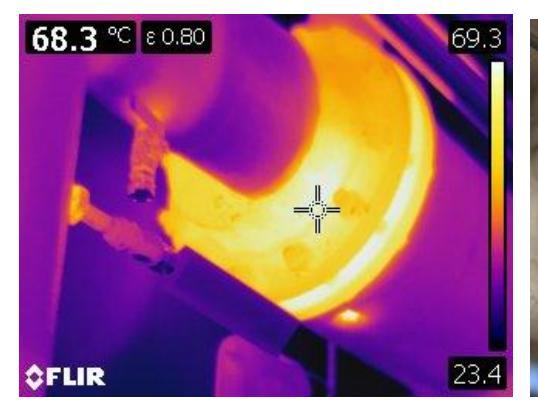
Figure 15 This thermographic image is of bare flange on a heat exchanger at 66° C or 150°F.

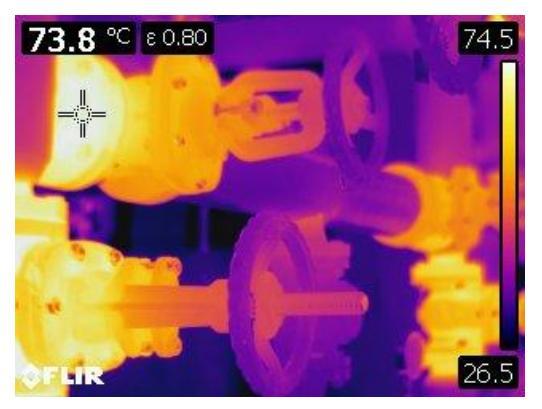
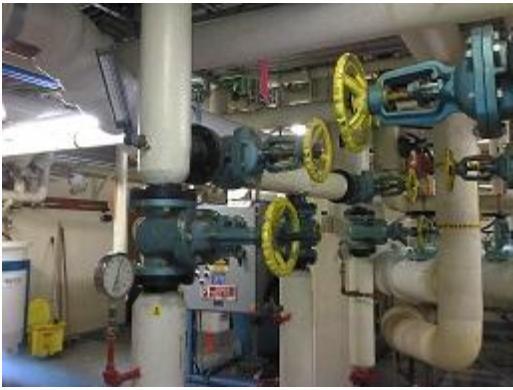
Figure 18 Thermographic image of a number of non insulated valves at 74° C or 164 °F.

Figure 19 Conventional image of the same group of bare valves.

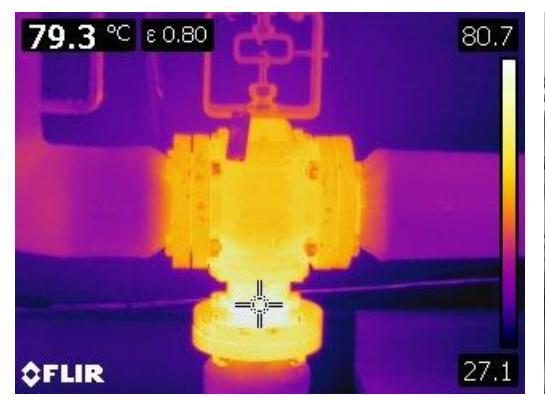
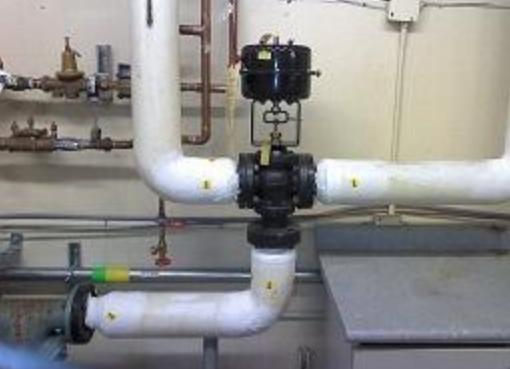
Figure 20 Thermographic image of a three way valve at 79° C or 176° F.

Figure 21Conventional picture of the same three way valve.

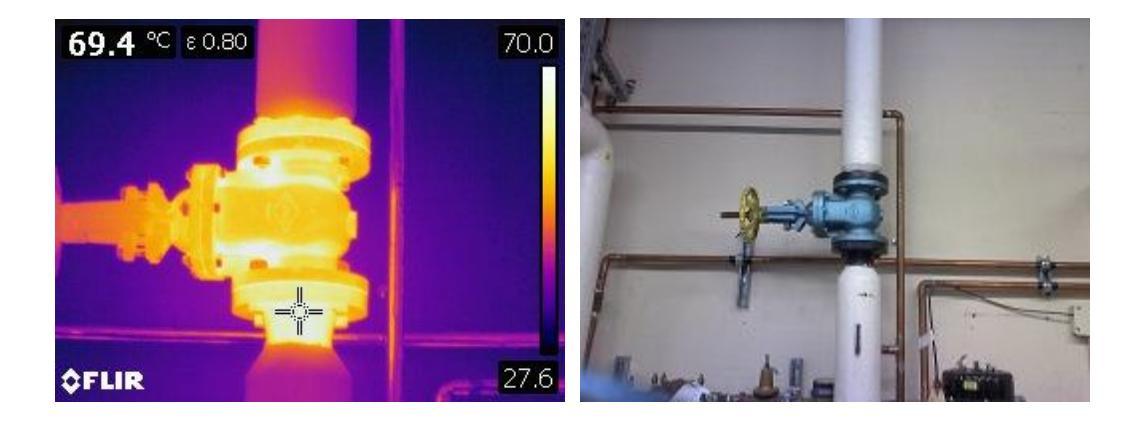
Figure 22 Thermographic image of a single bare valve at 69° C or 156 F.

Figure 23 Conventional picture of the same valve.

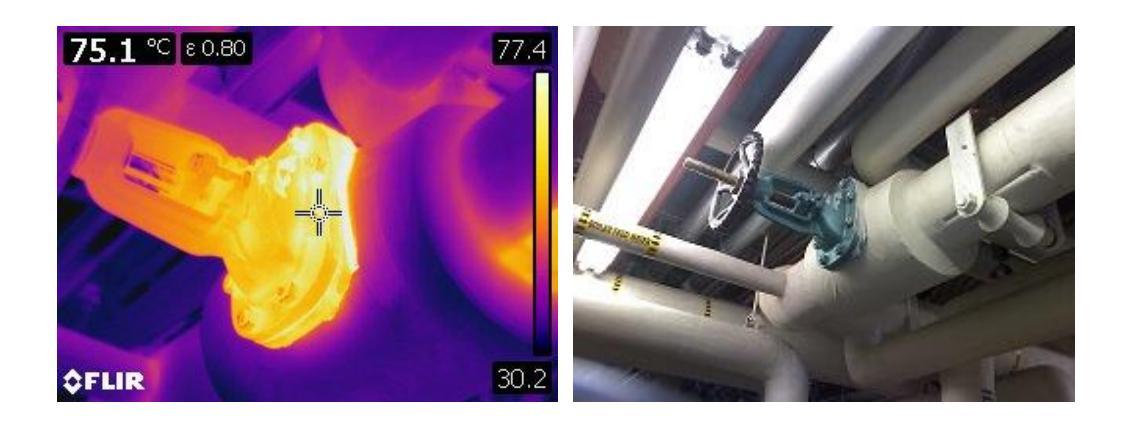
Figure 21 Thermographic image of a typical bare valve bonnet at 75° C or 167 F.

Figure 22 Conventional image of the same valve.

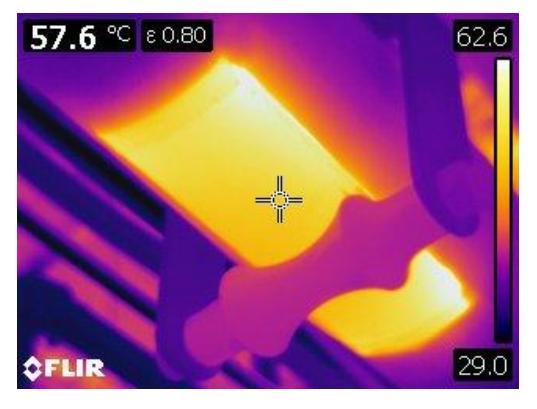
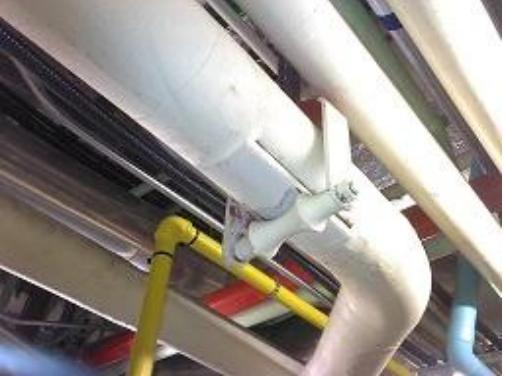
Figure 23 Thermographic image of pipe supports at 57° C or 134 F. (1 of 22)

Figure 24 Conventional image of the same pipe supports.

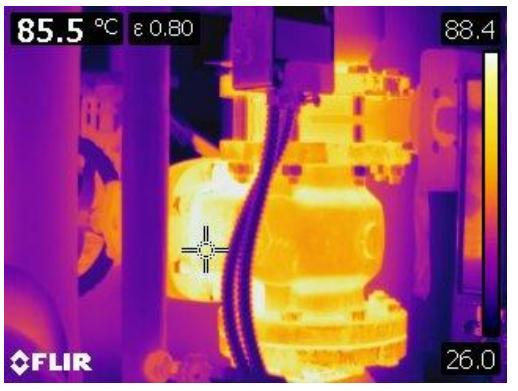
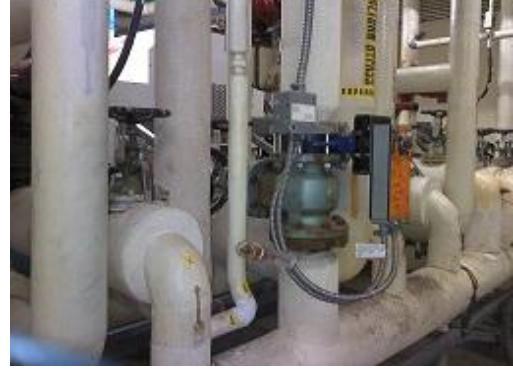
Figure 25 Thermographic image of multiple valves at 85° C or 185 F.

Figure 26 Conventional image of the same valves.

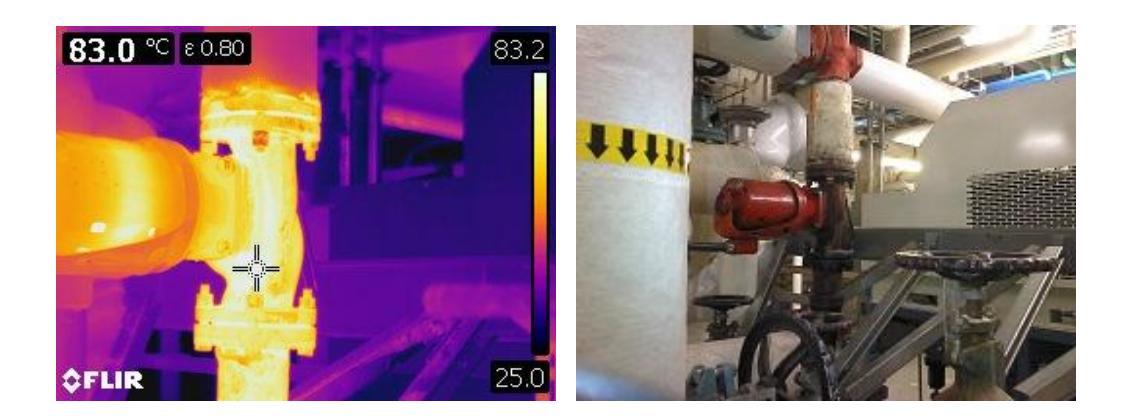
Figure 27 Thermographic image of a motorized pump at 83° C or 181 F.

Figure 28 Conventional image of the same motorized pump.

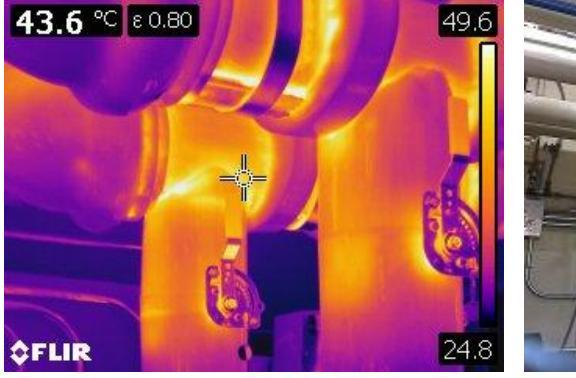
Figure 29 Thermographic image of new work with material backcut too much allowing heat transfer at 43° C or 111 F.

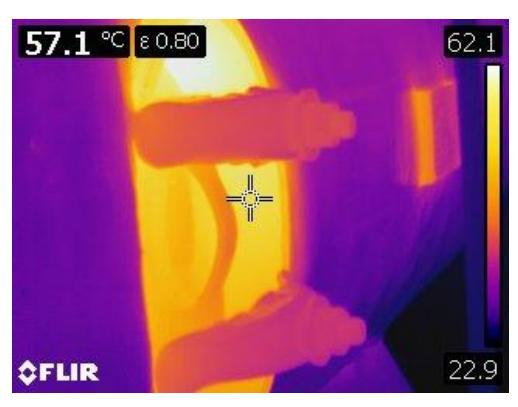
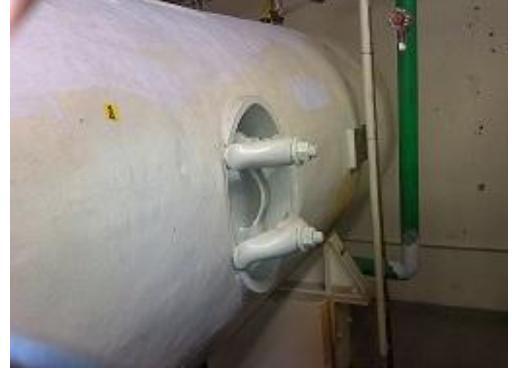
Figure 31 Thermographic image of an access hatch on a hot water tank (57° C or 134 F.)

Figure 32 Conventional image of the same access hatch.

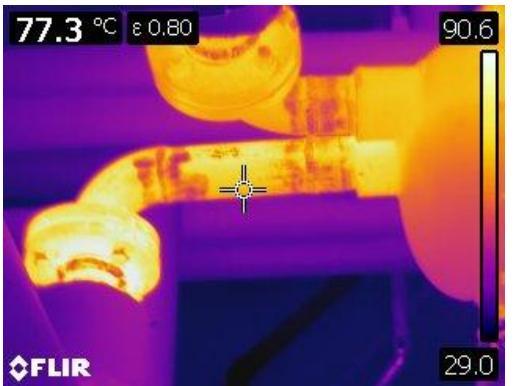
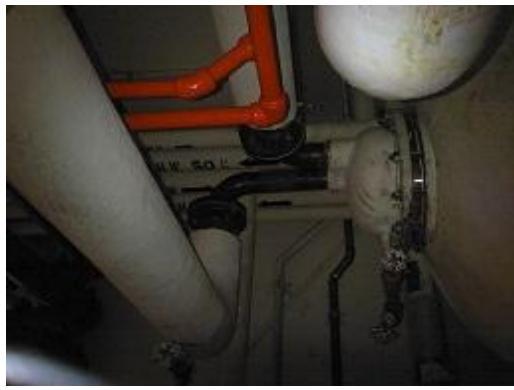
Figure 35 Thermographic image of bare piping to heat exchanger at 77° C or 170F.

Figure 36 Conventional image of the same piping to the heat exchanger.

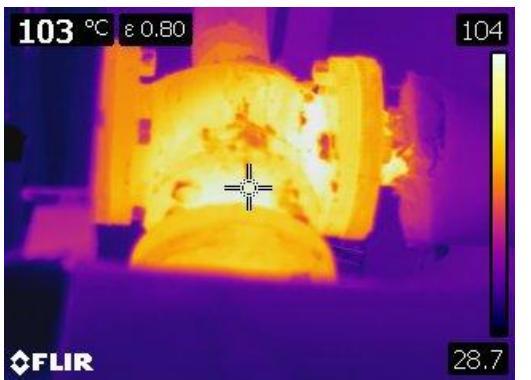
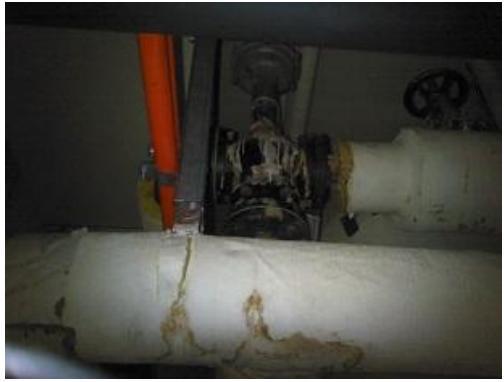
Figure 37 Thermographic image of bare valve 103° C or 219F.

Figure 38 Conventional image of bare valve.

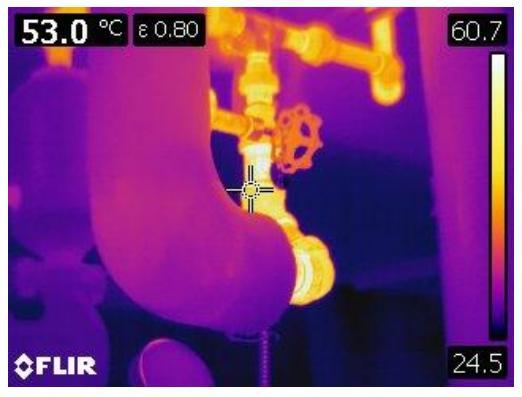
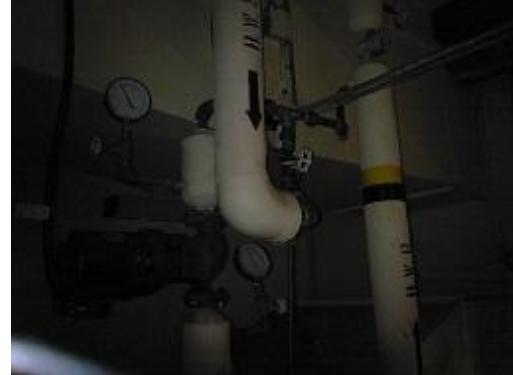
Figure 39 Thermographic image of bare piping within a mechanical room at 53° C or 127F.

Figure 40 Conventional image of the same bare piping.

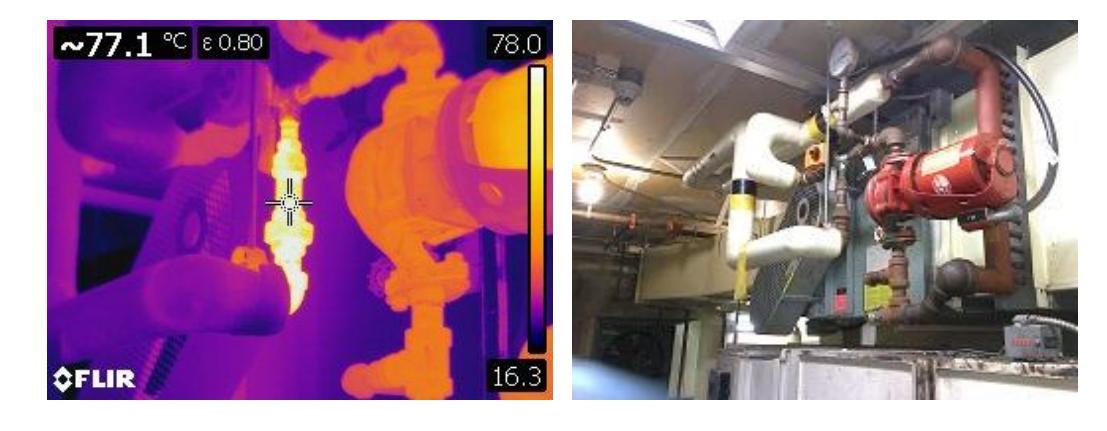
Figure 41 Thermographic image of bare motorized heating pump and piping at 77° C or 170F.

Figure 42 Conventional image of the same pump and piping.

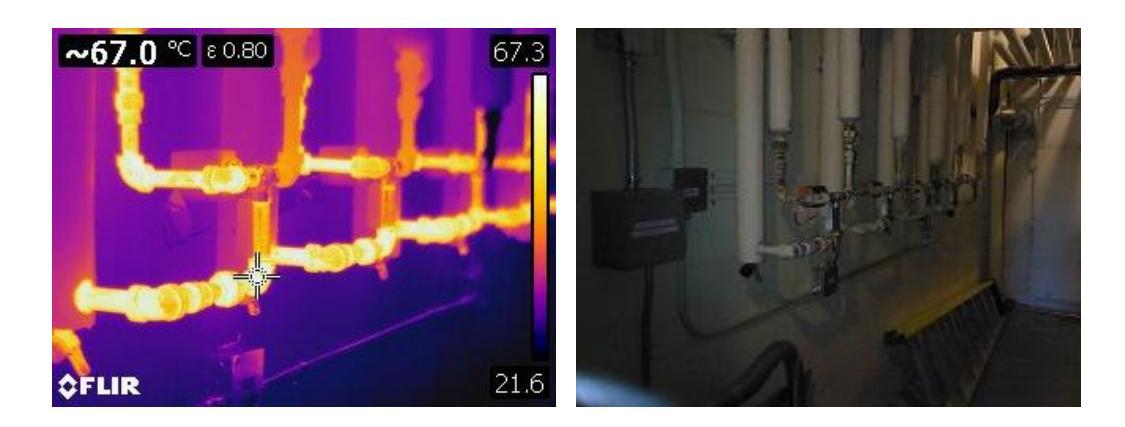
Figure 43 Thermographic image of bare heating supply to coils at 77° C or 152F.

Figure 44 Conventional image of bare small bore heating supply to coils.

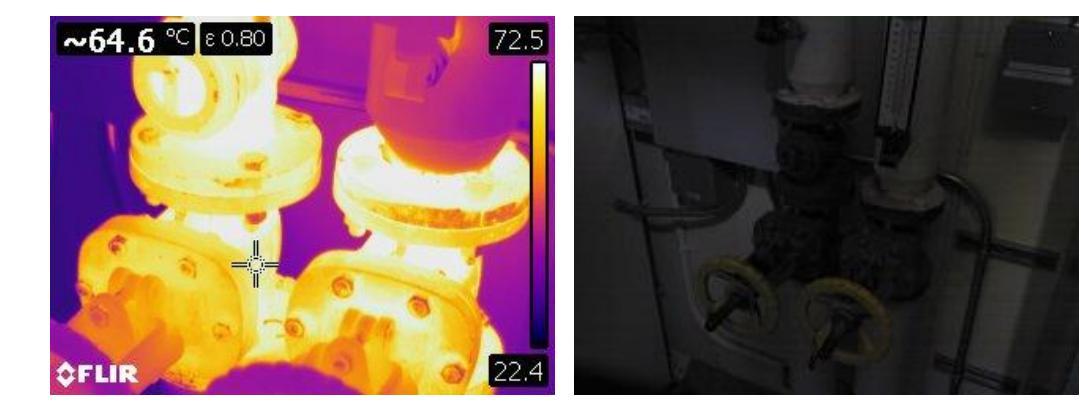
Figure 45 Thermographic image of bare heating supply to valves at 64° C or 147F.

Figure 46 Conventional image of bare supply and return valves.

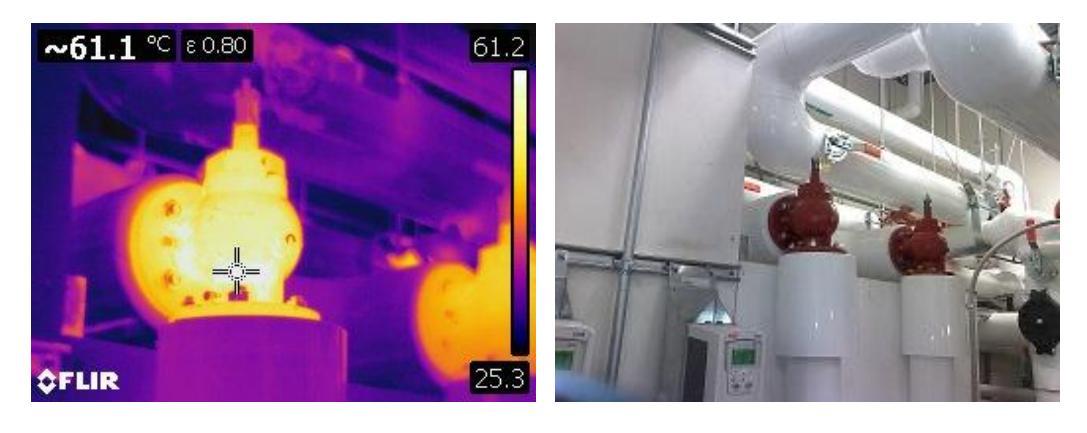
Figure 47 Thermographic image of bare heating supply control valves at 61° C or 141F.

Figure 48 Conventional image of bare supply and return valves.

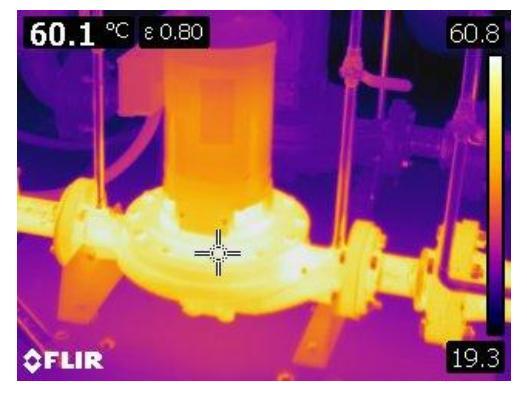
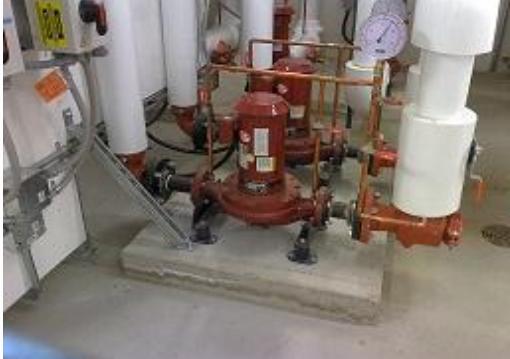
Figure 51 Thermographic image of bare heating supply pumps at 61° C or 140F.

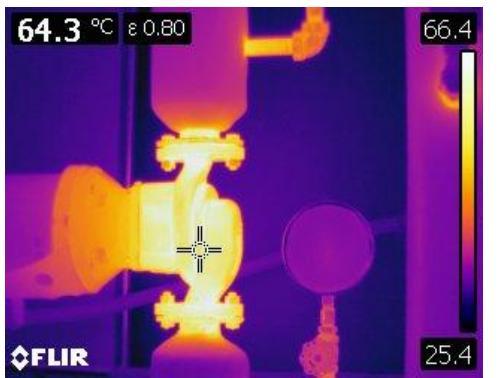
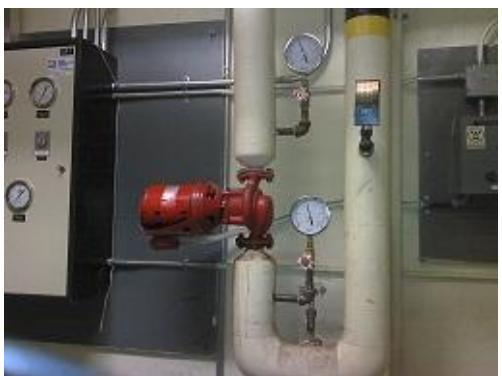
Figure 55 Thermographic image of a bare vertical motorized pump at 64° C or 147F.

Figure 56 Conventional image of the same motorized pump.

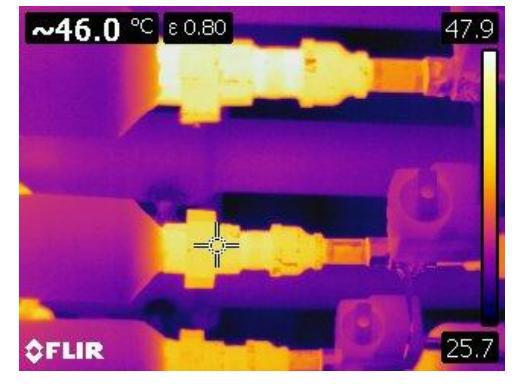
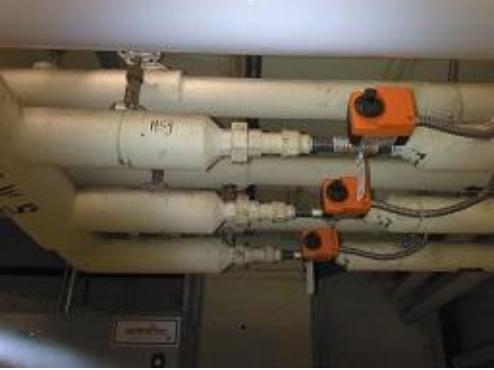
Figure 57 Thermographic image of a bare vertical supply/return and motorized valves at 46° C or 114F.

Figure 58 Conventional image of the same systems.
