# Testing of the biogenic sulfuric acid corrosion resistance of MasterSeal 7000CR

**BASF plc**

**Fraunhofer Institute for Environmental, Safety,  
and Energy Technology UMSICHT**

Oberhausen, 21 July 2016

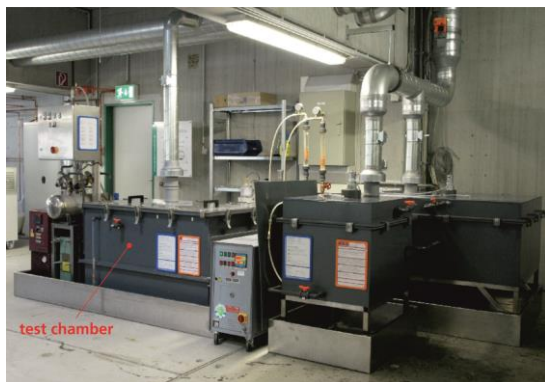
The test bench used for the weathering is located at Fraunhofer UMSICHT and operated by Fraunhofer UMSICHT. Figure 1 shows the test bench and the connected test chambers. In this project the chamber on the left hand side was used to carry out the weathering test.

Fig. 1 Test bench at Fraunhofer UMSICHT.

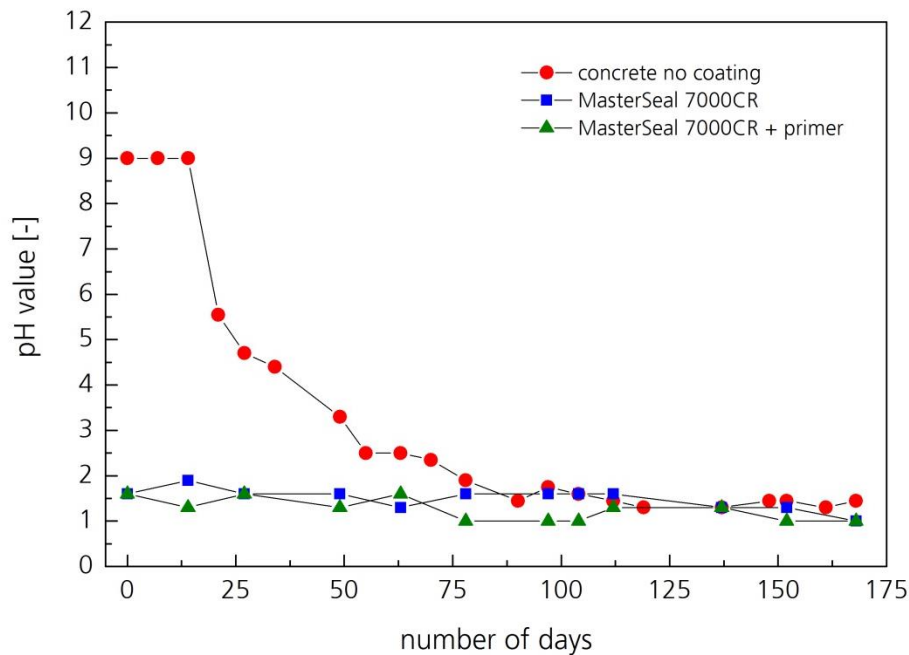
To determine the pH-values on surfaces the pH strips were used. In the test period at 21 days measurements were carried out. The results are listed in figure 5.

Fig. 5 pH-values of samples during the weathering test.

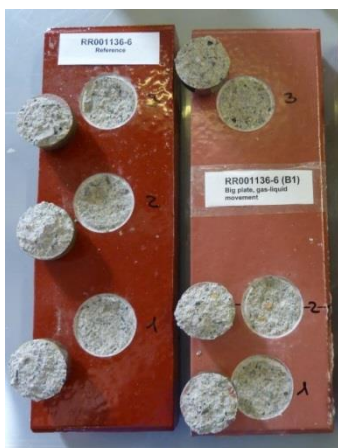
Fig. 2 Samples after adhesion testing.

All tests failed in concrete showing no reduction in adhesion and no attack of the concrete that was affecting adhesion.
