Piedmont Restoration Stops Water Intrusion

Chamberlin Roofing & Waterproofing performed roofing and waterproofing remediations on the Piedmont at River Oaks.

Expanding Horizons for 3D Scanning

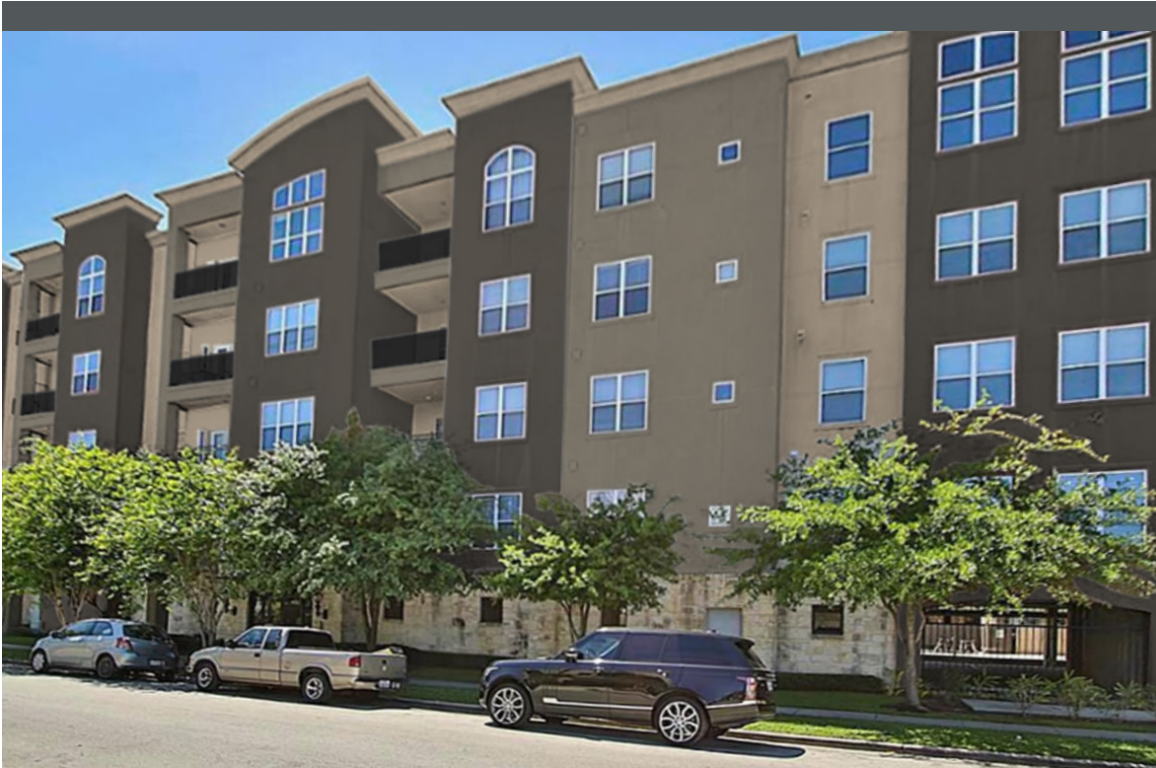
The Piedmont at River Oaks is a four-story luxury apartment complex comprised of 80 residential units and a parking garage. Located in Montrose, also known as "The Heart of Houston", the residents are minutes from restaurants, parks, museums, retail and running trails. Built in 2006, time and weather had taken their toll on the buildings. Additionally, the original building wrap waterproofing had failed, and through-wall flashing and weep system at each floor line were

not installed. These circumstances necessitated a large-scale renovation. Chamberlin Roofing & Waterproofing was contracted by Building Engineering Consultants, Inc. (BECI) to perform both roofing and waterproofing scopes.

balcony handrails, remedying water infiltration by establishing an improved waterproofing system, recladding the façade and replacing pool drains. These elements not only delivered improved aesthetics, but also created safer living conditions and gave the buildings a sustainable solution to mitigate water infiltration.

During remediation of the exterior building walls, almost 50,000 square feet of stucco was recladded. Underneath, over 27,000 square feet of sheathing needed to be repaired. Once the repairs were made, the City of Houston inspected all sheathing and lathe before new stucco was installed. Good communication among the various trades, project management, operations and quality assurance staff was essential to delivering a high-quality project. Despite having over 30 inclement weather delays, Chamberlin was able to complete the project on time, with no leaks and with zero safety incidents.

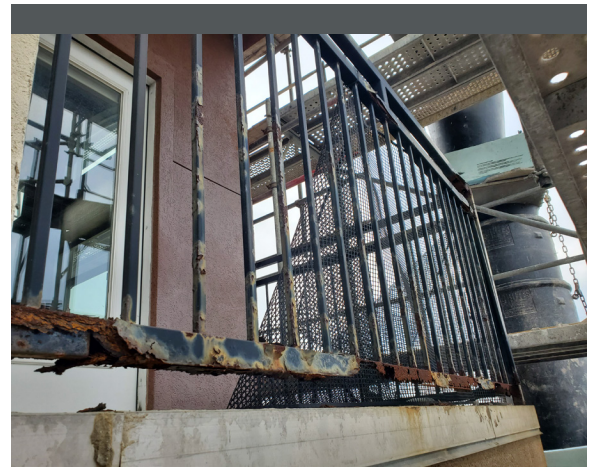
Chamberlin repaired 80 deteriorated balcony railings.

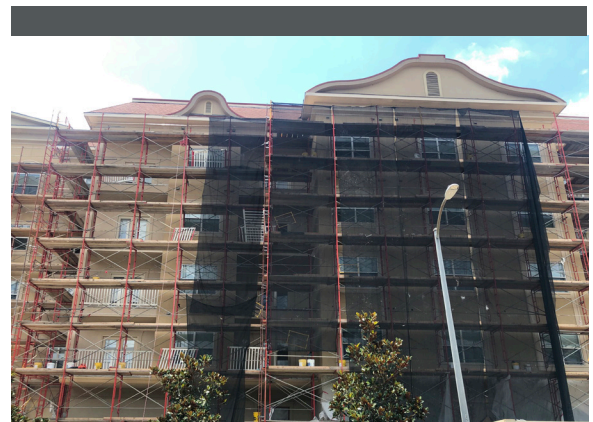
Extensive netting was hung to prevent falling debris during the exterior restoration.

The project site was crowded with tradespeople and residents. When working overhead, the crew installed extensive safety netting to keep workers and residents safe from falling debris. The adjacent walkways were also covered to protect pedestrians. Chamberlin's safety coordinator was invited to speak to other trades on several occasions to help them keep their approach to safety uniform and uphold equal importance of safety regardless of the scope of work.

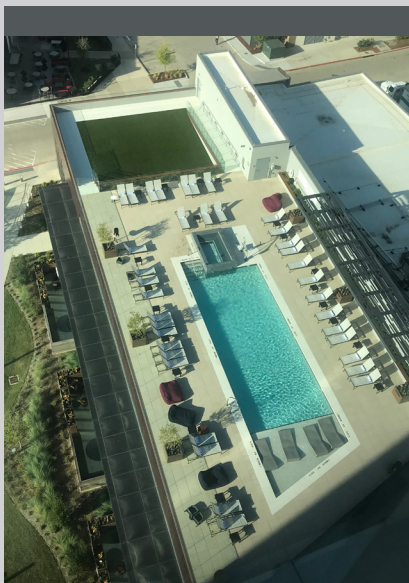
Westin Irving Convention Center Hotel pool deck

Specialty contractor Chamberlin Roofing & Waterproofing was contracted to install the two-tiered terrace for the new hotel. A full paver deck was specified to surround the pool on the upper level.

- 6,220 square feet of pavers
- Includes five treads and risers and ramp
- Some pavers mortar set
- Highly sloped structural deck
- Required R=20 rigid insulation (4" thickness)

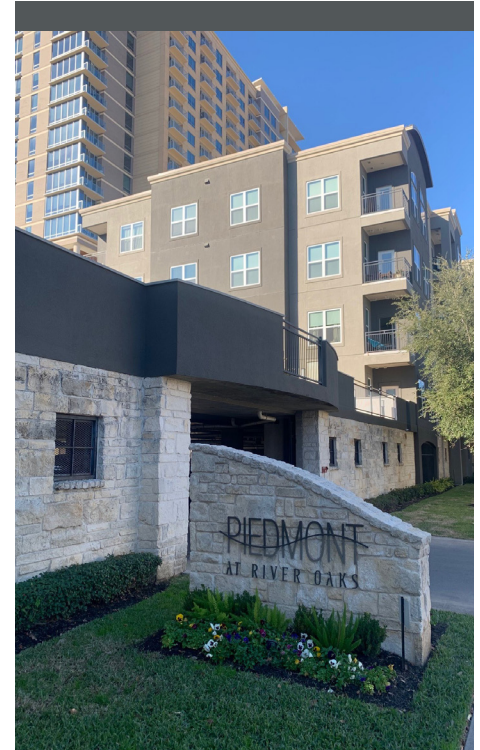
Chamberlin recladded exterior stone and stucco and replaced failing waterproofing underneath.

The need to reclad a stucco building short of its projected life is likely evident of poor waterproofing during initial construction. The strength of Chamberlin's reclad work on Piedmont was in the waterproofing plans. The BECI-Chamberlin team understands water management, and BECI developed every aspect of the reclad system from the standpoint of keeping water out of the building.

In addition to the original building waterproofing failing, the lack of through-wall flashing at each floor line allowed water to escape behind the cladding. Moving to the BECI reclad design provided for water shedding at all floor levels without changing the aesthetics of the building.

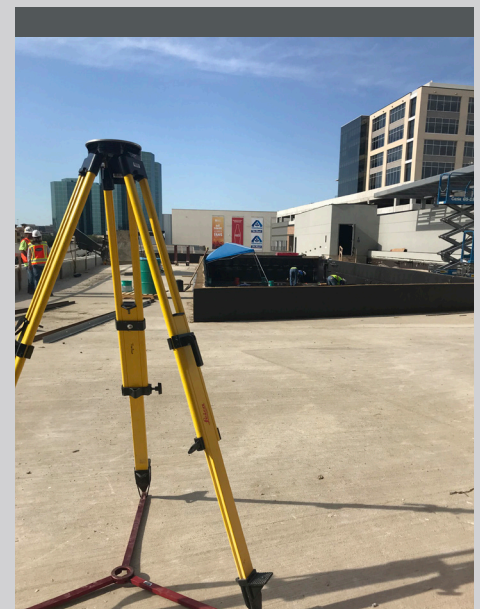
Leica laser scanner

TruePoint Laser Scanning provided high-definition laser scanning services to capture the existing conditions of the concrete pool deck before the waterproofing and pavers were installed. They captured comprehensive point cloud data with a survey-grade Leica laser scanner. This point cloud data represents spatial data as a collection of coordinates providing large datasets that can be valuable for decision making. Objects observed were the concrete structural deck, exposed columns and

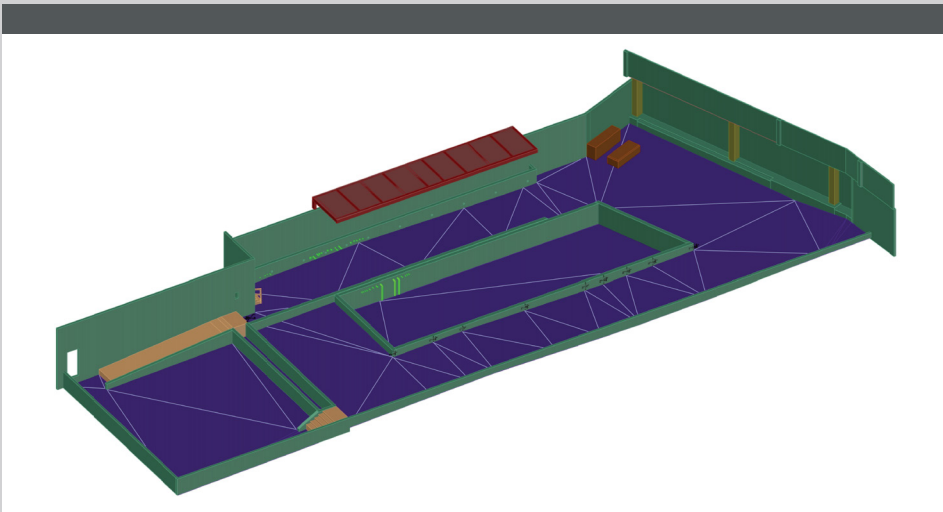
3D model of pool deck

After the scans, a 3D model of the hotel pool deck was created that included the basic structural elements such as the exposed concrete deck and structural supports plus the basic architectural elements. Items such as mechanical, electrical and plumbing (MEP), railing, ladders, catwalks and ancillary spaces were not included in the model. The scans and model were delivered in five to ten business days via an electronic file share platform.

After the 3D model was made from the on-site scans, Chamberlin used the model to take accurate measurements, within centimeters, of the finished products. This was a valuable asset in many ways for the project.

Finally, a big discovery was made with the data collected from the laser scan. Two layers of two-inch insulation were specified for the entirety of the pool deck. Even if the pedestals were installed at their maximum height of 21 inches, a two-inch gap remained between the top of the pedestal and most of the pool coping height. If this condition had been discovered during installation, it could have caused major delays. Since it was

discovered beforehand, the team was able to prepare for additional insulation. They opted for two three-inch layers of insulation to fill the gap while not adding additional labor costs. Furthermore, due to the concrete deck's slope, even more than six inches of insulation were required in some areas. The laser scan data allowed for accurate planning and material ordering ahead of time.
