## Decision Time: Re-Roof or Re-Cover?

## Facade Restoration Using Photogrammetry

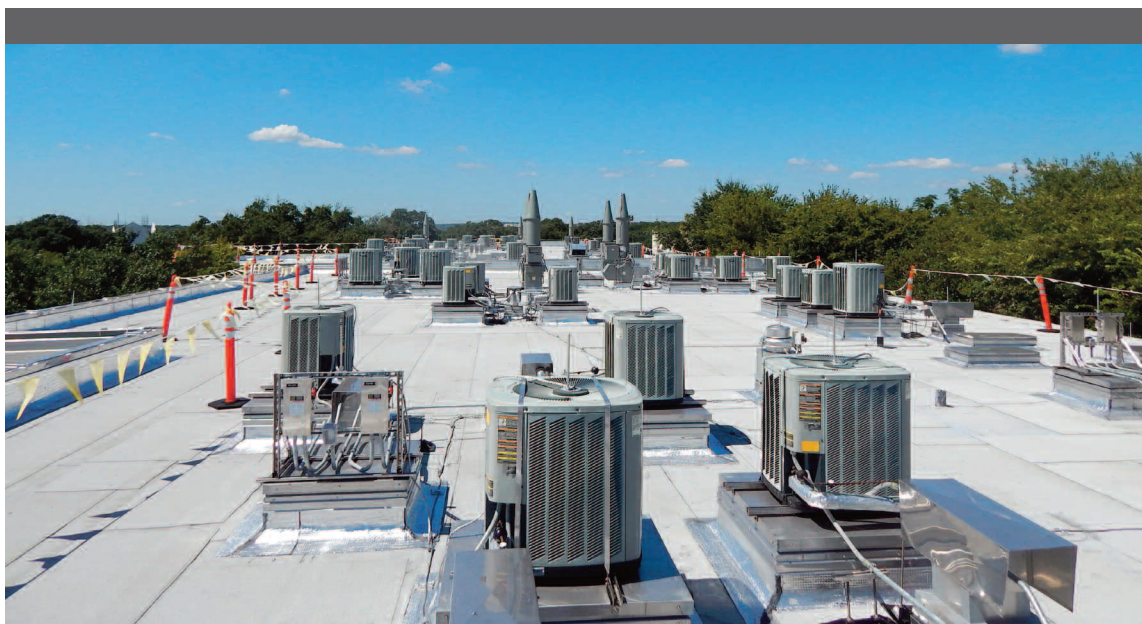
*The completed torch-applied roofing system for a leading environmental agency's headquarters in Austin, TX.*

First, chamfered insulation was mechanically attached through a metal panel to steel purlins. Once attached, another layer of ISO was installed with a urethane adhesive. Then, a gypsum-fiber roof board was installed with a urethane adhesive to act as a cover board and thermal barrier. The SBS base sheet was applied directly to the cover board, then the cap sheet was torched to the base sheet. On the vertical walls, Chamberlin torched the base and cap flashing to the plywood and installed a termination bar at the top of flashing. The cap sheet was embedded with ceramic granules to give the roof the required Solar Reflectance Index (SRI) value. The crew then fabricated and installed stainless steel sheet metal counter-flashings and copings. Stainless steel was the best choice for this project because it is very durable and holds up well against weather.

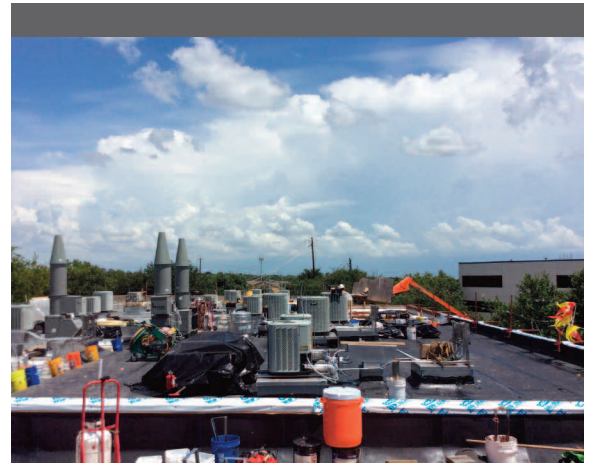
*Chamberlin had to work around the extensive existing rooftop equipment.*

The design for the roof re-cover was not your ordinary design. Because of the existing roof equipment – 52 HVAC units, four satellite dishes and 15 plume exhaust fans – the roofing crew needed to work meticulously to detail in the curbs. The roof insulation also had to be chamfered to fit inside the existing metal panel profile.

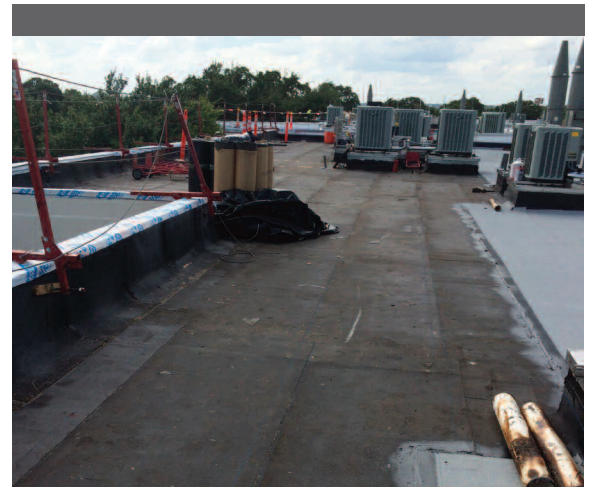
*Parapet clamps were used as one fall protection method while the base sheet and cap sheet were being installed.*

The importance of safety is critical for each project Chamberlin undertakes. To begin, parapet clamps were installed on the low parapet walls on

the east, west and south sides of the roof to extend the height above 39 inches for fall protection on those elevations. The north wall on the gutter side had no parapet wall. In lieu of a warning flag line, which is comprised of a rope and flags hanging 34" tall, Chamberlin went a step further and created a safety guardrail system built of 2X4s standing over 39" tall and installed it 10 feet from the leading edge. This acted as a safe guard for not only Chamberlin employees, but also other trades and authorized individuals accessing the area.

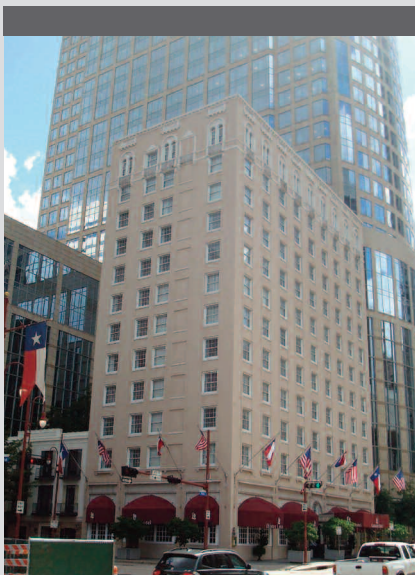
*Figure 1: Overall view of the Lancaster Hotel in foreground.*

The historic Lancaster Houston Hotel, located in Houston, TX, is a twelve-story structure built in 1926 (Fig.1). Originally known as "The Auditorium Hotel," the Lancaster was designated a Recorded Texas Historic Landmark by the Texas Historical Commission (THC) in 1984.

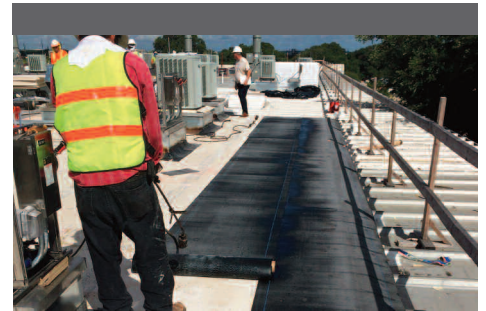
*A guardrail system was built on the north side of the roof where there was no parapet wall.*

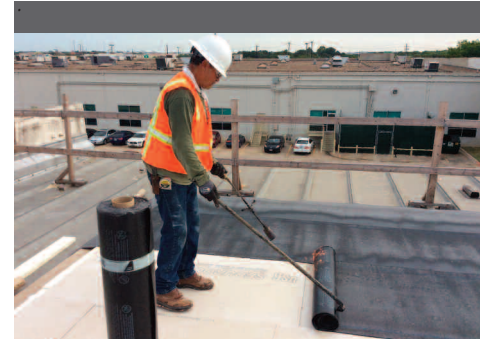
*Chamberlin installed 25,000 square feet of torch-applied roofing system.*

Chamberlin installed 25,000 square feet of torch-applied modified roofing system and flashed the new HVAC rooftop units. To ensure the HVAC curb units were watertight, Chamberlin

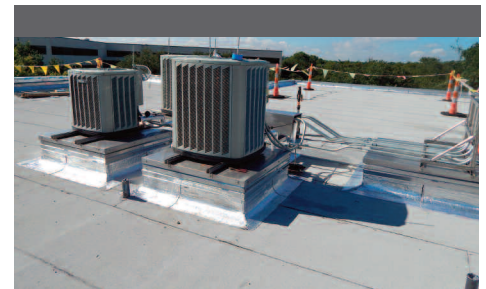
*The HVAC units were flashed to keep the building watertight.*

installed a self-adhered vapor barrier flashing to the existing standing seam roof.

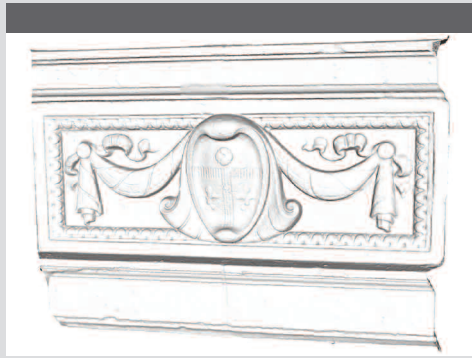
*Figure 3: 3D model of spandrel panel developed with photogrammetry.*

The general procedure was as follows: While on the suspended scaffold, hundreds of photographs were taken of the spandrel panels, columns and brackets using indicator targets in the objects so the photogrammetry software is able to recognize similarities between photographs. The photographs were then manually sorted to delete photographs that were either blurry or not part of the data set needed. Once sorted, the photographs were uploaded to a commercially available photogrammetry software package to process the point cloud. Once processed, the point cloud was imported to a free and open-source 3D modeling software in order to create a solid surface mesh that connects all of the points in the point cloud (Fig. 3). The time it takes to process a mesh is highly dependent on the complexity of the geometry and the density of the point cloud. For reference, the decorative spandrel took approximately three hours to generate the point cloud, one hour to mesh and three hours to edit the model and complete the final touches.

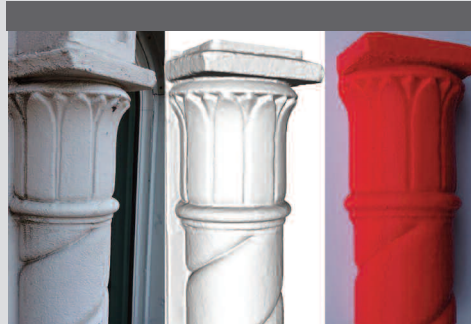
*Figure 4: Left - Existing decorative column, Middle - 3D model of column, Right - 3D print of model.*

As a trial, we used 3D printing to determine if the models were detailed enough for full scale production. A partial model of the spiral column and capital was generated, edited and printed using a MakerBot 3D printer and biodegradable thermoplastic aliphatic polyester filament, commonly known as PLA. The result was a miniature version of the column with all its surface defects and details (Fig. 4). Pleased with the results, it was time to move forward with the full scale replica of the spandrel panel.

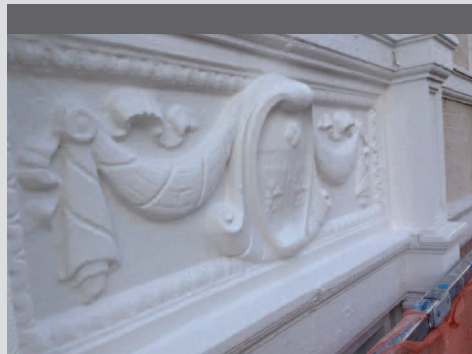
*Figure 5: New cast stone spandrel panel installed.*

The existing cast stone spandrel panels are supported by a steel shelf angle connected to the building frame with post-installed anchors and are laterally supported by corrugated metal ties. For the replacement panels, we utilized the same steel shelf angle to support the gravity loads and secured each panel with four new stainless steel post-installed chemical anchors to resist lateral wind loads. The chemical anchors were detailed to be installed at an angle of 15 degrees from the horizontal

Molds made of liquid urethane were fabricated from the master copy. The cast stone panels were fabricated at a plant using the master copy, delivered to the site and installed (Fig.5).
