Chamberlin Revitalizes Senior Living Community

Chamberlin restored forty-eight balconies at The Querencia senior living community in Austin, Texas, to remedy water infiltration.

Why We Continue to Have the Same Recurring Problems

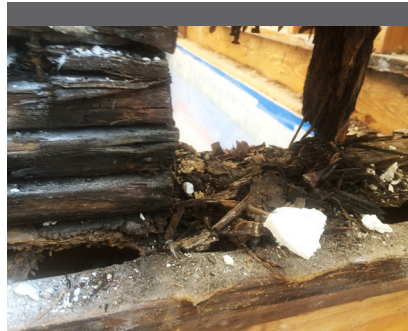
Unforeseen extensive wood rot was found on the balcony decks.

Glulam beams in the decks of four stacks of balconies were so severely rotted that they needed to be completely demolished and rebuilt. After demolition, only the skeleton of steel beams remained in place. Since there was no deck left to stand on, a plan was created to allow crews to safely install the new decking while being tied off 100% of the time. Crew members working from scaffolding surrounding the balcony framework used multiple anchor points depending on their access point, such as the top of the building and the balcony structure above. Additionally, the balconies' framework was shored to prevent any possibility of the structure collapsing, as crew members had to move about on the steel beams as well. Despite the additional scope, Chamberlin was determined to keep on track and had up to 50 crew members working at once to meet the original schedule.

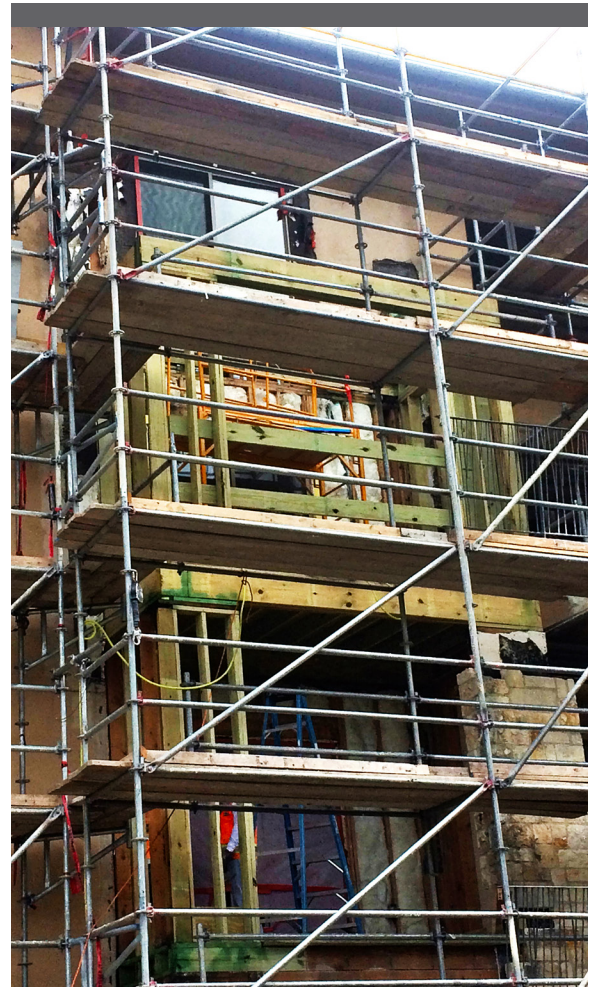
Four stacks of balconies had to be completely demolished and rebuilt.

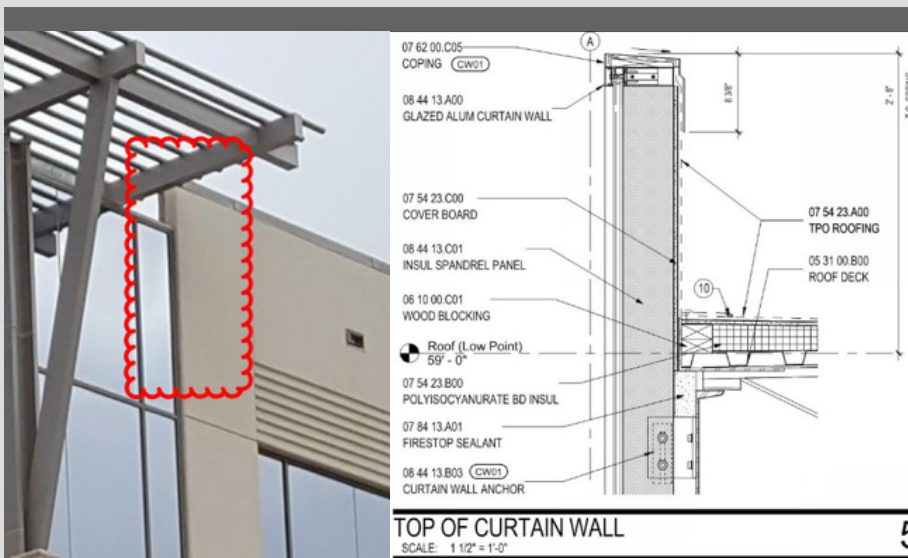
An example of typical conditions that have complex transitions between different systems and materials. This results in layering of materials from different manufacturers installed by different contractors at various times during the construction sequence. This shows the transitions from curtain wall to concrete tilt panel and single-ply roofing membrane.

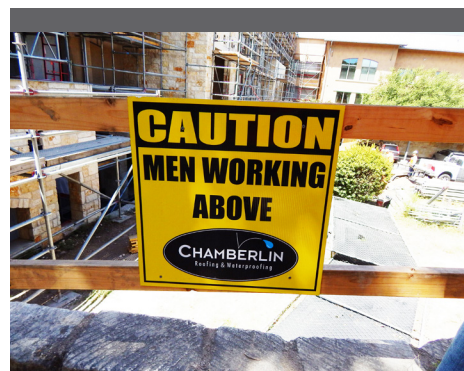
Safety is the primary focus at Chamberlin. Work areas were secured with signs and barriers to prevent residents from entering a work zone.

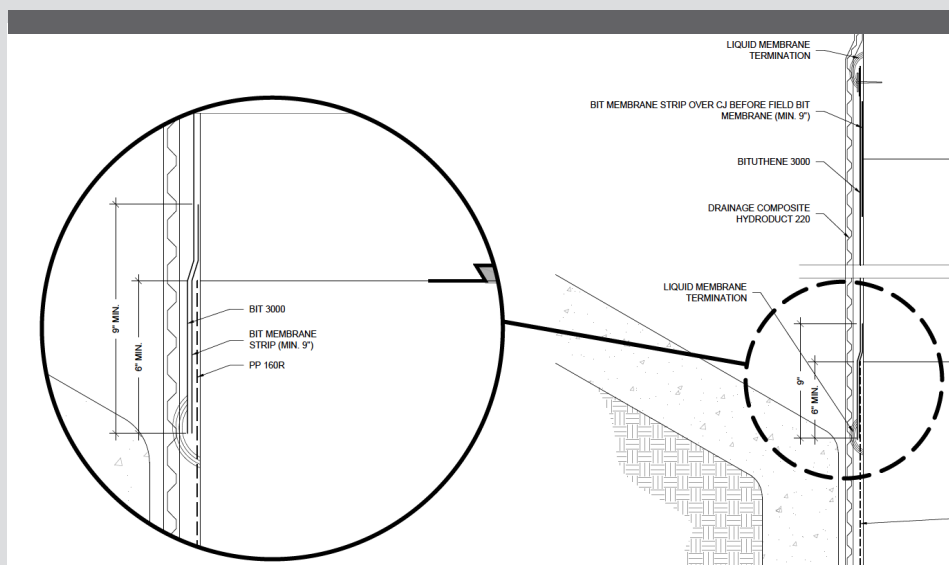
This detail shows the transition from below-grade waterproofing to above-grade waterproofing with a minimum requirement of a six-inch overlap.
