## Restoring TAMU Corps Dorms

*Texas A&M University Corps Dorms houses more than 2,600 students in College Station, Texas.*

### Parking Facility Restoration: Five Factors to Consider When Restoring Existing Parking Facilities

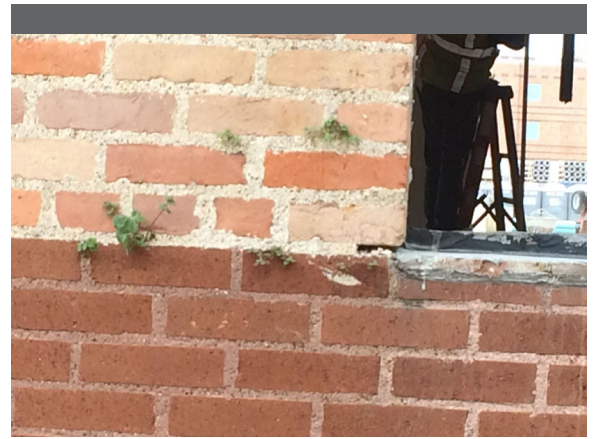
*Aged and weathered masonry and mortar in need of repairs and replacements.*

Chamberlin's scope of work began with water blasting the building to remove dirt from the existing brick in order to expose any flaws in the grout as well as cracks in the exterior skin of the building. The pre-applied sheet waterproofing and fluid-applied waterproofing were both replaced. The scope also included installation of thermal insulation, weather barrier, sheet metal flashing and trim, expansion joints, water repellent, tuckpointing, brick replacement, cast stone repair and joint sealants. Along with the remedial waterproofing renovations, Chamberlin also installed pre-applied sheet waterproofing and fluid-applied waterproofing on the new building connectors. Four building connectors were added to allow an easier flow of traffic between the 12 dorms.

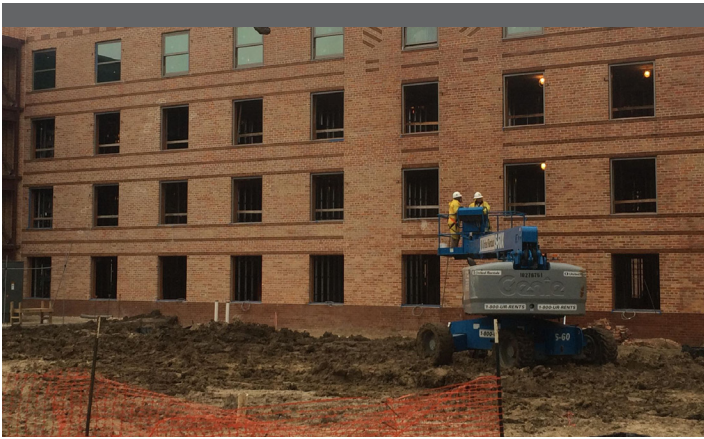
Chamberlin crews secured bricks matching original construction and took care to keep with existing installation patterns during repair and replacement.

All 12 of Texas A&M Corp Dorms were constructed with the same brick 76 years ago. It was challenging to find replacement bricks that matched the existing closely enough to use in the areas that were too damaged to be salvaged. Chamberlin searched all local brickyards for the appropriate color. After cleaning them out, the crew moved the search to Louisiana to obtain the last of the bricks. The 76 years of aging on the existing bricks added another level to the challenge, but in the end the team secured matching bricks for replacements on nine different dorms. Additionally, the crew was challenged to

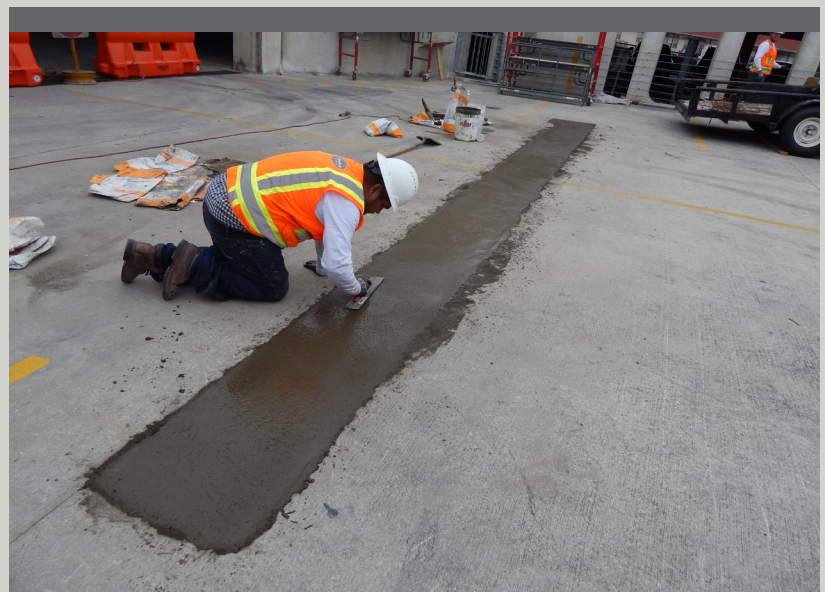
Parking garage concrete repair. Photo provided by Chamberlin Roofing & Waterproofing.

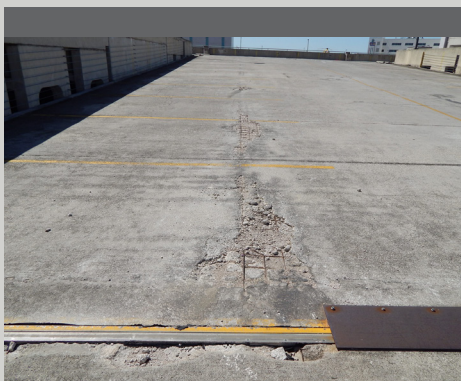
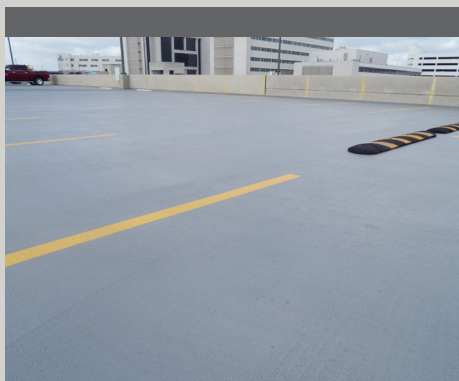
Before and after parking garage concrete patching and traffic coating installation. Photo provided by Chamberlin Roofing & Waterproofing.
