## Game-Changing Stadium Renovation

*Gaylord Family Oklahoma Memorial Stadium in Norman, Oklahoma, before and after renovation and leak remediation.*

## Water Vapor Transmission of Materials, aka Permeance

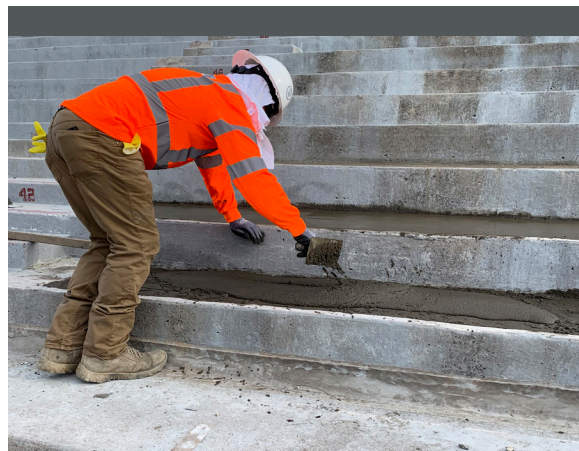
*Chamberlin crew member patching concrete prior to traffic coating installation.*

Various methods can be utilized to test the integrity of structural concrete repairs after they are completed. At the stadium, Chamberlin chose to conduct a chain drag sounding test for this purpose. This sound test indicates if an area of the concrete patching is hollow. While dragging a chain across the repaired concrete, the noise will change from a clear ringing to a somewhat mute and hollow sound when passing over deficient concrete. Chamberlin's test was successful and did not indicate any deficiencies.

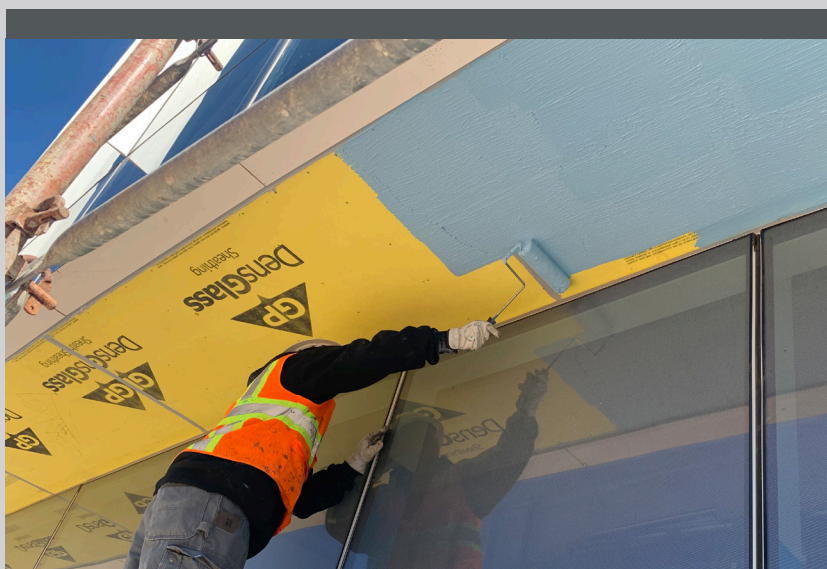
*Installation of fluid-applied air barrier with hand roller at computer software office building in Austin, Texas. Photo courtesy of Chamberlin Roofing & Waterproofing.*

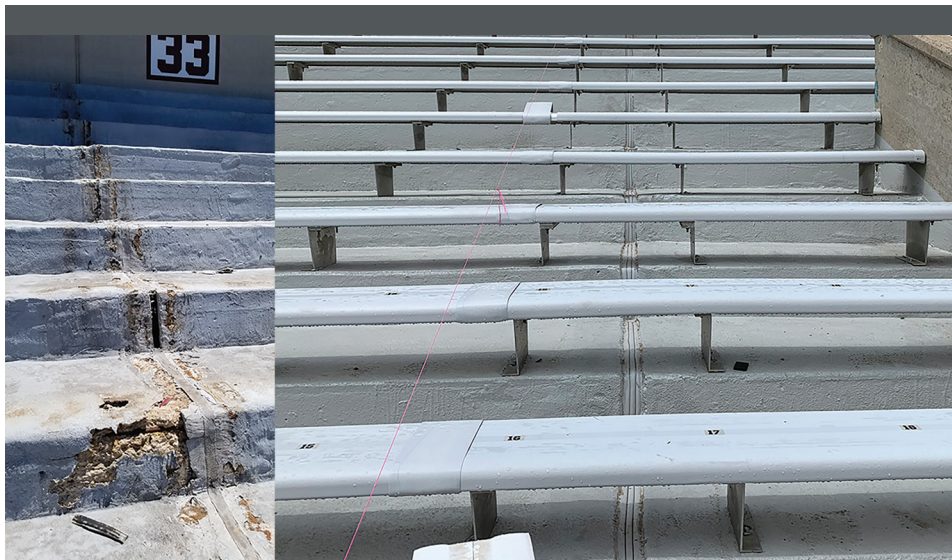
Before and after: Chamberlin remedied expansion joints in the OU stadium to stop water intrusion.

One area in need of structural repair was the concrete blockouts that housed and supported the existing expansion joints. These blockouts required extensive repair for placement of the new joints. To begin, Chamberlin cut out the existing joints to complete the repairs. While this work was in progress, the open joints

left the facility exposed to the elements. In case of rain, Chamberlin engineered a plan to quickly close the joints when needed and efficiently resume repairs when the rain passed. The solution was a sheet membrane waterproofing which was easily installed to seal the joints and swiftly cut away to allow quick access to the work afterward.

Chamberlin was able to find a permanent solution for the expansion joint leaks, alleviating water intrusion issues and, in turn, costly maintenance upkeep for the university. Additionally, their project team offered alternative materials for the traffic coating and expansion joints that provided the owner improved performance and durability at no increased cost. Chamberlin's proactive planning helped the scheduling and sequencing of all trades run smoothly and the project complete in just six months. The stadium was left rejuvenated and watertight by kickoff of the first football game of the season. ■

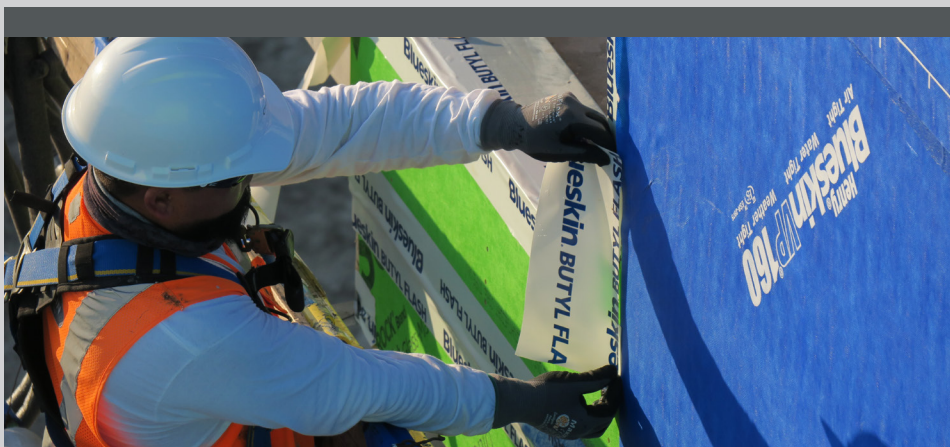
Installation of flashing on a self-adhered vapor permeable, water resistive air barrier membrane in Dallas, Texas. Photo courtesy of Chamberlin Roofing & Waterproofing.
