CHAMBERLIN
Roofing & Waterproofing

CHRISTUS Envelope Restoration

Chamberlin revitalized the CHRISTUS Santa Rosa Pavilion in downtown San Antonio, Texas, and resolved persistent water intrusion issues.

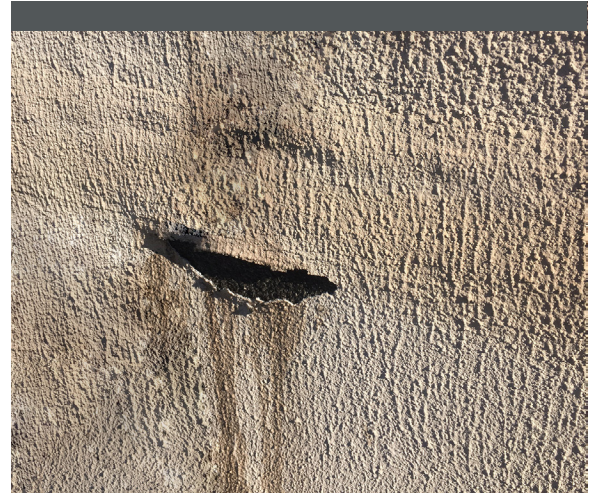
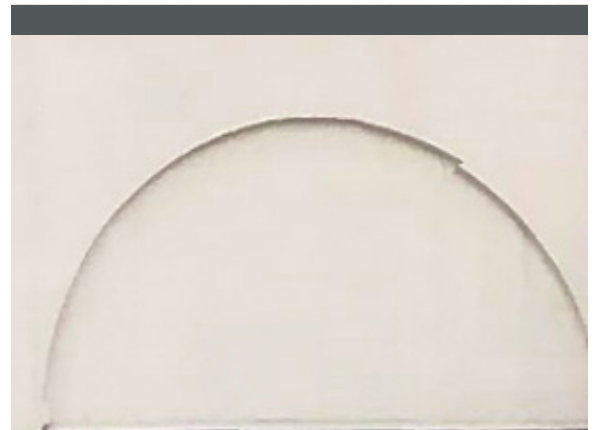
Before and after: Chamberlin cleaned the building envelope and restored the weathered, delaminated existing coating with a new elastomeric coating.

The restoration crew began by pressure washing the building to prepare the substrate for the 54,000 square feet of new BASF EL 750 elastomeric coating they installed with hand rollers. Failing horizontal and vertical joint tape was also repaired on the stucco facade. They coated the 7,000-square-foot mansard roof with a primer base coat followed with a silicone coating. A cut out and re-caulk was performed on the window perimeters, which began with the removal of existing sealant from the metal frame to stucco conditions and preparation of the joints for installation of new sealant. Chamberlin's

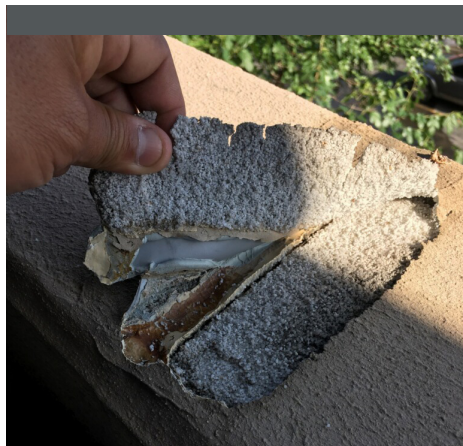
Chamberlin repaired failing joint tape in the parking garage and applied an elastomeric coating.

skilled craftsmen then installed new backing material where needed to the manufacturer's specified depth-to-width ratio, filled the joints with high performance silicone sealant and hand tooled the sealant for proper joint configuration, adhesion and a watertight seal. Additionally, they removed the weathered silicone sealants from the window zipper gasket intersections and installed a new sealant. To conclude the skin restoration, Chamberlin crews replaced wet glazing at the glass to frame conditions on over 450 windows. On the parking levels, technicians repaired 6,800 linear feet of joint tape on precast panel joints and installed elastomeric coating for additional water intrusion protection.

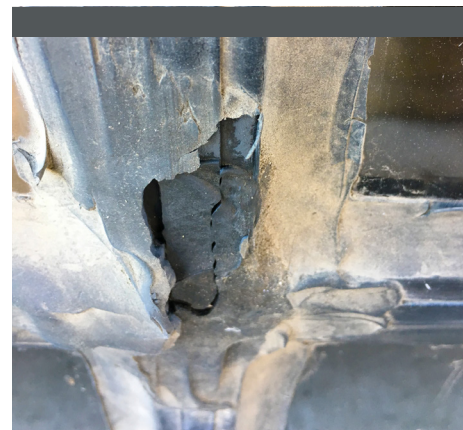
The window gasket system was severely deteriorated in some areas, allowing possible locations for water intrusion.

The main concern, however, was the persistent leaks. The owner wanted to alleviate the inconvenience to their tenants as soon as possible and with a long-term solution. Chamberlin's work on the window perimeter seals, gasket systems and building facade left it watertight. Even after a wet spring, Chamberlin has not been called back for water infiltration since the project concluded. ■

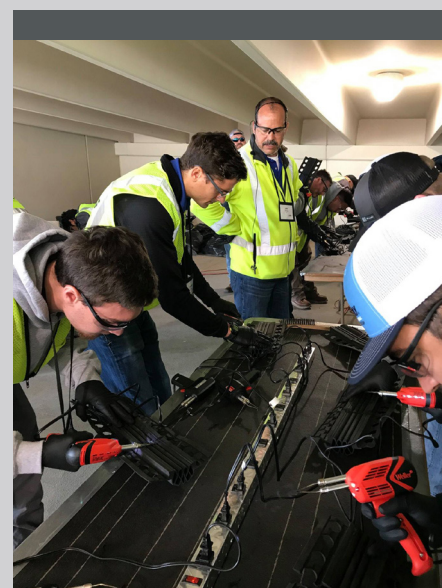
Field slicing of a winged expansion joint seal training.

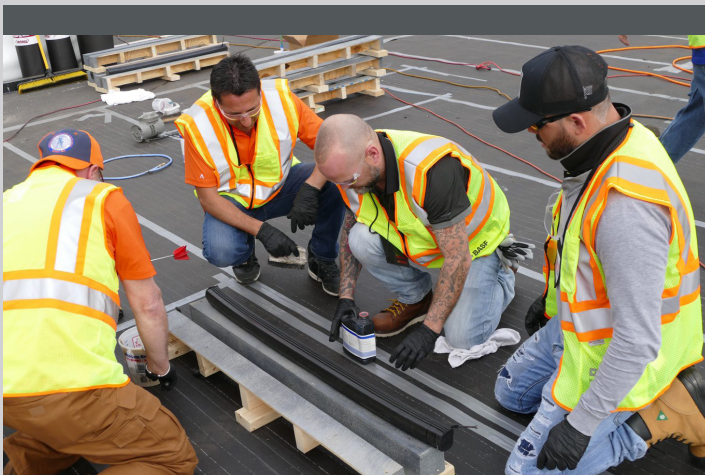
Preparing for a field inflatable expansion joint seal installation.

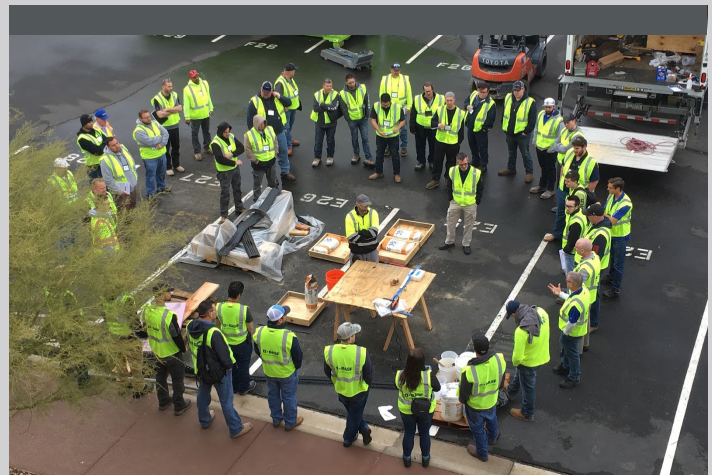
Group construction discussion during bagged concrete repair mortar placement training.
