Garage Restoration Hits the Jackpot

The parking garage at WinStar World Casino is watertight after five years of water infiltration.

High Voltage or Low Voltage?

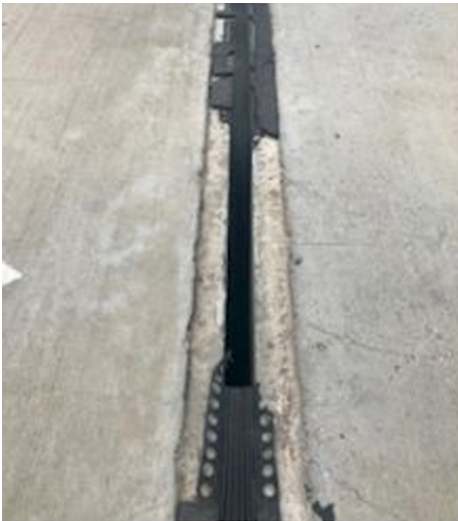
Original wing joint before restoration

The crew began by removing the existing deteriorated wing joints and epoxy nosing. They installed rigid insulation in the expansion joint to create a proper form for the new epoxy nosing

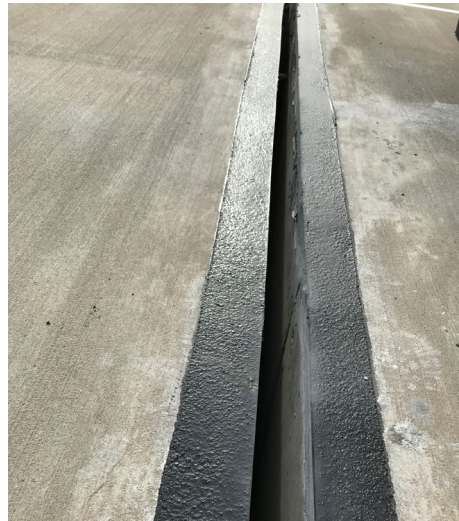
Epoxy nosing to fill in blockouts

while also preventing debris from sandblasting and grinding to travel to the parking decks below. The blockouts were then prepared to receive the new epoxy nosing which was poured and cured to create a solid and trafficable joint opening. The rigid insulation was then removed from the joint opening and the Silspec RFS expansion joint assembly was installed in the joint opening.

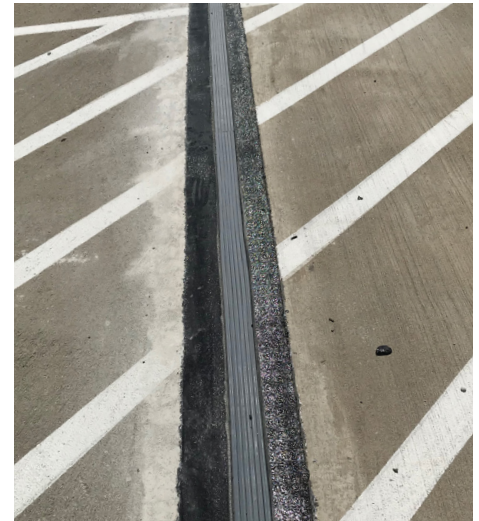
Completed Silspec RFS expansion joint

Chamberlin suggested the Silspec RFS expansion joint assembly to replace the failing joints in the garage because they are comprised of a compressed foam joint with integral carbon fiber rods inside, a first of its kind. Because of the reinforcing rods, vehicular traffic can drive over the joints without the need for bumpy cover plates. These joints would also give the parking garage a longer lifespan and higher movement without increasing the cost for the owner.
