## Detail and Precision on Project 180

### Basic Do's and Don'ts of Waterproofing

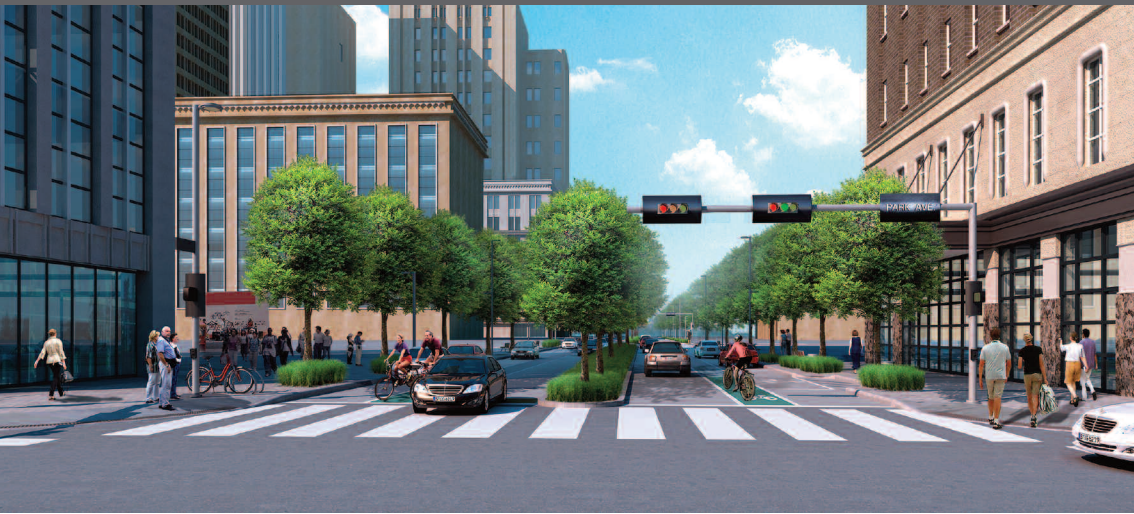
*Rendering of completed sidewalk on streetscapes portion of Project 180.*

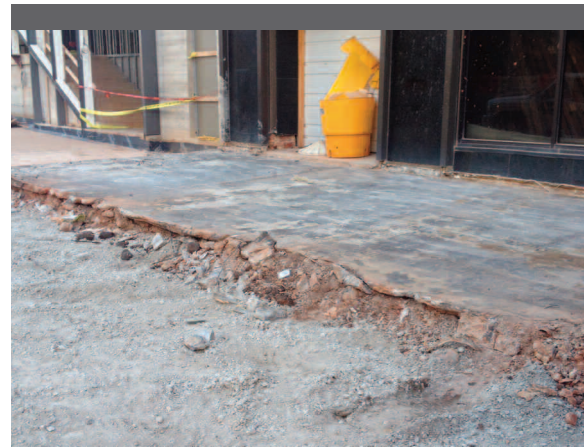
city. Surface water from street level was making its way through a failed caulking joint to a basement directly underneath a commercial building. The leaks were causing the concrete above the basement to severely deteriorate. To remediate, Chamberlin performed a scope of work that consisted of

*The concrete on the sidewalk and above the basement was severely damaged.*

patching existing damages to the concrete above the underground basement, surrounding areas and sidewalks along with new waterproofing installation.

The damage to the concrete on top of the basement was very extensive and required the entire sidewalk to be demolished and removed. Chamberlin also removed all of the old waterproofing and buffed out all bulges and imperfections as well as patched existing holes with a cementitious filler to ensure the waterproofing would be installed properly and adhere to the substrate. Once prepared, a liquid membrane was applied to the concrete followed by the installation of sheet waterproofing.

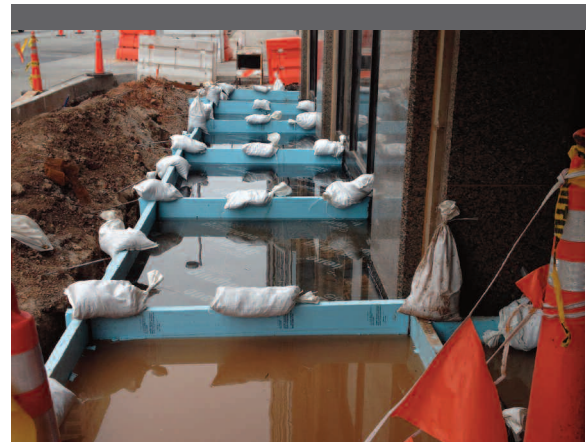
*Chamberlin performed water tests to ensure there were no leaks to the underground basement.*

Upon completion of the scope, it was necessary for Chamberlin to ensure the installation was watertight. Water tests were performed on the area over a 24-hour period by creating water dams and allowing a two-inch pool of water to sit during that stretch of time. Chamberlin precisely measured the standing water to ensure there was no penetration into the basement below. Chamberlin's work proved to be successful with no leaks detected during the water tests.

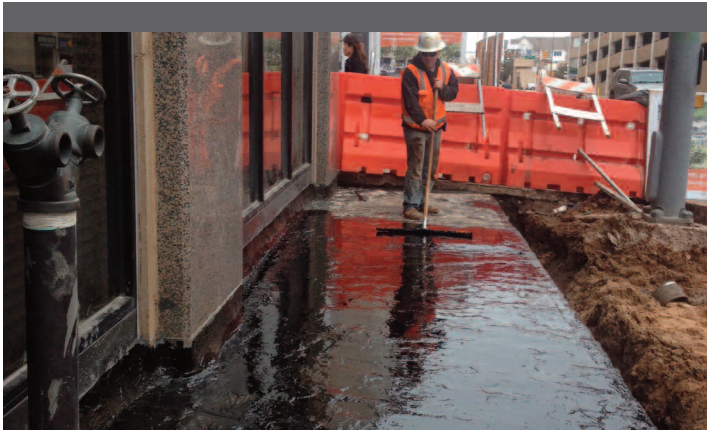
Chamberlin crew member applies a cementitious filler to ensure the waterproofing would be installed properly and adhere to the substrate.

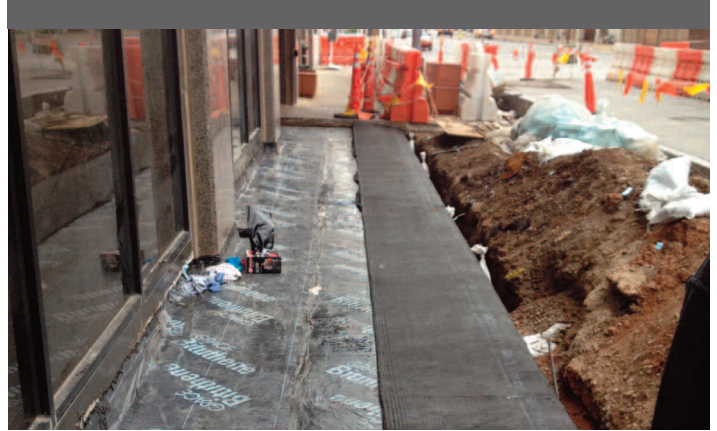
Chamberlin applied waterproofing on multiple sidewalks for Project 180.

As this is a beautification project with a lot of landscaping, the placement of root systems from trees was taken into consideration during the waterproofing installation. Chamberlin strategically maneuvered material around the current tree roots in order to prevent possible future root penetration through the completed waterproofing.

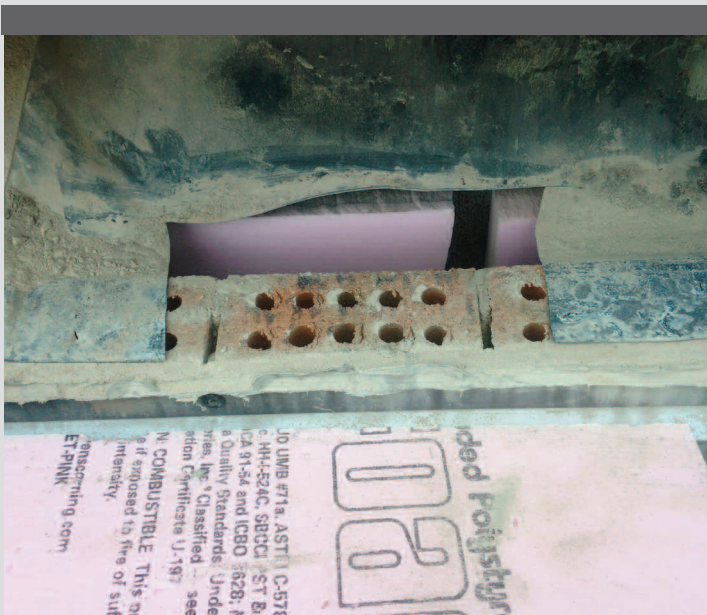
Excavation at a cut back flashing prior to remediation. The flashing installation was a significant source of water infiltration since original construction.

**Do** provide robust detailing and ensure that more than a single line of defense against water intrusion is provided. When detailing the exterior cladding systems, some water intrusion should be expected to get past the exterior cladding system, and waterproofing detailing should provide a means for dissipating water to prevent accumulation and subsequent damage. Because sealant failures are inevitable and periodic sealant maintenance is unavoidable, reliance on a single bead of sealant as the sole means of preventing water infiltration is not a prudent waterproofing approach. A robust waterproofing system should accommodate the eventual water intrusion from the failure of sealant joints.

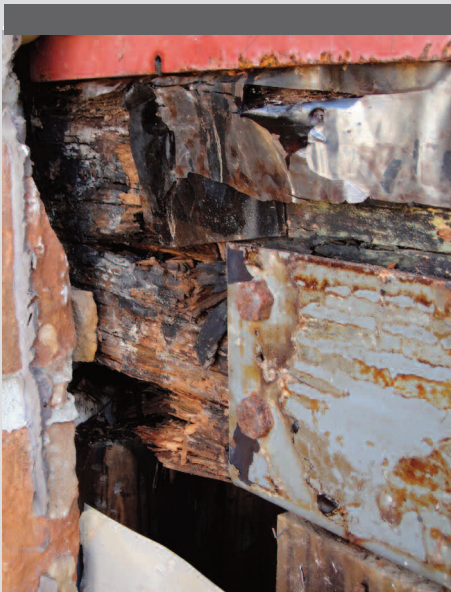
*Deterioration of a glulam beam due to improper integration of balcony and wall interface detailing.*

**Do** provide waterproofing detailing for interface conditions between cladding system, joints, junctures, penetrations and unique conditions. The detailing should be consistent with the designer's selected water management approach and should ensure proper integration of components and systems.

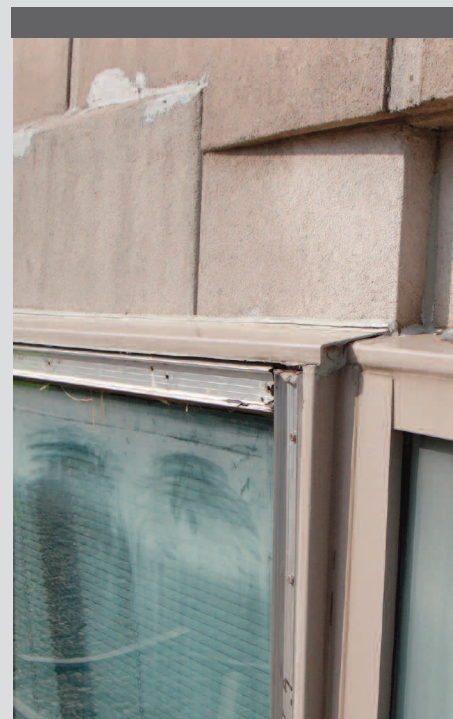
the corners unless the wind is blowing water into the plane of the assembly. However, in a sloped wall application, wetting occurs over the entire surface of the wall during all rainfall events, and water cannot be shed off the wall surface through the use of drip edges and projections. In essence, a sloped wall assembly should be thought of as a roof from a waterproofing perspective and conventional wall waterproofing detailing will not be durable or effective. Gaps, open joints and failure or defects in seals and sealants will be a significant source of water infiltration.

*Sloped EIFS and window assemblies, vertical and horizontal offsets. The epitome of complexity, poor detailing, and pushing performance limits. Surprise. It leaked and wasn't durable.*

**Don't** use materials or cladding components in applications that push the limits of performance beyond the normal or intended use. A simple example of this situation would be the use of a cladding system or window assembly in a sloped wall application. By changing the wall orientation to increase the skyward exposure of the assembly, the moisture loads on the wall assembly are increased significantly beyond the normal loads experienced by a similar vertical wall assembly. In a vertical wall, the pattern of wetting during a rainfall event is typically concentrated at the top of the wall and at
