A Hallmark Restoration

The Use of Electronic Leak Detection (ELD) on Waterproofing Membranes over Concrete Surfaces

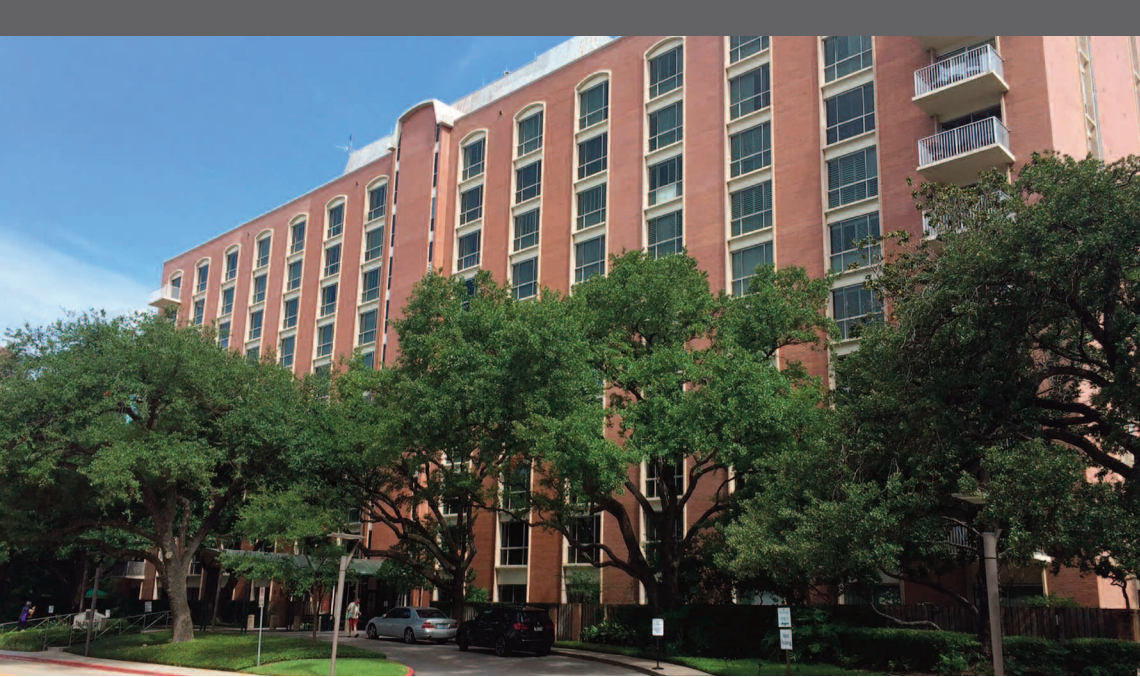
The Hallmark, senior living community in Houston, TX, after exterior restoration.

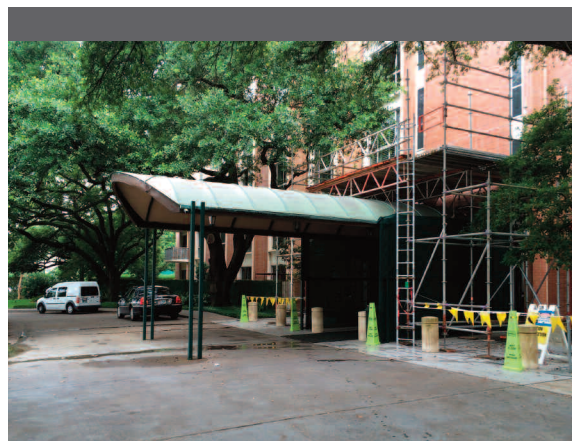
The front entrance of The Hallmark with overhead protection and safety barricades in place.

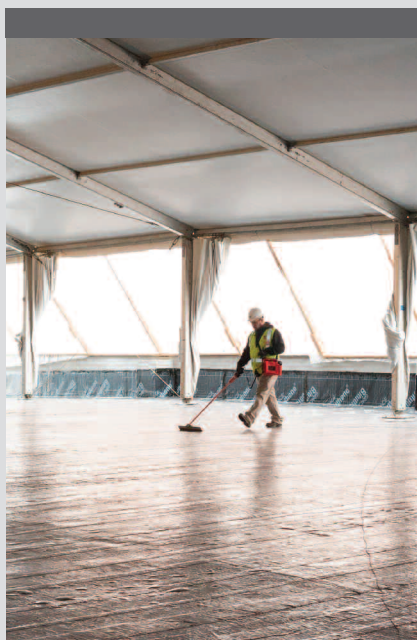
Figure 1: HVELD testing in progress

horizontal surfaces under dry conditions (Fig. 1). The principle of the HVELD process involves a generator that delivers an adjustable stabilized direct current (DC) output voltage for the detection of breaches to the electrically insulated roof or waterproofing membrane.

The generator emits a calibrated voltage discharge which conducts through membrane penetrations to a grounded earth lead, such as a metal drain body or steel reinforcing embedded in the concrete slab. Should the current make contact with the ground, this will complete the circuit emitted by the generator. An audible beep from the test equipment alerts the technician of the breach. Small sparks can sometimes be seen or heard when a breach location is contacted by the probe.

The initial test voltage is based on the thickness of the waterproofing membrane and is verified (calibrated) by creating a sample breach in a typical section of membrane being tested to ensure detection levels are appropriate. In the case of liquid applied membranes,

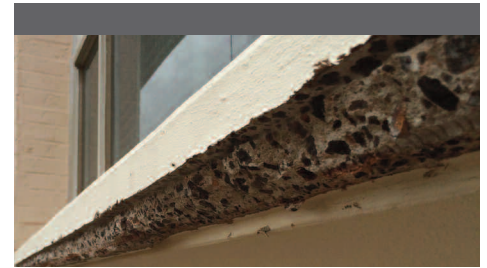
Horizontal eyebrow on the building prepped for concrete patchwork to repair extensive deterioration.

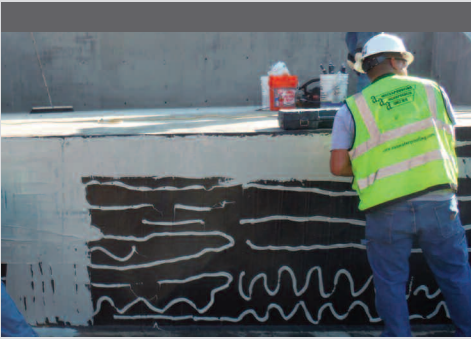
Figure 5: Retroactive sealant application to repair pinholes.

and required the use of ELD for detection. It was determined that the cause of the pinholes on the vertical surfaces was due to the irregular surface of the formed concrete substrate. To correct this deficiency at locations where the waterproofing membrane had already been installed, an expensive and time consuming retroactive application of repair sealant was applied on the waterproofed vertical surfaces (Fig. 5). Once the sealant had cured, the vertical areas were retested using ELD and confirmed to be watertight. To prevent similar pinholing at future locations, a pre-treatment of the concrete surface with extra waterproofing material or repair sealant was implemented to create a smooth surface for the waterproofing application. ■
