Sealing Sooners' Residential

Oklahoma University Cross Village houses more than 1,200 students at the new mixed-use complex in Norman, Oklahoma.

What to Expect When Commissioning the Building Enclosure

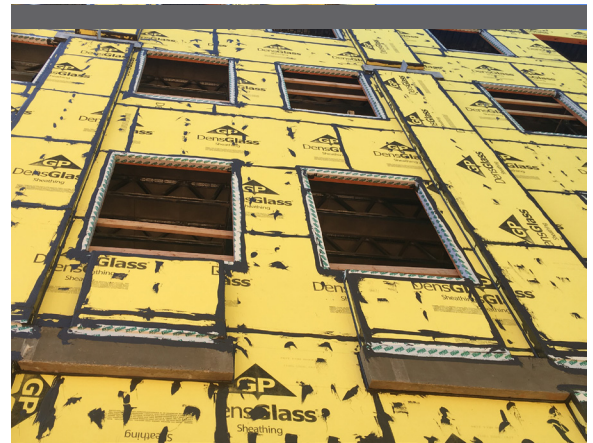
Chamberlin crews sealed the sheathing seams and covered the countersunk screw heads to prevent water from penetrating the building.

Crew members installing the air barrier inspected the material before use to make sure it was in proper condition for application and confirmed the sheathing seams were properly sealed for a watertight system. As the material was spray-applied, crew members tested for proper millage periodically each day striving for a smooth finish and optimal performance.

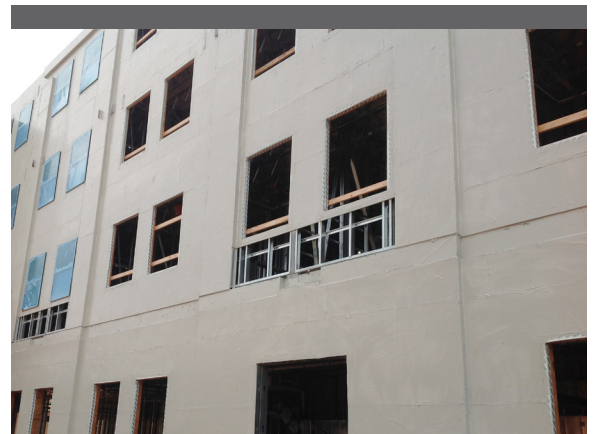
Air barrier installed on one of the residential buildings.

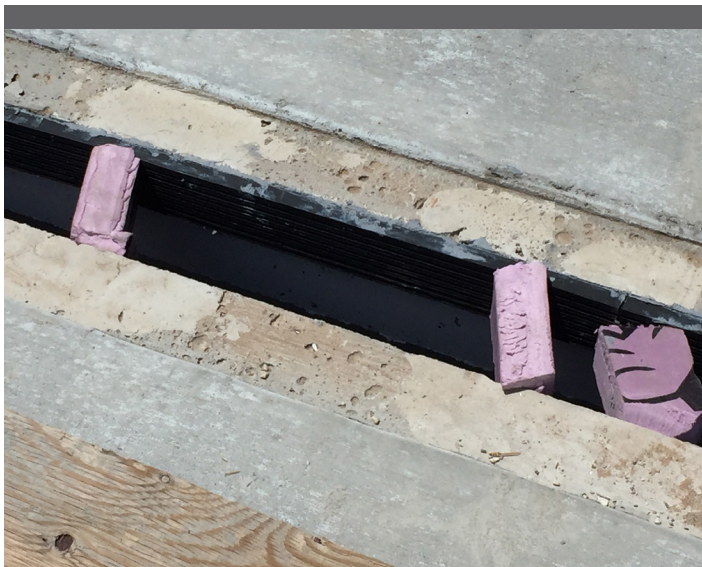
A 3/4-inch gap reducer installed on the wall of the joint with an epoxy adhesive.

Chamberlin did their research and found one manufacturer who produces a joint gap reducer that is installed on the wall of the joint with an epoxy adhesive. A 3/4-inch gap reducer combined with a larger expansion joint was the solution. However, this discovery was made three weeks from project finish, so a great deal had to be done in a short time. Chamberlin started by getting the new manufacturer approved by the project team. They then worked with the manufacturer to release the materials they currently had in stock so crews could start installing immediately as they waited for the remainder to arrive. Chamberlin increased manpower to accommodate for the short time frame, as well as the added step of installing a gap reducer in each joint, and completed the installation on time.

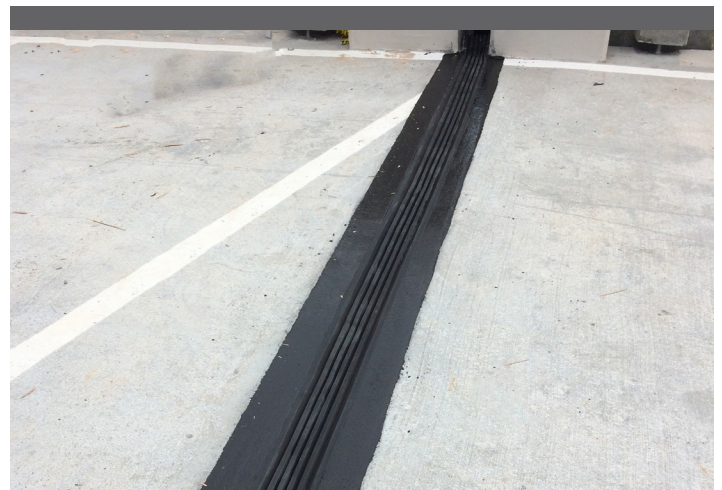
Expansion joint installed in the parking garage.

In the parking garage, the block outs for the expansion joints were wider than the specified product to be installed. One possible solution would be embedding a plate to close in the joint, but that would require drilling into the concrete. The concern with this approach was disrupting the post-tension cables, which could affect the structural integrity of the garage.

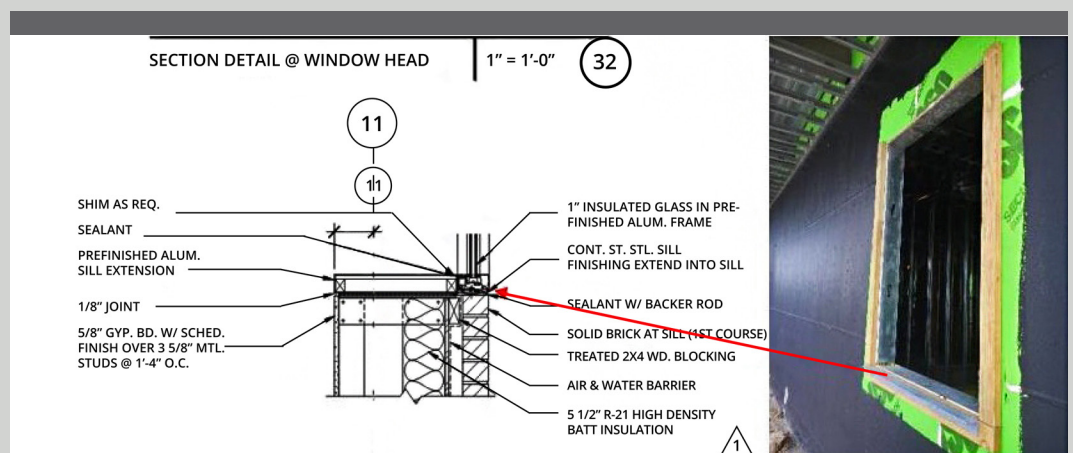
Figure 2: Plan section view versus actual installation

air and water barrier detail. In figure 2, we can see a galvanized sill installed at the base of the window opening that interferes with the designed continuous air and water barrier. At this point in the project, the substituted windows were ordered and the field alteration had occurred at all of the more than 50 window locations. Sticking with the original design would have been costly and time consuming. The contractor, designer, owner, and BECx provider worked together to come up with a solution and revised the design to incorporate the air and water barrier wrapping over the sill. This correction was incorporated into the project with no lost time or add in cost because the team understood sometimes the design needs to change to accommodate reality.

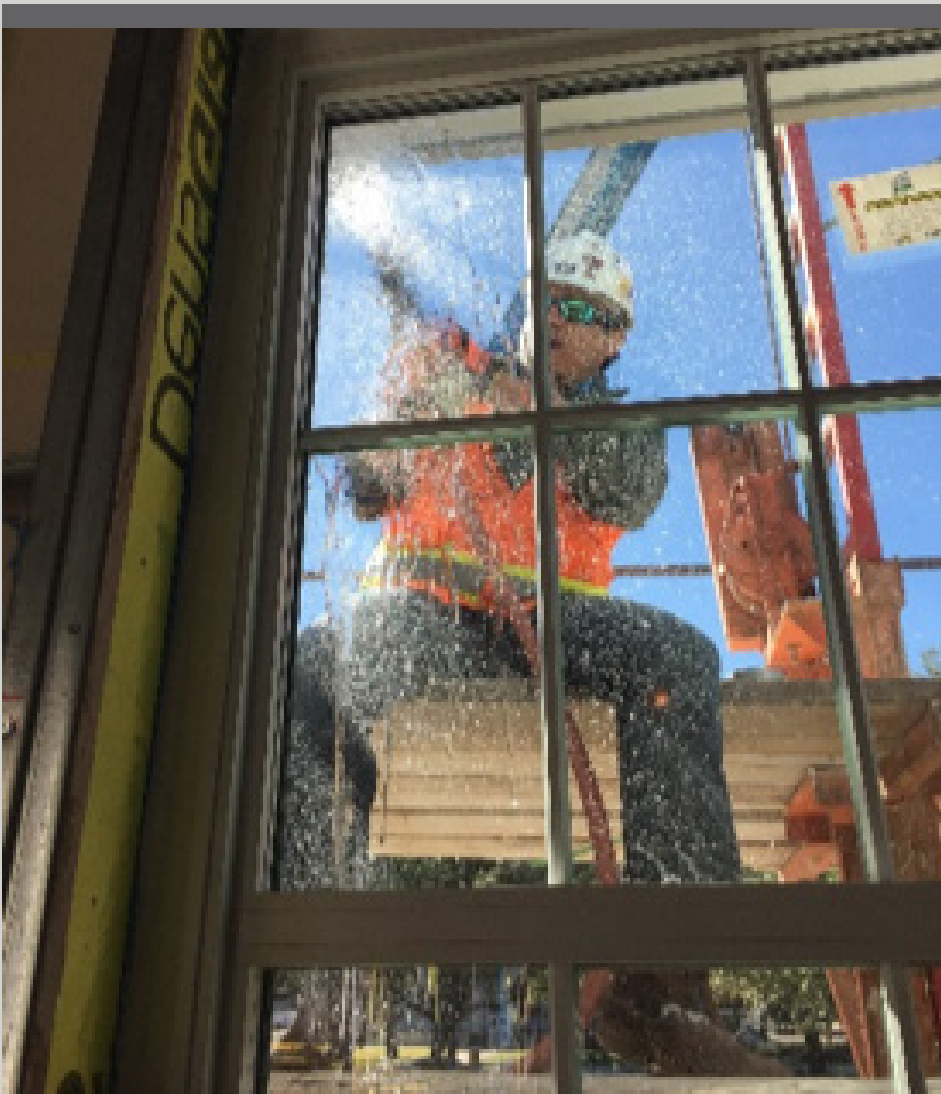
Figure 3: AAMA 501.2 Testing

the enclosure. Figure 3 shows an intrepid BECx provider hoisted above a window enclosure for water intrusion testing. The coordination effort to ensure the exterior of the window was installed well in advance of the interior finish-out was imperative so the water intrusion testing could occur without damaging finishes. Coordination with the landscaping contractor was also important so the scaffolding and water didn't damage finished landscaping. This coordination occurred during pre-testing meetings well in advance of actual testing and included all of the project stakeholders involved to make sure the goals and consequences of the water intrusion testing were understood and precautions were incorporated to minimize damage to finished surfaces and project delays due to repair.
