New Braunfels Receives the Wurst Renovations

A fire destroyed the Marktplatz and damaged the iconic Wursthalle of Wurstfest in New Braunfels, Texas.

Catastrophic Exterior Wall Fires in High-Rise Buildings

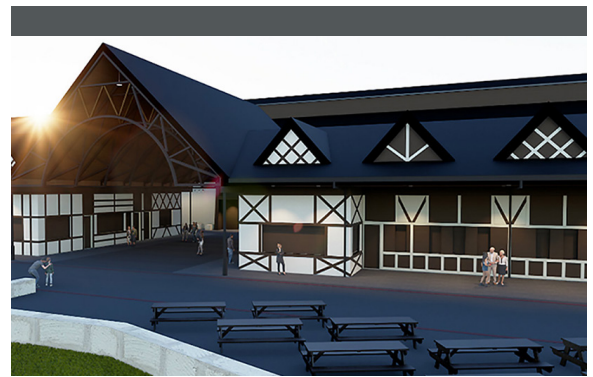
Rendering of the new Marktplatz

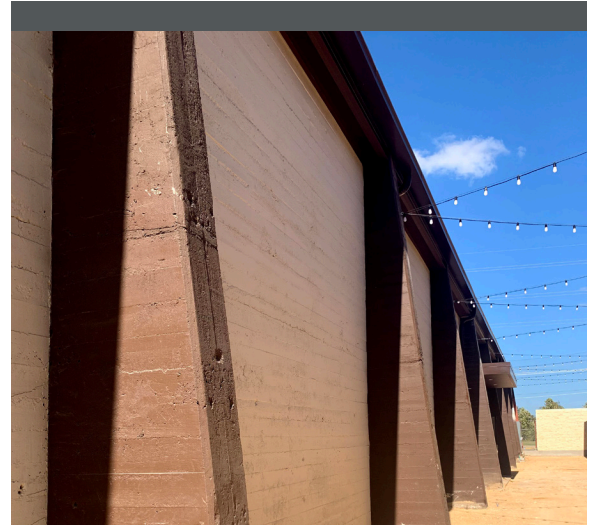
Nineteen buttresses with unique imprints on the concrete needed repair at Wursthalle

The Marktplatz was attached to Wursthalle and, when it burned down, it damaged the buttresses that were supporting the adjoining wall and roof of the hall. The extreme heat from the fire caused the concrete buttresses to crack and pull away from the wall in some areas. It also caused severe spalling in multiple locations.

Nineteen buttresses were in need of concrete repairs. The crew began by removing all loose spalls and

unsound concrete from identified buttresses and the wall using hand tools only. No mechanized tools were used for fear the vibrations would cause even more cracking and damage. The crew then prepared the concrete surfaces per Sika Sarnafil requirements, coating all exposed reinforcements and steel plates with Sika Armatec 110 EpoCem to receive Sika VOH repair mortar. To repair the cracks, Chamberlin installed stabilization ports into the wall, injected the cracks with Sikadur 35 Mod LV, removed the ports and then sealed over the cracks.

Due to the age of Wursthalle, the buttresses and wall still had the imprint of the original forms. The crew had to match those imprints so the patches and repairs would blend evenly with the parts that were not destroyed in the fire. Through several mock-ups and trial runs, a solution to diligently match the imprints to make the building cohesive was found.

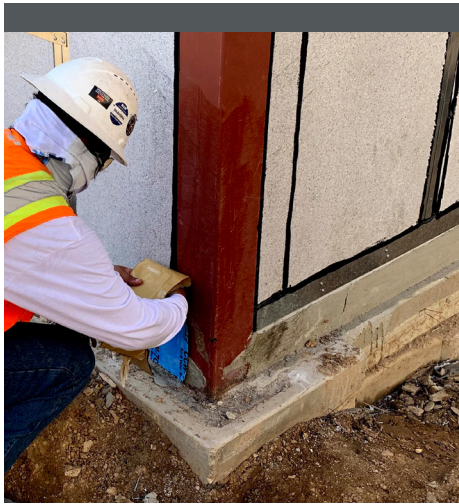
Chamberlin installed peel and stick waterproofing at the new Marktplatz

The fire brought all of Marktplatz to the ground, making an entire redesign necessary. Chamberlin's scope included furnishing and installing self-adhered membrane flashing at window and door openings, structural columns up to the I-beams and at the base of the wall where stucco meets stone.

The walls were an extremely unique product, an insulated metal stud panel system that utilizes EPS (High Density Expanded Polystyrene) from Novidesa that is manufactured in Mexico City. These panels replace typical batt and rigid insulation, metal stud framing, sheathing and waterproofing in one step. The challenge for Chamberlin was how to integrate these panels with Chamberlin's waterproofing into a warrantable product. Byrne Construction, Carlisle Coatings and Waterproofing Inc. and Chamberlin went

through several mock-ups to determine an installation method that would successfully seal off the I-beams and wall panels at the base of walls, openings and structural columns with the peel and stick waterproofing.
