SUSTAINABLE SOLUTION FOR CALIFORNIA REST AREA

APPLICATION
Wastewater

PRODUCTS
Two 8'-diameter
single-wall tanks

TOTAL CAPACITY
25,000 US gallons

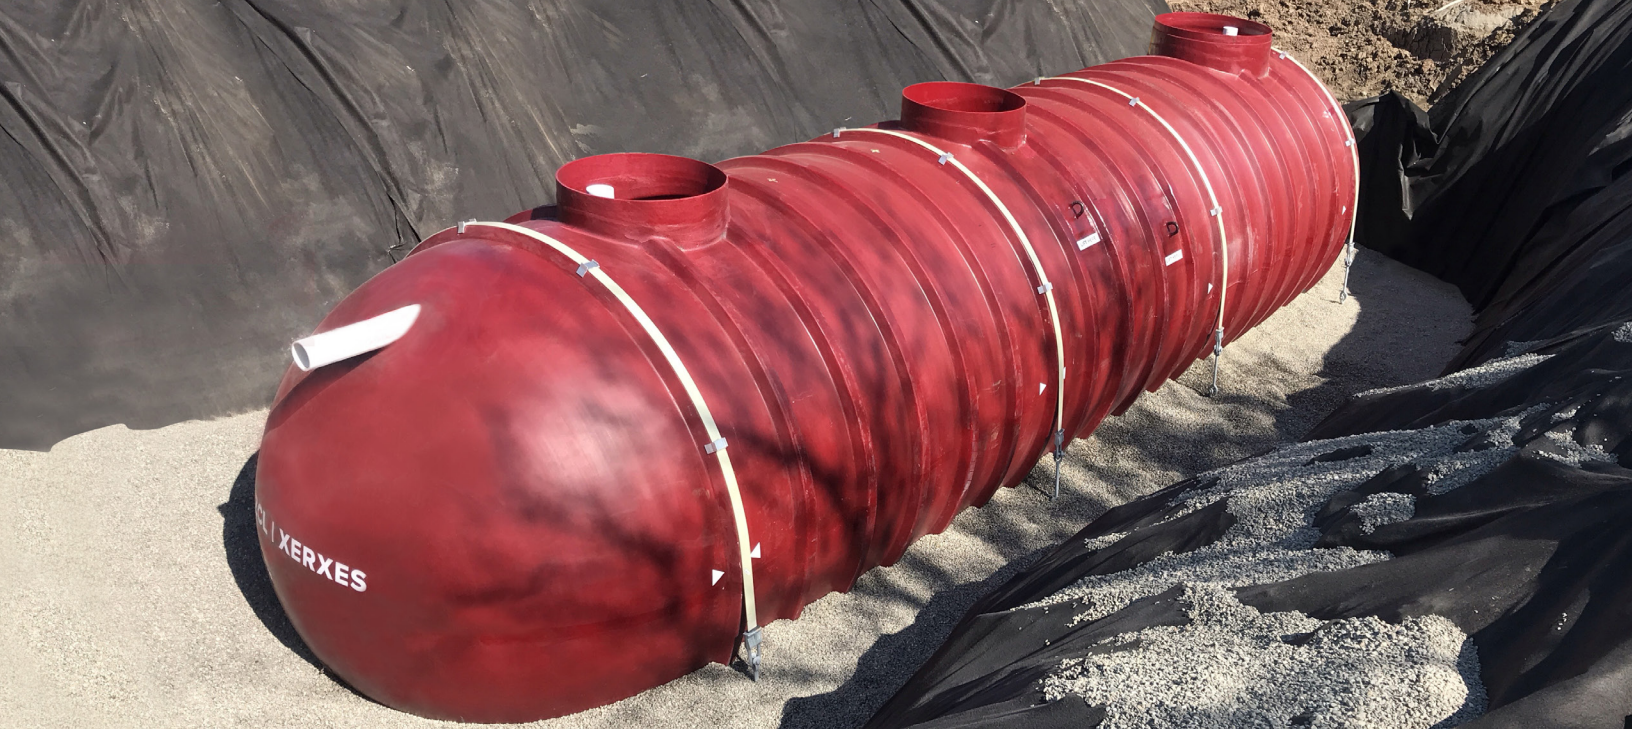
In April 2020, two Xerxes corrosion-resistant fiberglass tanks were installed at a rest stop area in Elkhorn, California. They replaced a cast-in-place concrete system that was installed about 15 years ago, which, in turn, replaced the rest area's original precast-concrete septic installation.

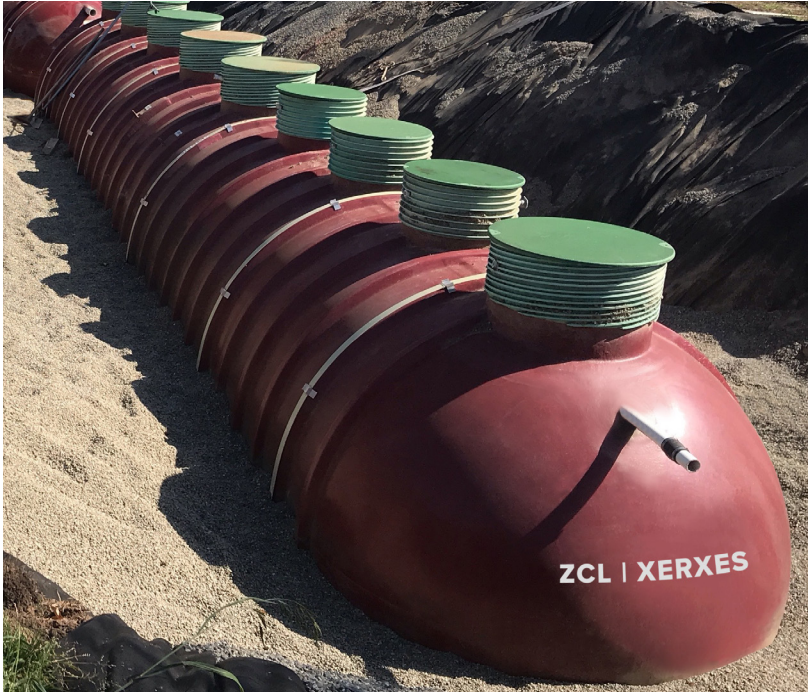
Not only is rest-area wastewater more acidic, it also contains more sludge, making it a heavier consistency. In its original location, Caltrans used the 15,000-gallon tank to test the value of using several compartments to address this challenge. The design of the relocated five-compartment tank allows most of the sludge to settle in the bottom of the tank's first and longest compartment. The system is designed to handle an average daily flow of 3,600 gallons a day.

The Elkhorn installation involved a deeper burial than the test site. That required taller access risers for the relocated tank. That change was easily managed by simply setting the nine risers higher on the tank's collars.
