# Japan's Tonen Corp. Solves Refinery Corrosion Problems with APC's ChemLine®

**ChemLINE®**  
CASE STUDY

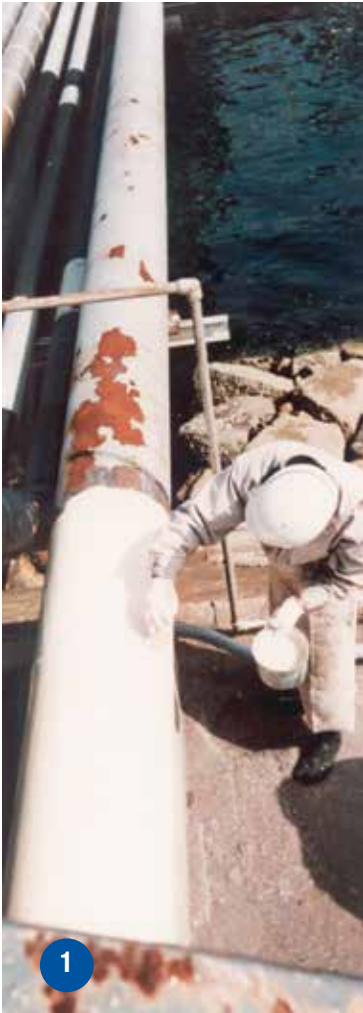
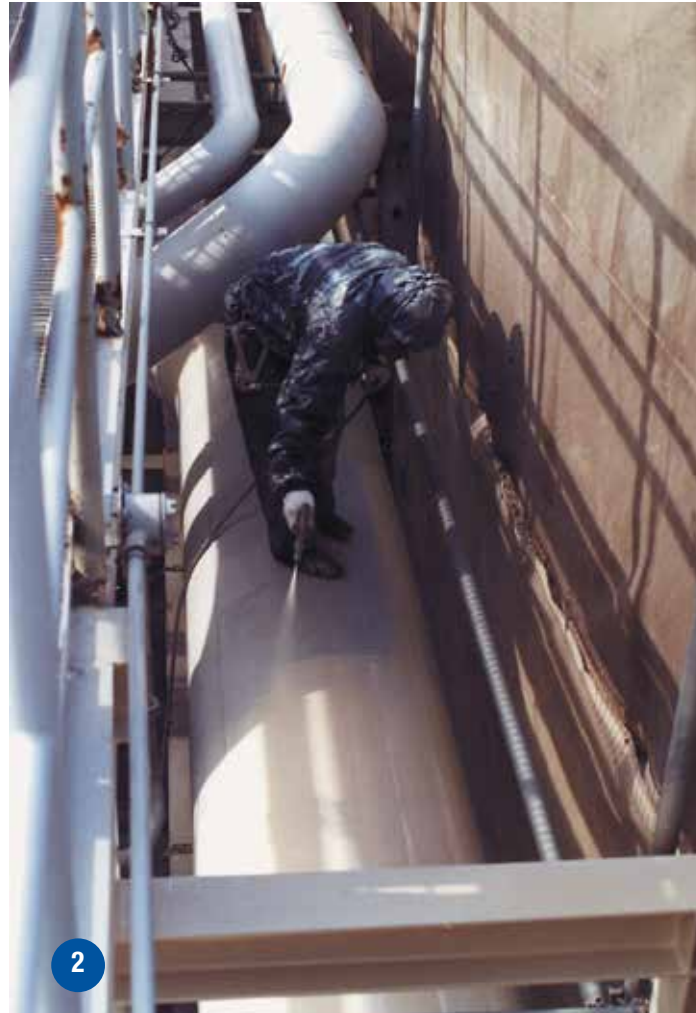
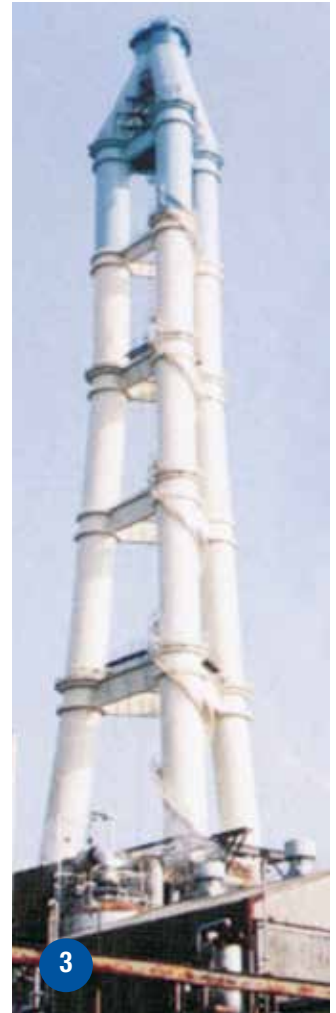
1 - Tonen Corp.'s major refinery in Wakayama, Japan, encountered severe corrosion problems due to the manufacturing nature of the plant and the surrounding seas and its corrosive salt air. In this application at the refinery, APC's ChemLine® coating with excellent bonding capability, was applied directly to pipelines over hard rust. 2 - ChemLine® is sprayed on areas of piping throughout the Tonen refinery. 3 - Stacks at Tonen are coated with a pigmented ChemLine® coating to blend in with the surrounding environment.

Tonen also utilized another feature of the ChemLine® coating – its ability to be pigmented in various colors. At the Tonen refinery, earth colors were used to blend in with the surrounding natural environment. For example, pipes located by the beach were coated with a sand color. Stacks were coated white at the base and progressively tinted with blue as the stack rises. At the top of the stack the color became darker blue to blend in with the sky.

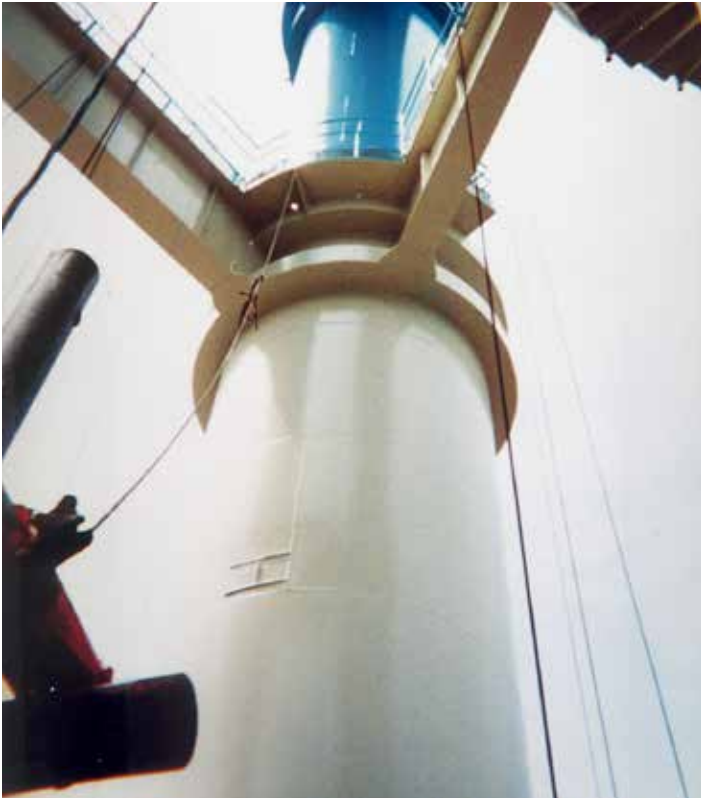
*Closeup of coating on stack.*

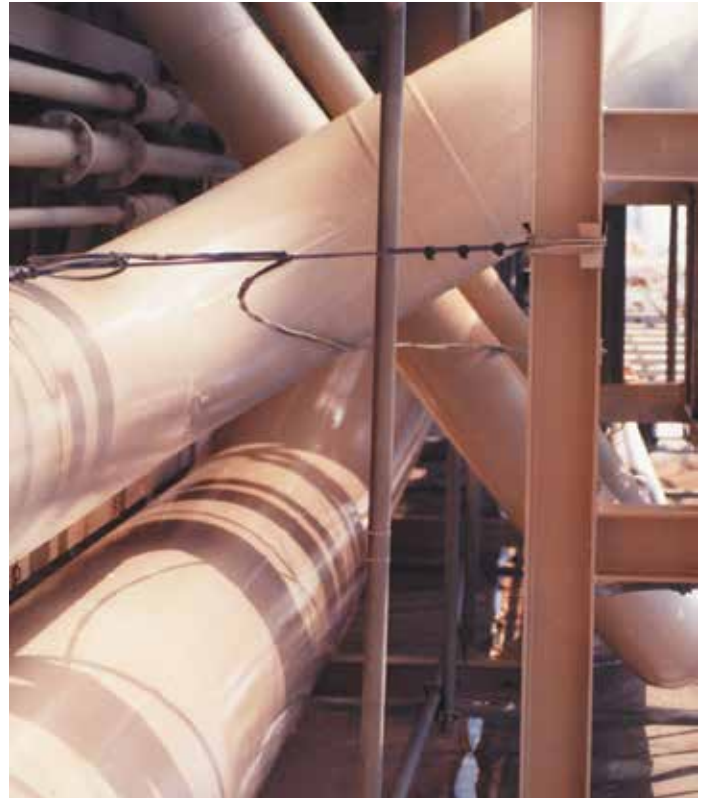
*Pipe running throughout Tonen facility is coated with ChemLine®.*

Once all surfaces were ready, the ChemLine® coating was applied in two separate 3-4 mil coats (75 to 100 microns). This guaranteed complete encapsulation of the lead based paint. The coating was even applied over hard rust without surface preparation.
