ChemLine® Provides Over 10 Years Sulphuric Acid Service in Canada

ChemLINE®
CASE STUDY

This case study highlights several sulphuric acid tank coating projects done with Advanced Polymer Coating's ChemLine® 784/32 polymer coating more than decade ago, and which are still in service today.

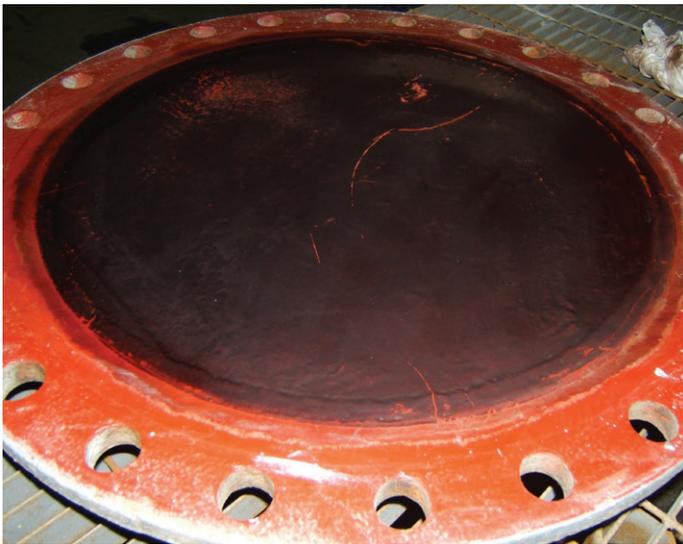
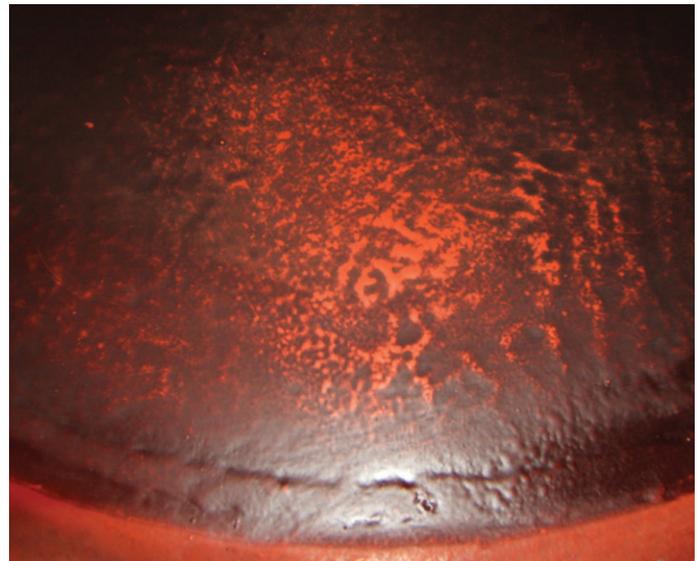
ChemLine® 784/32 coating intact after 10 years service (left). Staining can be removed (right).

The photos are of the manway lid for storage Tank #1 after it was removed for tank inspection. These photos are indicative of the staining of the lining system that was found in both storage Tanks #1 and #2. Some mechanical damage can also be observed. This appears to have happened during removal and transport of the lid. Scrubbing with a damp cloth removed some of the staining and the coating could be observed as being close to its original color before being placed in service.

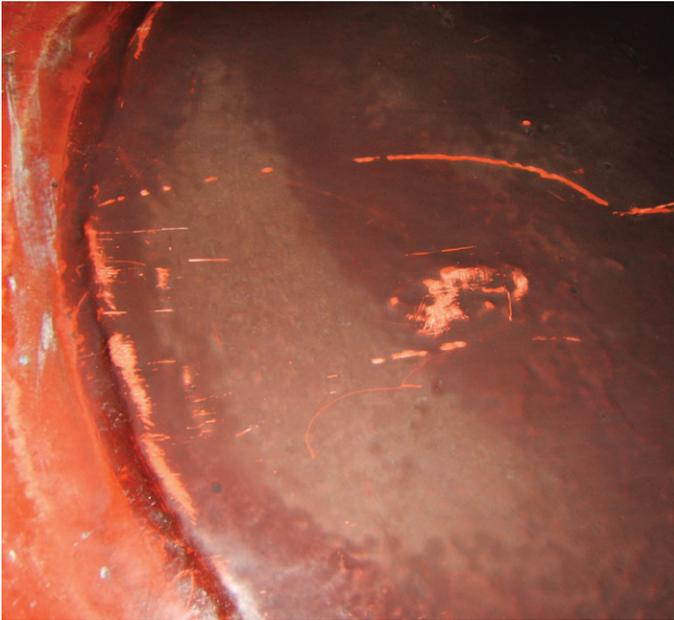
Staining from acid (left). No loss of coating thickness (right).
