This case study highlights an application done using Advanced Polymer Coatings' ChemLINE® polymer coating inside a stainless steel tank at a major pharmaceutical-grade chemical company in the U.S.

### Background

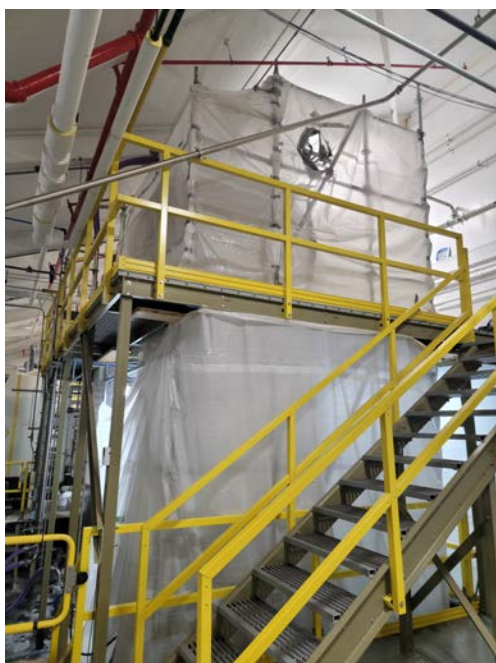
*(Far Left)* 100% containment achieved. *(Near Left)* A look inside the tank, post-blast, with suspended scaffolding. *(Below)* The exterior of the tank and entryway.

Due to the location of the tank, and the sensitive surrounding environment of the facility, nothing less than 100% containment needed to be met. Arbonite, a leading corrosion protection company, had a structure erected surrounding the 4,000-gallon tank and a floating scaffolding was suspended from the top of the surrounding structure where a protective wrapping was then hung from the structure, ensuring 100% containment was met.

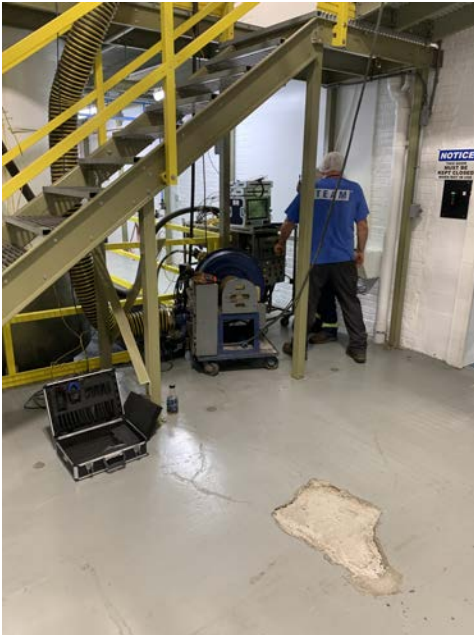
(Above Left) The heat curing equipment is set up to cure the ChemLINE® coating to spec. (Above Middle) The vent is set up to move the fumes out of the manufacturing facility. (Above Right) Heat cure equipment with an insulated vent extended from the heat curing equipment into the tank. (Bottom Right) Fully cured topcoat layer inside the storage tank.
