Creative Pultrusions, Inc. Standard Minimum Visual Requirements Guide. Based on ASTM D4385-19

Revision – 02-10-2020 Total page count - 44

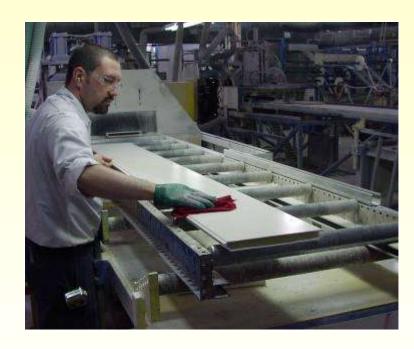
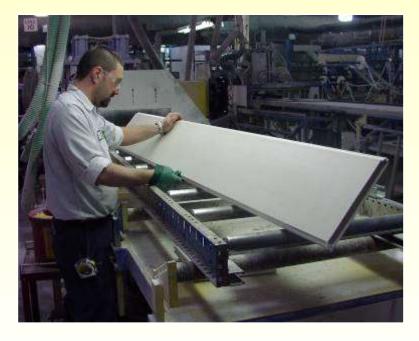
Visual Inspection

Visual Inspections are required on every part. Visually inspect 100% of the surface area, cross section and the interior of the profile as permitted.

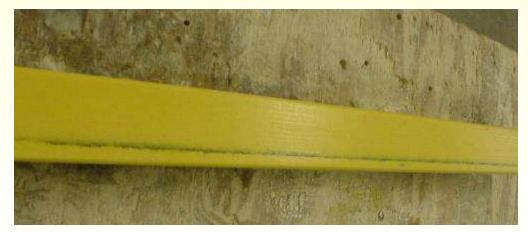
Black Marking

Black smudges on the surface of the pultruded product that are unremovable by cleaning, scrubbing, or wiping with solvent. This defect is cosmetic in nature and does not affect the structural serviceability.

A single smudge shall fit in a 1 in. (25.4 mm) diameter circle. Multiple smudges are permitted.

Note: photo shown depicts profile not meeting the specification.

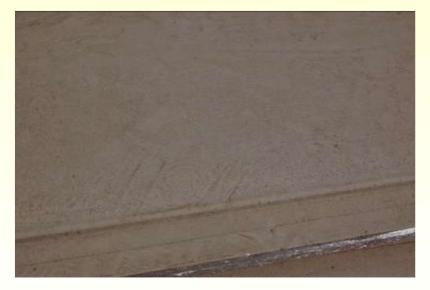
Blooming Fiber

A pultrusion surface condition exhibiting a fiber prominence or fiber show that usually has a white or bleached color and a sparkling appearance.

Permitted for rod and bar with all roving reinforcement. Not permitted for a mat and roving construction unless there is no surfacing veil.

Note: photo shown depicts profile with veil not meeting the specification.

Fibers must be encapsulated by resin.

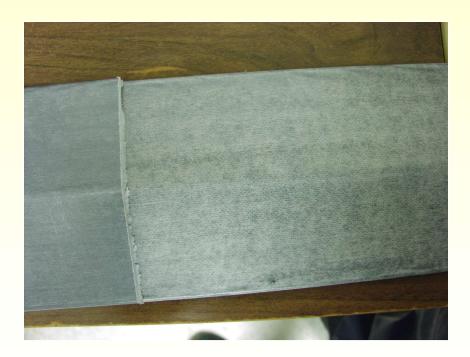
Blooming, Under cure

A dull and bleached surface color that is evident in pultruded material not exposed to the weather.

Acceptance / Rejection Criteria
Not Permitted

Undercure can be determined By use of a Coleman Barcol Impressor. Acceptable readings should be 55-65.

Note: photo shown depicts profile not meeting the specification.

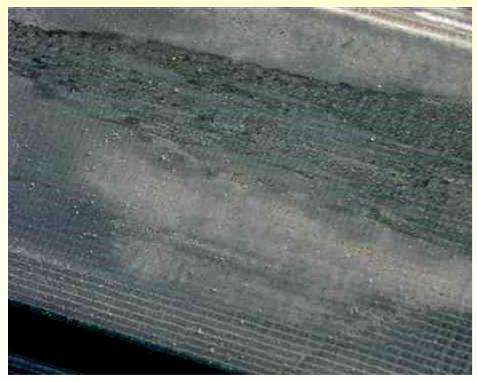
Burn or Thermal Decomposition

A discoloration, distortion, or destruction of the pultruded surface as a result of thermal decomposition.

Note: This defect affects the structural serviceability

Acceptance / Rejection Criteria
Not Acceptable

Note: photo shown depicts profile not meeting the specification.

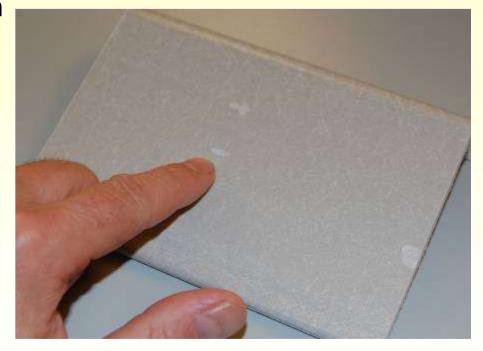
Chips (Gouges)

Minor damage to the pultruded surface that removes material but does not cause a crack or craze.

Acceptance / Rejection Criteria Not over .393 in. (10 mm) wide or long. Not more than five per 10 ft (3.048 m) length. Chips that penetrate past the depth of the surface veil are not permitted.

Note: photo shown depicts profile meeting the specification.

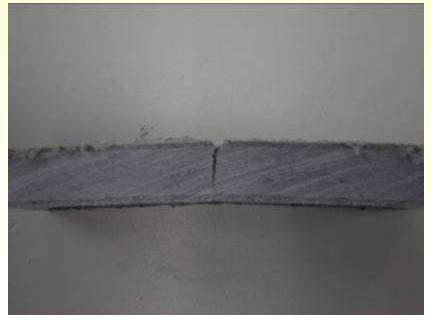
Crack

A visual separation that occurs from the pultruded surface to the equivalent of one full ply or more of reinforcement 0.02 in. (0.508 mm). Reference Internal Shrinkage Cracks.

Note: This defect affects the structural serviceability

Acceptance / Rejection Criteria
Not Acceptable

Note: photo shown depicts profile not meeting the specification.

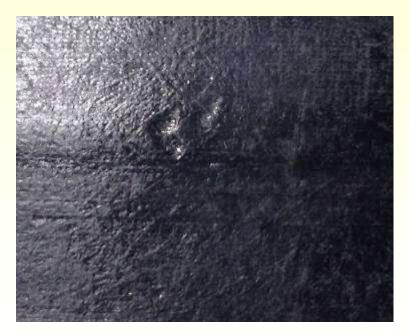
Crater

A small, shallow pultrusion surface imperfection.

Acceptable if it does not reduce the part thickness below the minimum specification.

Note: photo shown depicts profile meeting the specification.

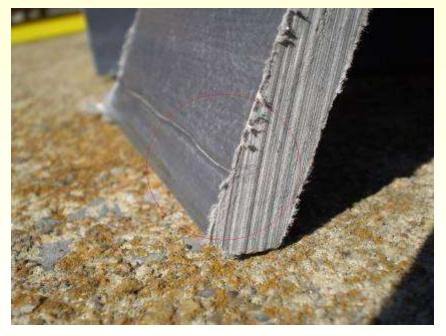
Craze

Multiple fine separation cracks at the pultruded surface not penetrating into the reinforcement nor to the equivalent depth of one ply of reinforcement.

Note: This condition is usually due to resin shrinkage during cure in resin rich areas.

Acceptance / Rejection Criteria Acceptable and can be over the entire length of the part.

Note: photo shown depicts profile meeting the specification.

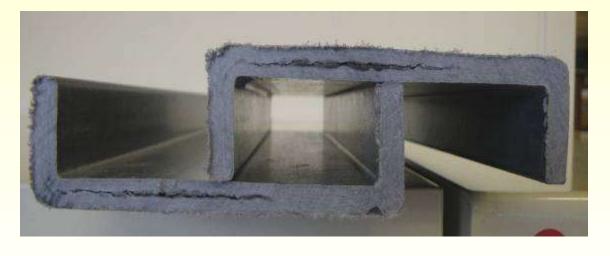
Delamination

The separation of two or more layers or plies of reinforcing material within a pultrusion.

Note: This defect affects structural serviceability.

Note: photo shown depicts profile not meeting the specification.

Acceptance / Rejection Criteria Not Acceptable

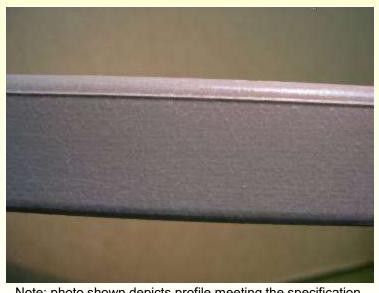
Die Parting Line

A lengthwise flash or depression on the surface of a pultruded plastic part. The die parting line is not part of the dimensional tolerance.

Note: The die parting line is associated with the area where separate pieces of the die join together to form the cavity.

Note: photo shown depicts profile meeting the specification.

The line projection caused by the die parting line shall not extend past the product's surface by more than .02 in. (0.508 mm). It shall not create a sharp feeling or have loose fibers.

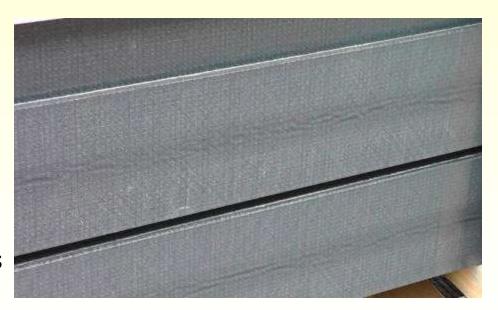
Discoloration

A streak or other pattern on the surface that causes a noticeable change of color from the rest of the pultruded surface that has not been exposed to the weather.

Spots of any color not over 0.75 in. (19.05 mm) in diameter or 8 per 10 ft (3.048 m) of length are permitted. Streaks or longitudinal stains permitted if not over 0.75 in. (19.05 mm) wide, 10 in. (25.4 cm) long or more than six per 10 ft. (3.048 m) of length. Continuous discolorations caused by veil overlap or resin rich areas are permitted. Mat discolorations are not rejectable.

Note: photo shown depicts profile meeting the specification.

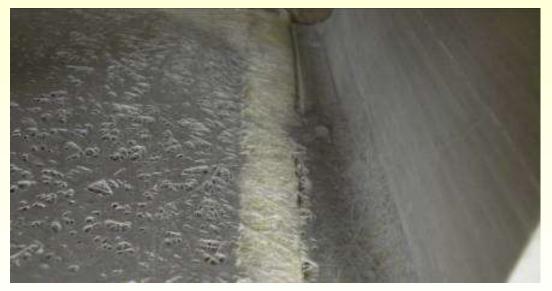
Dry Fiber (Lack of Resin Fill out)

A condition in which fibers are not fully saturated by resin during pultrusion.

Note: This defect affects structural serviceability.

Acceptance / Rejection Criteria
Not acceptable.

Note: photo shown depicts profile not meeting the specification.

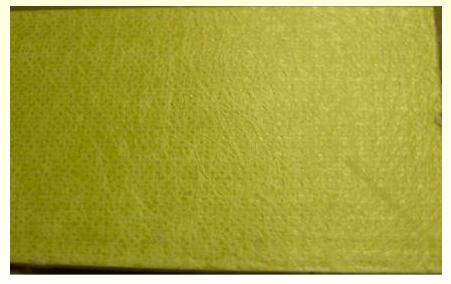
A lack of normal pultruded surface gloss or shine.

Note: This condition can be caused by insufficient cure (typically in large areas) or a stop mark, (more defined and abbreviated in size), which result in a dull area on a pultruded profile.

Note: photo shown depicts profile not meeting the specification.

Determine cause of condition and reference the "Insufficient Cure" section or "Stop Mark" section for direction.

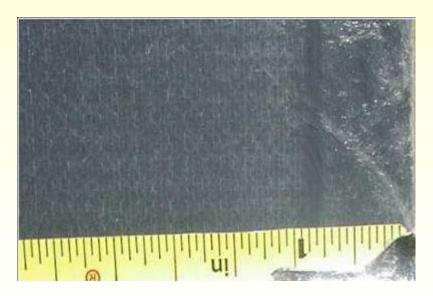
Expose Roving / Veil Slippage

The underlying layer of roving or mat not covered by surface material in a pultrusion.

Note: This defect is cosmetic in nature and does not affect the structural serviceability. Can lead to fiber blooming when exposed to sunlight.

Permitted if surfacing material covers all but .4375 in (11.112 mm) from each free edge, but not to exceed 25% of the width of the surface being inspected or 10% of the circumference of a round product. It is acceptable to use carrier rovings on the inside surface of the tube. Exposed rovings in the connection areas are acceptable.

Note: photo shown depicts profile not meeting the specification.

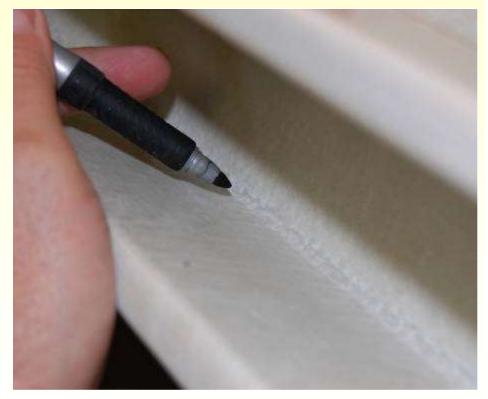
Fiber Bridging

Reinforcing fiber material that is found bridging across on an inside radius of a pultruded shape.

Note: This condition is caused by shrinkage stresses around such a radius during cure.

Acceptance / Rejection Criteria Permitted if reinforcing fibers are encapsulated by resin, no corner cracks exist, and there is no evidence of delamination.

Note: photo shown depicts profile meeting the specification.

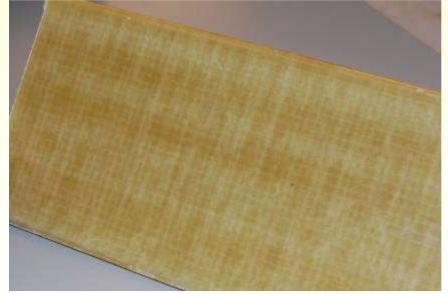
Fiber Prominence

A visible and measurable pattern of the reinforcing material on the surface of a pultruded plastic part.

Acceptance / Rejection Criteria
Permitted if reinforcing material is encapsulated by resin.

Note: photo shown depicts profile meeting the specification.

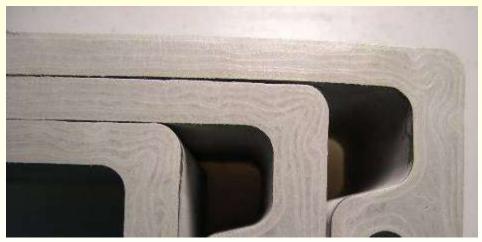
Folded Reinforcement

An unintentional or unspecified misalignment of mat or fabric reinforcing material in relation to the contour of a pultruded section.

Note: It is possible that such folds will affect the surface appearance of the pultrusion and will be visible in a cut cross section of the product.

Acceptance / Rejection Criteria
Permitted if properties meet the
minimum mechanical and physical
properties as published by
manufacturer or properties agreed
upon between pultruder and
purchaser. Other visual requirements
caused by mat folds must satisfy the
specification.

Note: photo shown depicts profile meeting the specification.

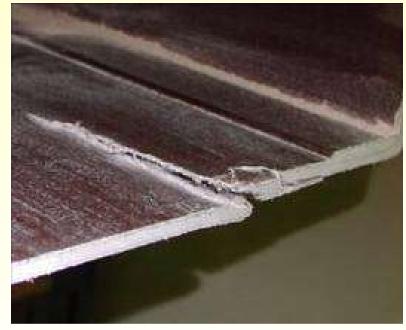
Fracture

Cracks, crazing, or delamination, or a combination thereof, resulting from physical damage to the pultrusion.

Note: This defect affects structural serviceability.

Acceptance / Rejection Criteria
Not acceptable

Note: photo shown depicts profile not meeting the specification.

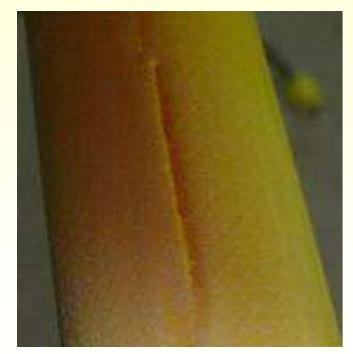
Grooving

Long narrow grooves or depressions in a surface of a pultrusion parallel to its length.

Permitted if material thickness reduction is not over 10% and the groove width is .125 in. (3.175 mm) or less. Grooves on opposing surfaces of the cross sectional thickness are not permitted. Intermittent and continuous grooves are acceptable as long as the profile satisfies dimensional and mechanical requirements.

Note: photo shown depicts profile meeting the specification.

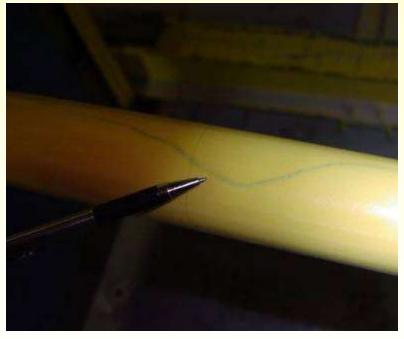
Inclusion

Any foreign matter or particles that are either encapsulated or imbedded in the pultrusion.

Permitted if product meets test requirements. None in excess of 0.50 in. (12.7 mm) in diameter or no more than six per 10 ft (3.048 m) of length. Any surface blemish created above the resin due to an inclusion shall not be permitted.

Example - Thermal wire inclusion pictured which is not acceptable Note: photo shown depicts profile not meeting the specification.

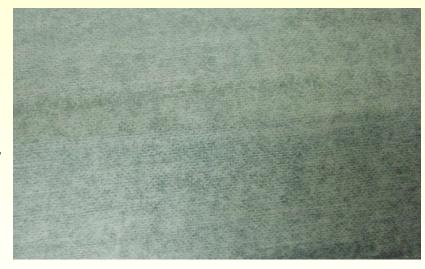
Insufficient Cure

A pultrusion abnormally created by lack of, or incomplete, cross linking of the resin.

Note: This condition can usually be detected by dull surface appearance,

low Barcol hardness, and low physical properties. Thick sections, cured from the outside in, can reveal insufficient cure in the center of the section even though completely cured on the surface. This condition can be caused by insufficient die temperature, improper catalyst, or pulling too fast for the die temperature.

Note: photo shown depicts profile not meeting the specification.

Repair by post cure to meet test requirements and surface appearance is acceptable.

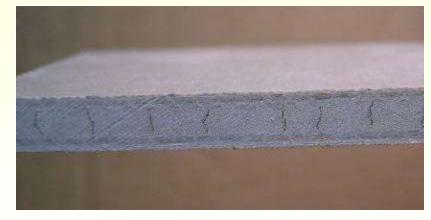
Internal Shrinkage Cracks

Cracks in the pultrusion that are found within areas of roving reinforcement and terminate in the off axis reinforcement.

Note: This condition is caused by shrinkage strains during cure that appear in the roving portion of the pultrusion where transverse strength is low.

Permitted without numerical limit if the crack does not reach the surface of the product or penetrate through an internal layer of the reinforcement and the product meets test requirements.

Note: photo shown depicts profile meeting the specification.

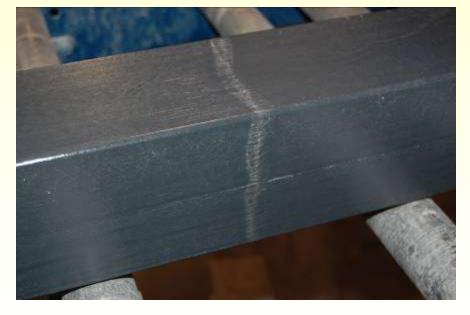
Stitching on or near the surface of the part that is utilized to splice mat reinforcements.

Acceptance / Rejection Criteria
Permitted if dimensions
requirements are met.

Note: photo shown depicts profile meeting the specification.

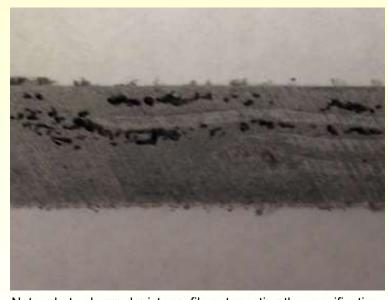
Porosity, Internal (Void)

The presence of numerous pits or pinholes beneath the pultruded surface, usually observable only in a cut cross-section.

No more than two pits / pinholes for every 0.0625 in. (1.6 mm) of thickness per 1.0 in. (25.4 mm) width.

Shapes exceeding the limits are acceptable if the properties including water absorption are satisfied.

Note: photo shown depicts profile not meeting the specification.

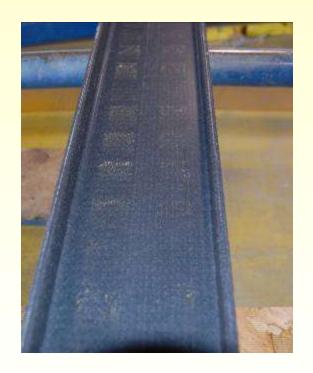
Puller Track Marks

Depressions at regular intervals by excessive pull block pressure.

Acceptable if the depression is less than .005" (.12mm) measured from the surface. MUST verify that the composite profile has not been cracked / fractured as a result of the puller track pressure by carefully examination of the surface and end cut of the profile.

Note: photo shown depicts profile meeting the specification.

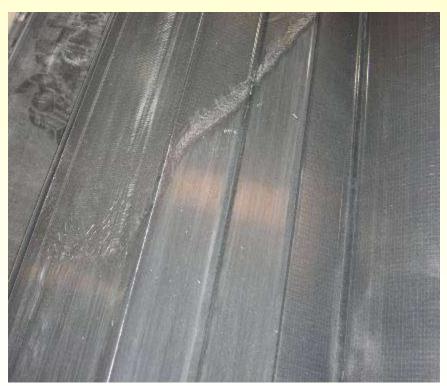
Reinforcement Distortion

Knotted, tangled, widely spaced, or otherwise abnormal but local irregularities in reinforcement distribution throughout the pultruded cross section.

Note: This condition usually causes noticeable changes in the local reinforcement content with crushing of the reinforcement or resin-richness in isolated areas

Acceptance / Rejection Criteria
Permitted if defect fits in a 3 in.
(76.2 mm) circle.
Multiple occurrences permitted.

Note: photo shown depicts profile not meeting the specification.

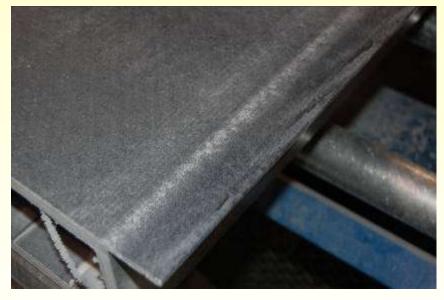
Reinforcement Rich Area

An over-concentration of reinforcement in the pultruded crosssection.

Note: This usually occurs where mat or other reinforcement is folded, creased or bunched in a portion of the cross section.

Acceptance / Rejection Criteria
Permitted if product meets test
requirements and other visual
requirements.

Note: photo shown depicts profile meeting the specification.

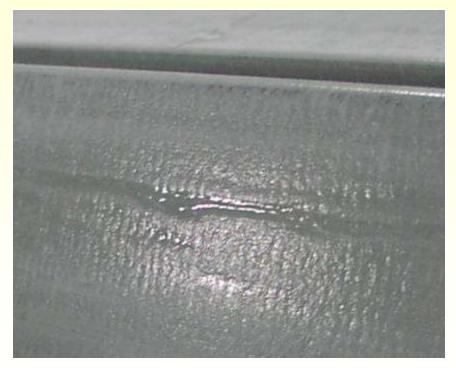
Resin-Rich Area

An area of the pultrusion that lacks sufficient reinforcement.

Acceptance / Rejection Criteria
Permitted if product meets test requirement.

Note: photo shown depicts profile meeting the specification.

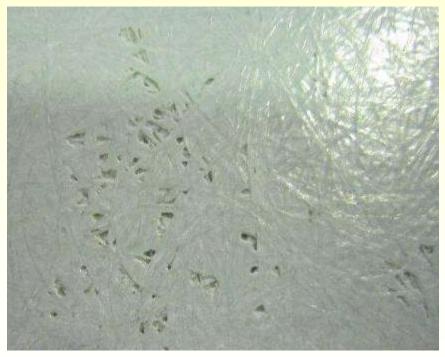
Resin voids appearing as multiple surface interruptions that conform to the pattern of cloth weave or continuous strand mat. These defects occur only on the surface layer of the resin in contact with the pultrusion die or mold that do not contain a veil.

Acceptable on products that do not contain a surface veil.

Not acceptable on parts containing a surface veil.

Note: photo shown depicts profile meeting the specification.

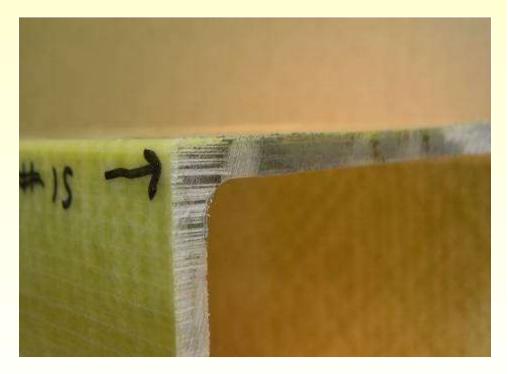
Saw Burn

Blackening or carbonization of a cut surface of a pultruded

Note: This defect is cosmetic in nature and does not affect structural serviceability if Acceptance Criteria are met and not caused by dry fiber.

Acceptance / Rejection Criteria
Permitted unless caused by dry
fiber

Note: photo shown depicts profile meeting the specification.

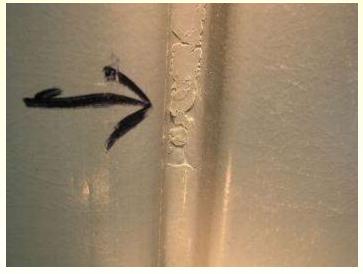
Scale

A condition wherein resin plates or particles are on the surface of a pultrusion.

Note: Scales can often be readily removed, sometimes leaving surface voids or depressions.

Permitted if removal does not expose dry fibers and dimensional tolerances are met.

Note: photo shown depicts profile meeting the specification.

Note: Repair of exposed fiber permitted if dimensional tolerances are met.

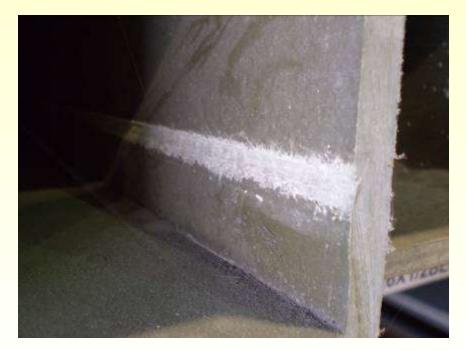
Scuffing

Long white scrape marks on the surface of the pultrusion.

Note: This condition usually results from mechanical scraping or scratching of the pultrusion in the machine or in handling it afterwards.

Permitted if not over 0.75 in. (19.05 mm) wide or 12 in. (30.48 cm) long and not over five such marks per 10 ft (3.048 m) of length. On inside radius, permitted if not over 0.125 in. (3.175 mm) wide or 6.0 in. (15.24 cm) long even if they appear intermittently along each length.

Note: photo shown depicts profile not meeting the specification.

Note: It may be possible to repair if limits exceeded.

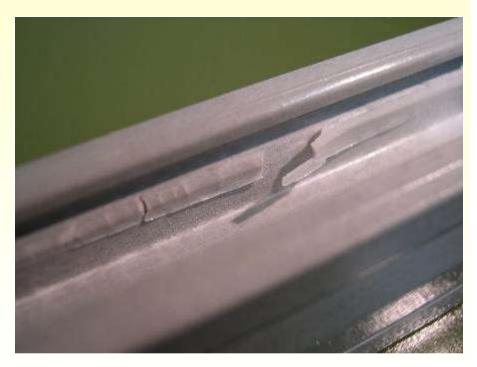
Sluffing

A condition wherein scales peel off or become loose, either partially or entirely, from the pultrusion.

Acceptance / Rejection Criteria Repair permitted if dimensional tolerances are met.

Note: photo shown depicts profile meeting the specification.

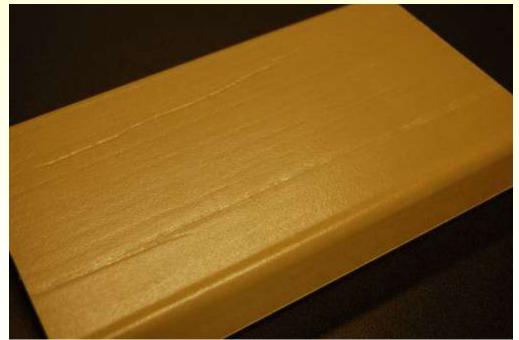
Note: This defect is cosmetic in nature and does not affect structural serviceability.

Acceptance / Rejection Criteria
Permitted if dimensional
tolerances are met.

Note: photo shown depicts profile meeting the specification.

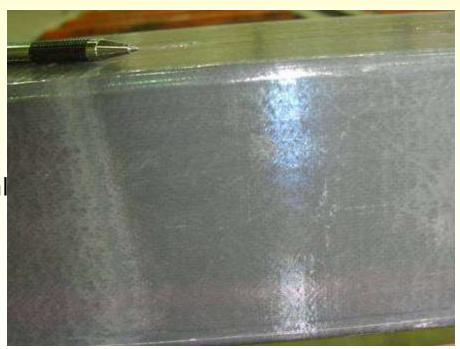
Note: This condition is the result of an interruption in the normal continuous pulling operation.

Note: This defect is cosmetic in nature and does not affect structural serviceability unless a burn or thermal decomposition occurs. Reference the "Burn or Thermal Decomposition" section.

Permitted unless a burn or thermal decomposition occurs.

Note: photo shown depicts profile meeting the specification.

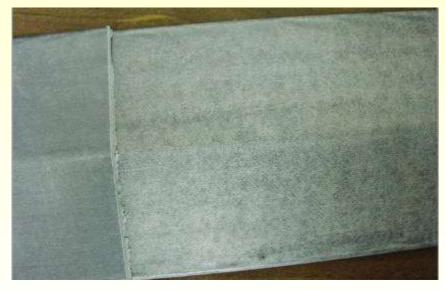
Insufficient cross linking of polymer chains. It could be caused by inadequate process temperature and or catalyst chemistry.

Note: Undercured parts look dull and bleached without any exposure to weather or chemicals. This defect affects the structural serviceability.

Acceptance / Rejection Criteria Not acceptable.

Undercure can be determined By use of a Coleman Barcol Impressor. Acceptable readings should be 55-65.

Note: photo shown depicts profile not meeting the specification.

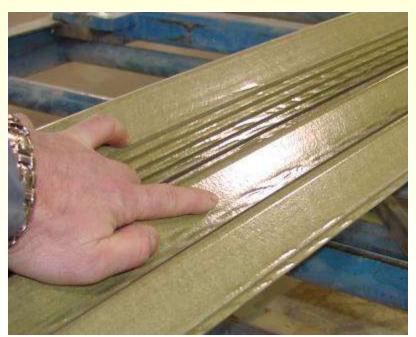
Note: This condition can occur in either the lengthwise or crosswise direction of the pultrusion and is caused by reinforcement shifting and

Depressions are permitted if less than 15 % of shape thickness and the minimum shape thickness and flatness specification are satisfied.

Note: photo shown depicts profile meeting the specification.
