### Affected Area HVAC Readings

### Affected Area: Kitchen

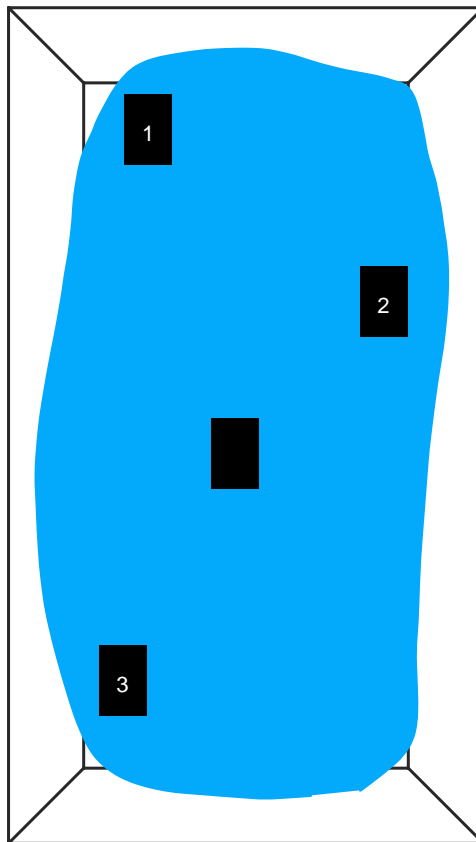
Point 1: Moisture Point 1

1.1: Wood Sill Plate <a href="#">Tramex Wood 30%</a> Dry Standard: 5%					
#	Time	Meter	Moisture Content	Surface Temperature	Notes & Photos
1	Nov 5, 10:20 AM	Tramex Wood 30%	25%		
1.2: Carpet <a href="#">Delmhorst 100%</a> Dry Standard: 0%					
#	Time	Meter	Moisture Content	Surface Temperature	Notes & Photos
1	Nov 5, 10:21 AM	Delmhorst 100%	100%	65°F	
1.3: Drywall <a href="#">Tramex 100%</a> Dry Standard: 5%					
#	Time	Meter	Moisture Content	Surface Temperature	Notes & Photos
1	Nov 5, 10:23 AM	Tramex 100%	75%	55°F

Point 2: Moisture Point 2

2.1: Carpet <a href="#">Delmhorst 100%</a> Dry Standard: 0%					
#	Time	Meter	Moisture Content	Surface Temperature	Notes & Photos
1	Nov 5, 10:25 AM	Delmhorst 100%	65%	67°F	
2.2: Drywall <a href="#">Tramex 100%</a> Dry Standard: 5%					
#	Time	Meter	Moisture Content	Surface Temperature	Notes & Photos
1	Nov 5, 10:25 AM	Tramex 100%	75%	66°F

Point 3: Moisture Point 3

3.1: Carpet <a href="#">Delmhorst 100%</a> Dry Standard: 0%					
#	Time	Meter	Moisture Content	Surface Temperature	Notes & Photos
1	Nov 5, 10:25 AM	Delmhorst 100%	100%	65°F

**Equipment List: Kitchen**

**Dehumidifier: Phoenix 300 MAX LGR (102)**

**Air Movers: Kitchen**

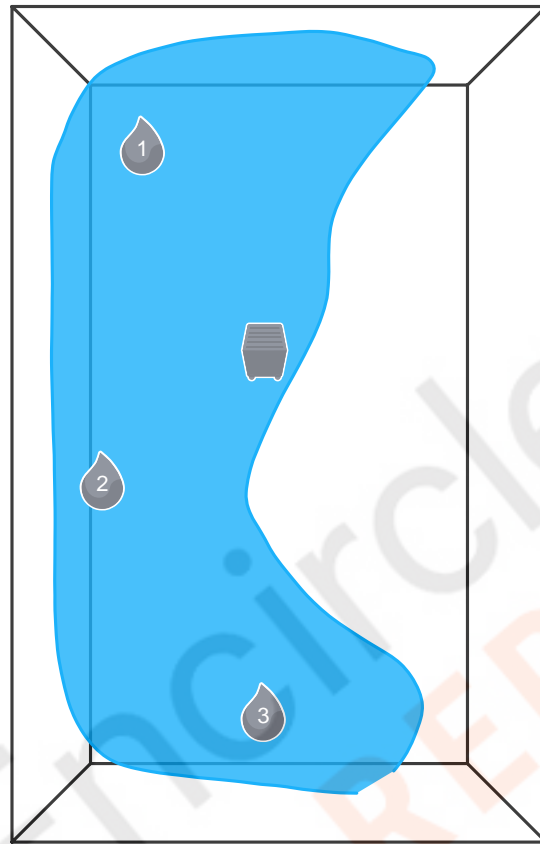
Affected Area: Dining Room

Point 1: Moisture Point 1

1.1: Wood Sill Plate 25%					Still Wet
<a href="#">Tramex Wood 30%</a> Dry Standard: 5%		Nov 5 Nov 6			
#	Time	Meter	Moisture Content	Surface Temperature	Notes & Photos
1	Nov 5, 10:26 AM	Tramex Wood 30%	25%		
1.2: Carpet 80%					Still Wet
<a href="#">Delmhorst 100%</a> Dry Standard: 0%		Nov 5 Nov 6			
#	Time	Meter	Moisture Content	Surface Temperature	Notes & Photos
1	Nov 5, 10:26 AM	Delmhorst 100%	80%	66°F

Equipment List: Dining Room

Dehumidifier: Phoenix DryMax LGR (DH008)

Air Movers: Dining Room

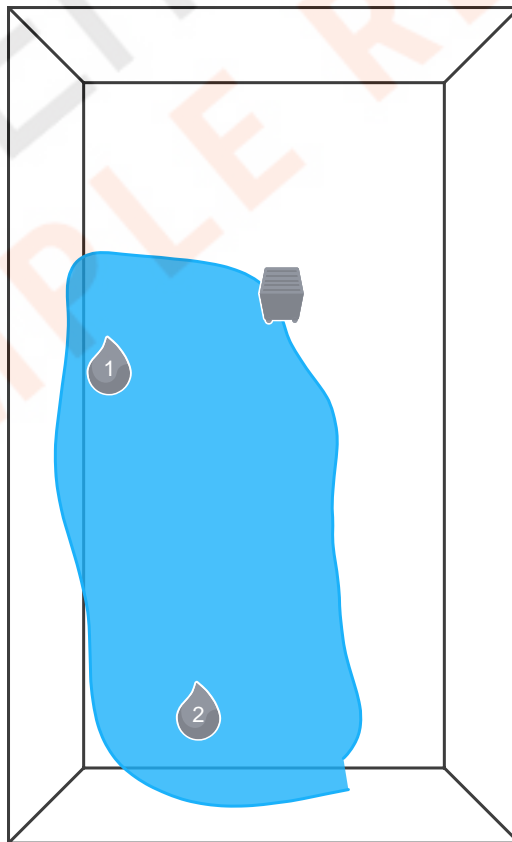
Affected Area: Living Room

Point 1: Moisture Point 1

1.1: Wood Sill Plate 25% <a href="#">Tramex Wood 30%</a> Dry Standard: 5%

Still Wet

#	Time	Meter	Moisture Content	Surface Temperature	Notes & Photos
1	Nov 5, 10:28 AM	Tramex Wood 30%	25%	65°F	
1.2: Carpet 100% <a href="#">Delmhorst 100%</a> Dry Standard: 0%

#	Time	Meter	Moisture Content	Surface Temperature	Notes & Photos
1	Nov 5, 10:28 AM	Delmhorst 100%	100%	62°F	
1.3: Drywall 80% <a href="#">Tramex 100%</a> Dry Standard: 5%

2.1: Wood Sill Plate 22% <a href="#">Tramex Wood 30%</a> Dry Standard: 5%

#	Time	Meter	Moisture Content	Surface Temperature	Notes & Photos
1	Nov 5, 10:29 AM	Tramex Wood 30%	22%	63°F	
2.2: Carpet 75% <a href="#">Delmhorst 100%</a> Dry Standard: 0%

#	Time	Meter	Moisture Content	Surface Temperature	Notes & Photos
1	Nov 5, 10:29 AM	Delmhorst 100%	75%	65°F	
2.3: Drywall 100% <a href="#">Tramex 100%</a> Dry Standard: 5%

#	Time	Meter	Moisture Content	Surface Temperature	Notes & Photos
1	Nov 5, 10:32 AM	Tramex 100%	100%	70°F

Equipment List: Living Room

Dehumidifier: Phoenix DryMax LGR (DH007)

Air Movers: Living Room
