Encircle Sample Report

Claim ID	Date of Loss Apr 22, 2020
Date Claim Created Apr 22, 2020	Type of Loss Water
Address 159 North Lake Drive, Waterloo, Ontario	Policyholder Name John Smith
Policy Number P123456	Policyholder Email johnsmith@gmail.com
Policyholder Phone Number (226) 338-1593	Emergency Estimate / Reserve \$10,000
Repair Estimate / Reserve \$15,000	Contents Estimate / Reserve \$2,500

Initial Visit / Site Inspection

Met with home owner today at 8:30 am. They were away for the weekend at a cottage, came back Sunday afternoon and noticed water in hallway of main floor. Cat 1 Class 2, approx 50% of hallway and kitchen affected.

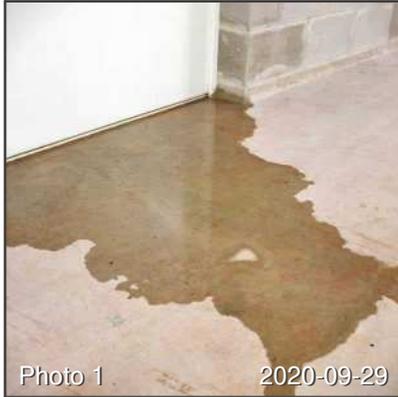
Policy Holder Photos

The customer provided these photos to our team virtually using Encircle LINK before our crew arrived on the scene.

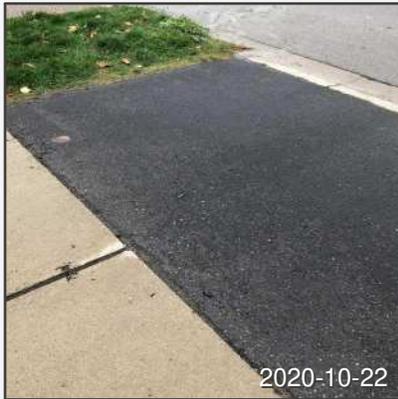
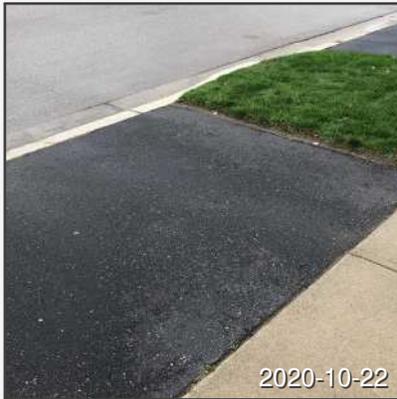
Driveway

Condition of driveway pre arrival. No cracks or damage noted

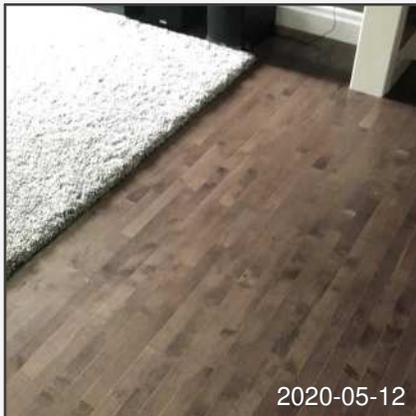
Preexisting damage to floor

Initial walkthrough noted significant scratching/wear and tear on living room hardwood floor. Damage featured in attached picture.

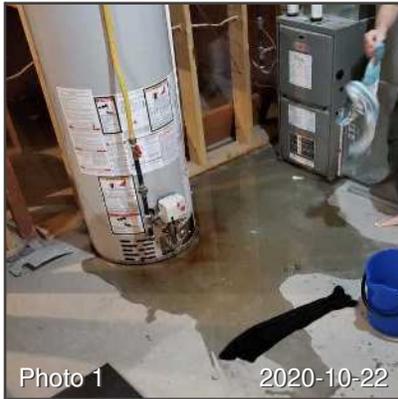
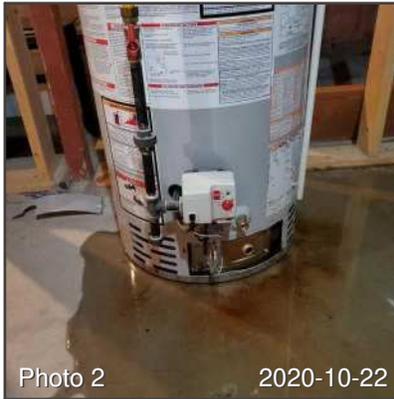
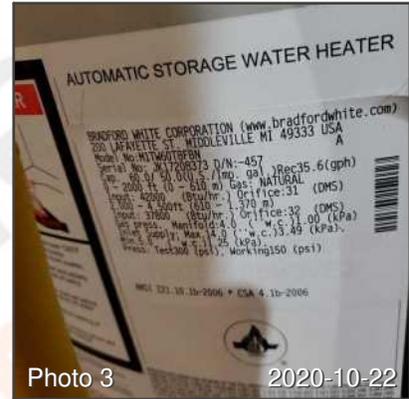
Cause Of Loss

Cause of loss was determined to be a faulty water heater in the basement of the client's home. Upon arrival water the heater was continuing to rapidly expel water onto the basement floor saturating the immediate surrounding area.
