Claim Details

Carrier Identifier	Contractor Identifier	Assignment Identifier
P1037336W-2	22-0001	--
Project Manager	Date of Loss	Date Claim Created
Steve Smith	Oct 18, 2021	Oct 19, 2021
Insurance Company	Adjuster	Policy Number
ABC Insurance	Kal Ridhu	P27378Q
Source of Loss	Initial Category of Water	
Ruptured waterline	Category 1

Encircle
SAMPLE REPORT

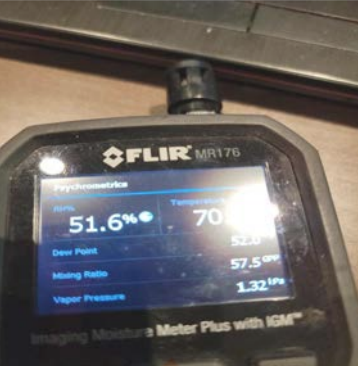
#	Time	Room	Relative Humidity	Specific Humidity	Air Temperature	Notes & Photos
1	Nov 5, 6:59 AM	Bedroom - Master	52%	56.7 gpp	70°F

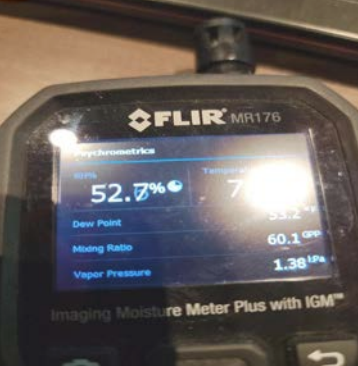
#	Time	Room	Relative Humidity	Specific Humidity	Air Temperature	Notes & Photos
1	Nov 5, 7:00 AM	Bedroom - Master	15%	22.7 gpp	80°F
