Lakhta Center: Automated Structural and Geotechnical Health Monitoring

General information about design and organizational arrangements for deploying automated structural and geotechnical health monitoring system of the «Lakhta Tower» is provided in the following paper. SHM architecture and topology, applied instrumentation, measurement methodology, software and monitoring parameters of the structure are described.

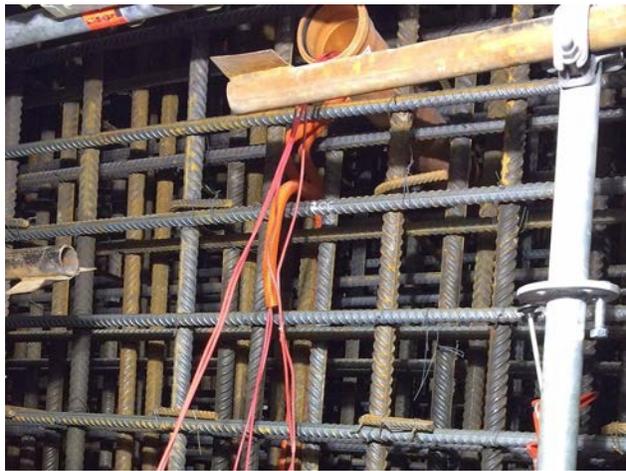
Fig. 8: Embedded PVC details for gauge signal cables

The installation of strain gauges in the BF structure and the core wall was complicated by very dense reinforcement (Fig. 8).

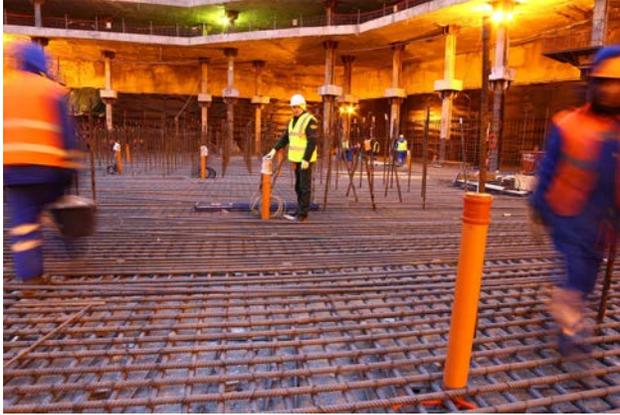
Fig. 10: Strain gauge cables arrangements (outlet from the BF plate)

Cable laying through horizontal structures was performed in PVC pipes, which were built up as the reinforcement cage was installed (Fig. 10).

The outlet of cables from the concrete body was carried out exclusively on vertical structures. At the time of concreting, the cables were stored inside specially prepared embedded details made of PVC products. After dismantling the formwork, embedded parts were opened, and the cables were brought out (Fig. 11), where they were connected to the data acquisition system.

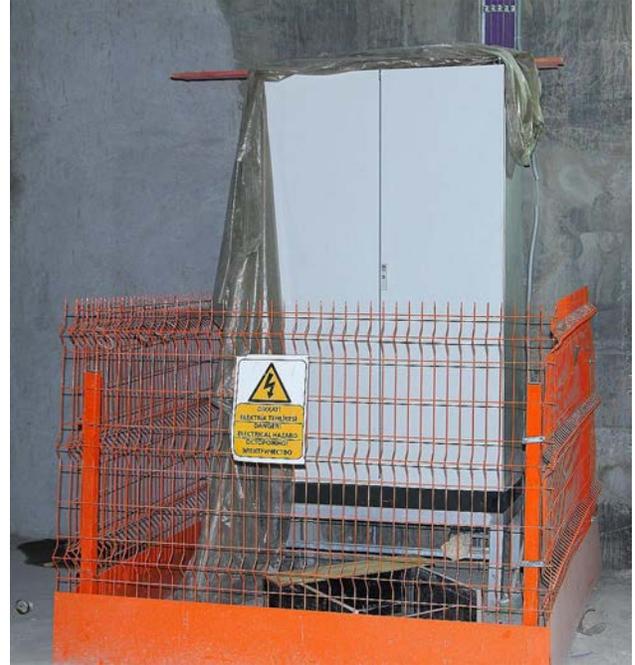
Fig. 12: BF data acquisition enclosure

in the early stages of construction, which imposed a number of significant restrictions on the entire system architecture. It was decided to deploy a distributed data acquisition system as opposed to centralized. Equipment for automatic recording, located on the technical levels of the Tower (B3, B2, L18, L34, L50, L66, L81) as the bearing structures were built (Fig. 12), formed seven autonomous subsystems to which the downstream sensors were connected.

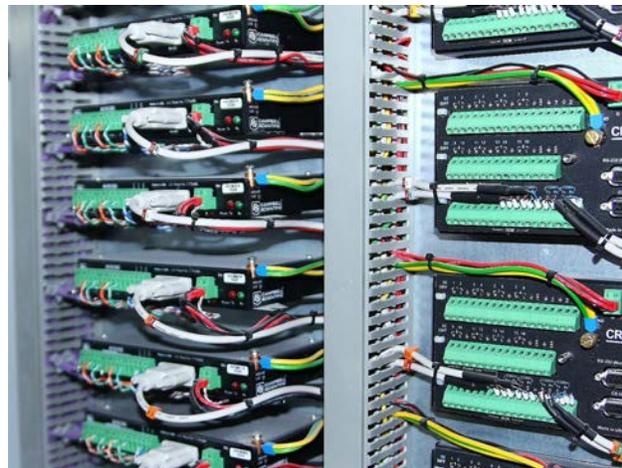
Fig. 15: Typical contents of data acquisition enclosure

All data acquisition nodes were built using Campbell Scientific equipment (Fig. 15).

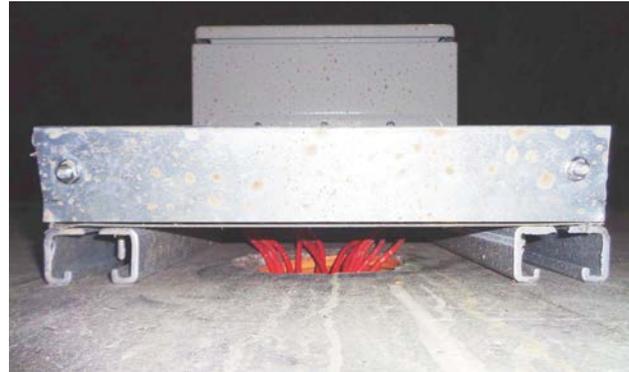
Fig. 16: Multiplexer enclosure installed above the embedded detail with gauge cables

For the monitoring of BF structures, two data acquisition nodes were arranged at the levels B3 and B2. Multiplexing hardware was installed directly

above the embedded details at every outlet point of the signal cables (Fig. 16).

This solution has significantly reduced the length of cable lines, reduced the likelihood of cable damage during construction, simplified and cheapened repairs, allowed promptly change of cable routing, and eliminated the need to splice strain gauge cables.

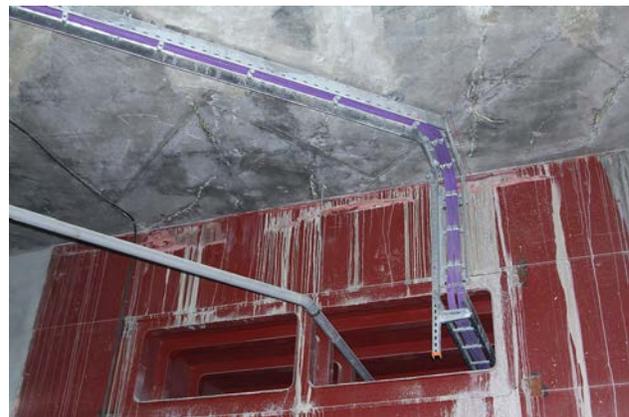
Fig. 17: The supporting system of gauge cables

Cables were laid in trays (Fig. 17), which reduced the damage to lines during the construction to isolated cases.

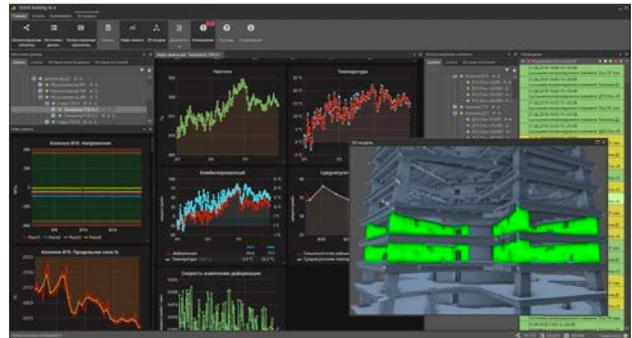
Fig. 20: SODIS Building M interface

The implementation of a large-scale monitoring system, including more than 2,800 sensors, required the deployment and support of a modern IT infrastructure. As a software platform for working with monitoring data, the SODIS Building M4 environment was used (Fig. 20), it includes a large number of problem-oriented services and tools for solving the tasks of long-term monitoring of building structures.

The capabilities of the SODIS Building M software platform (Fig. 21) made it possible to provide automated accounting for individual sensor characteristics (gauge factors, initial measurement data), meta information (coordinates of installation points, sensor orientation, structure type, deformation characteristics of materials, geometric characteristics of sections, affiliation to the gauge sections, etc.) required for data analysis, which allowed by using the automatic methods move from direct (strain) measurement results to stresses and internal forces in structural elements, for which it is possible to make
