SALAMANDER INSPECTIONS LTD

Mechanical Insulation Energy Audits

Energy Audit

For the Food Processing
Development Center
6309 – 45 Street Leduc, Alberta

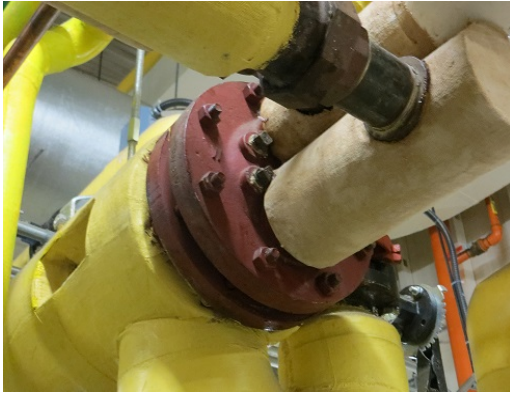
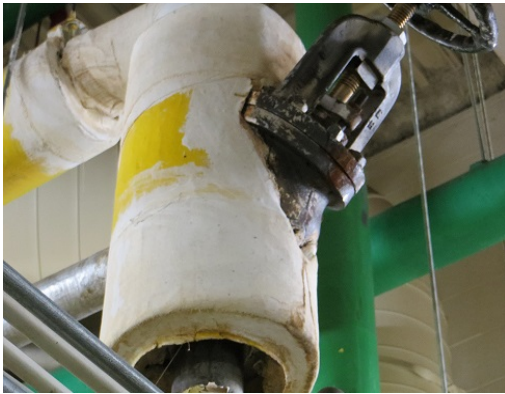
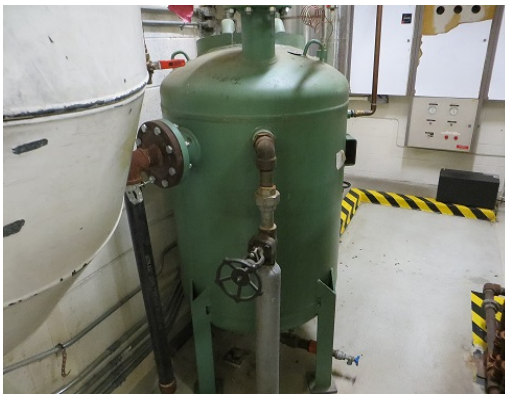
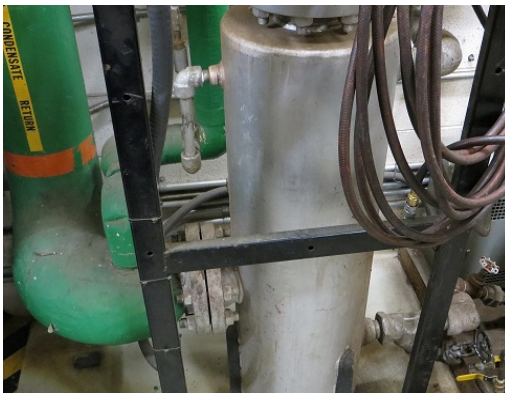
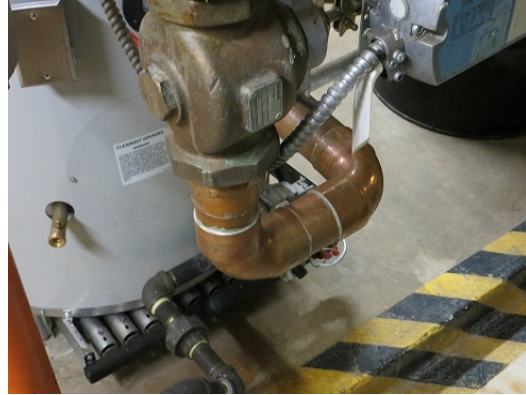
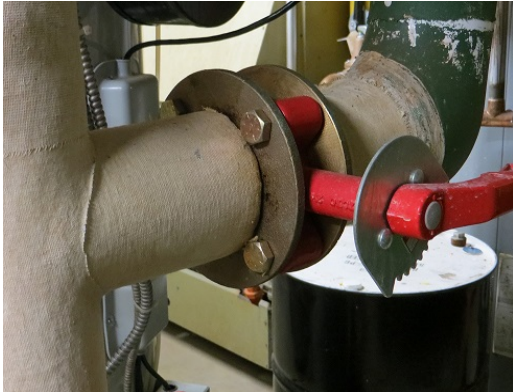
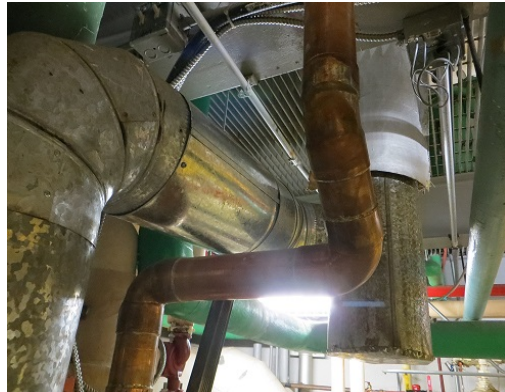
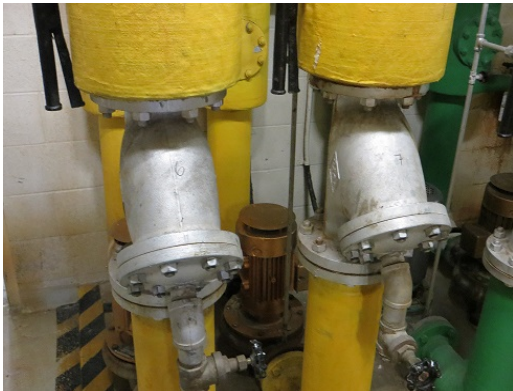
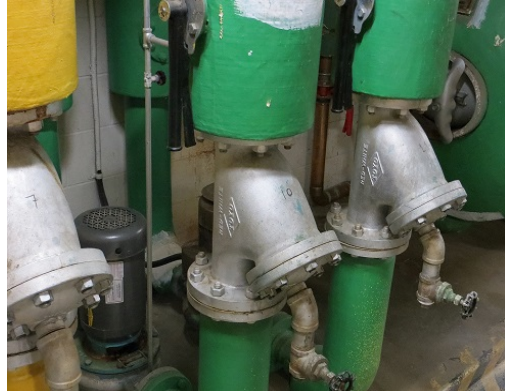
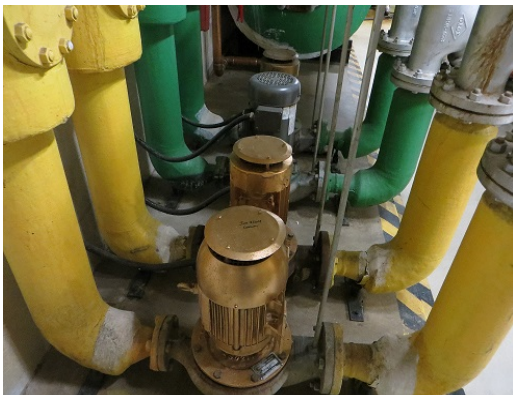
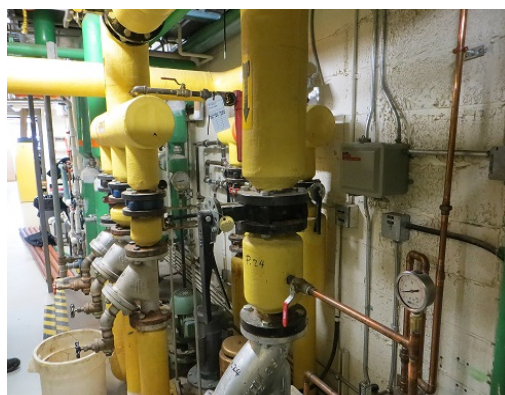
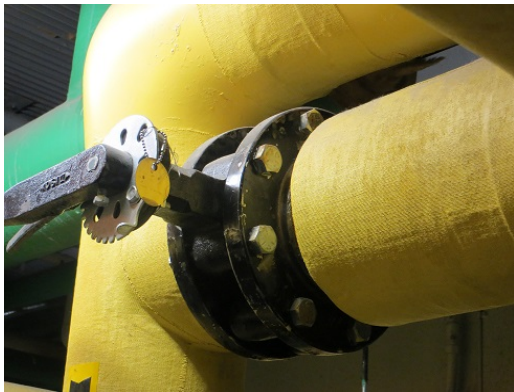
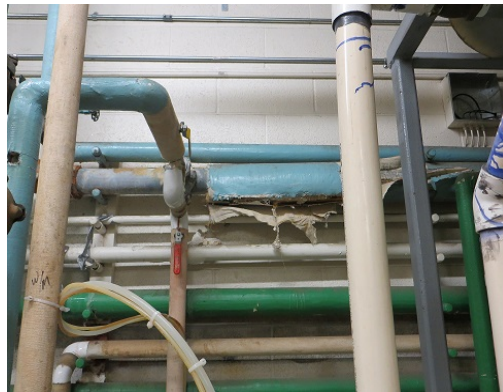
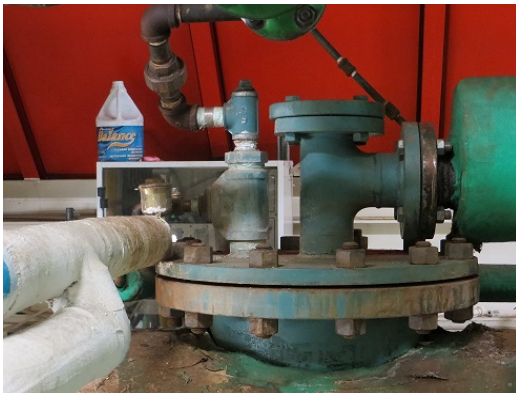
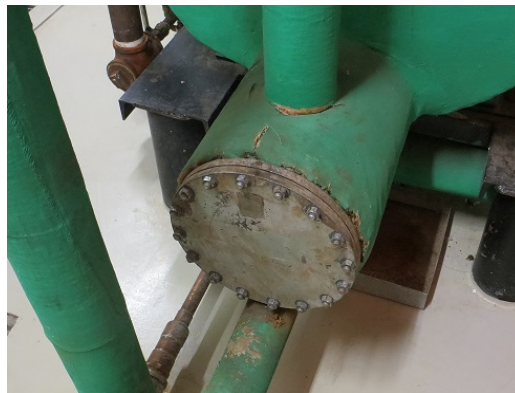
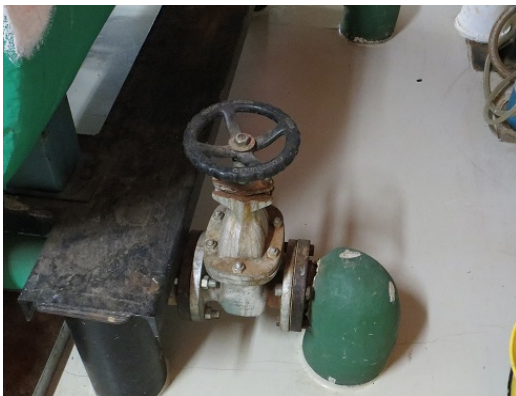
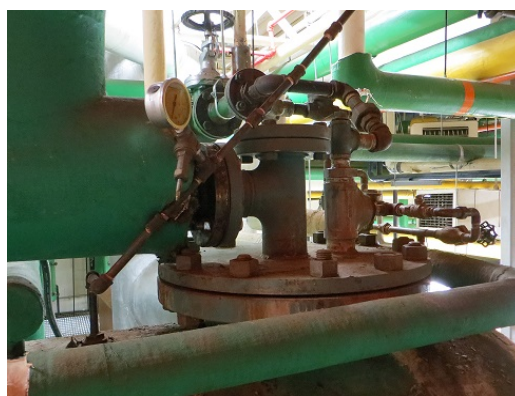
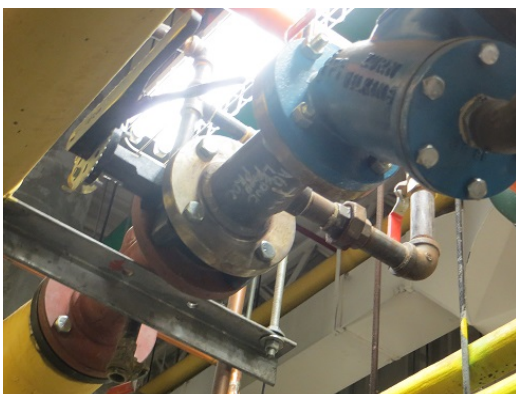
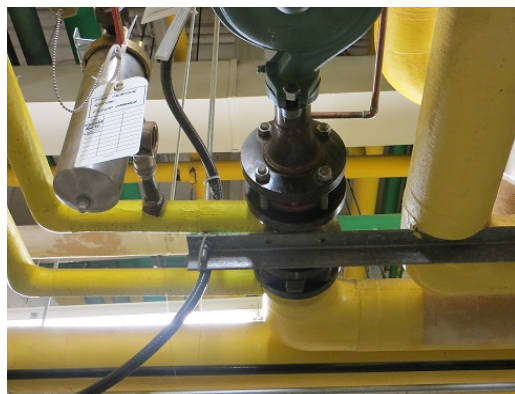
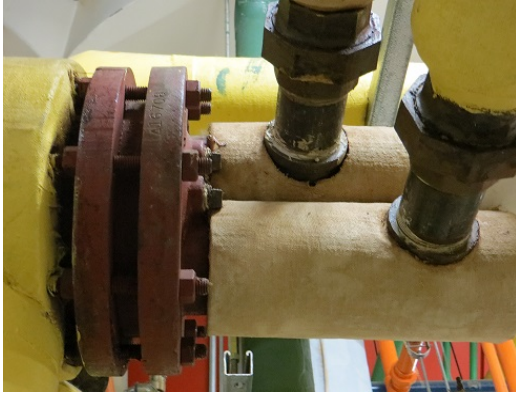
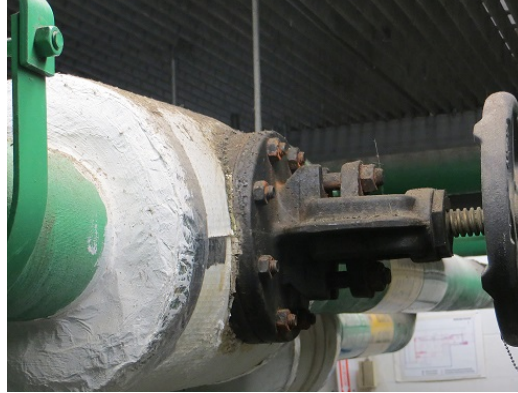
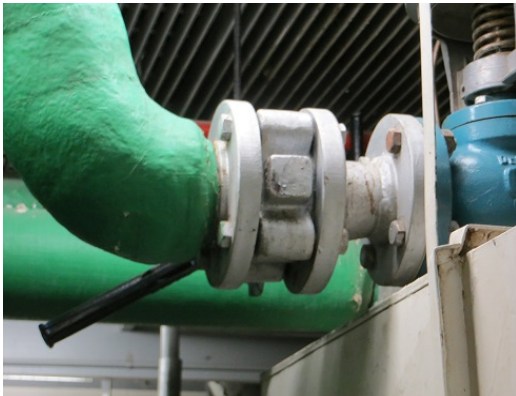
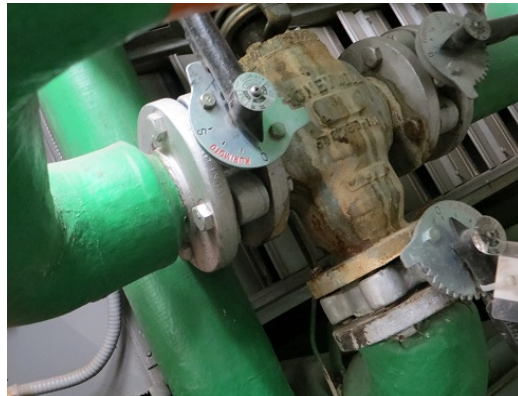
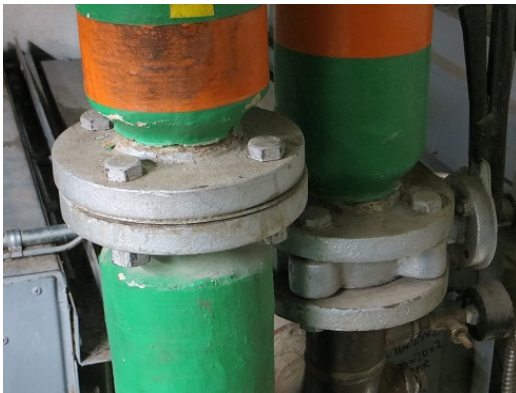
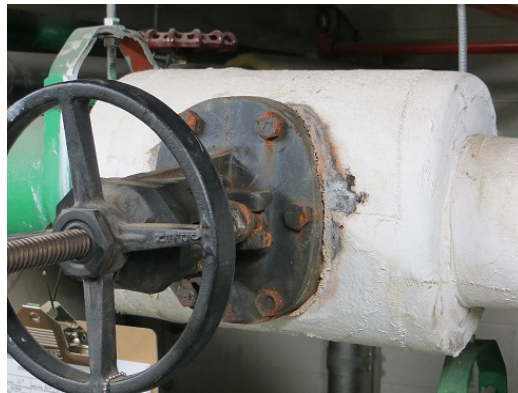
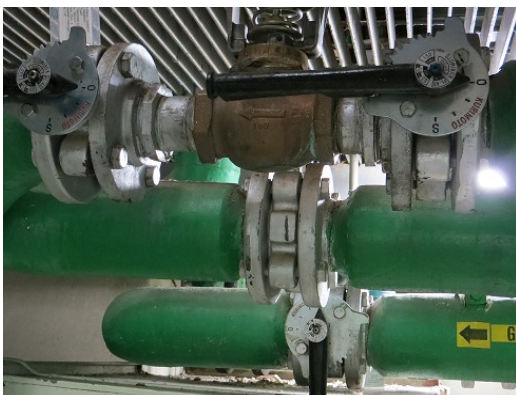
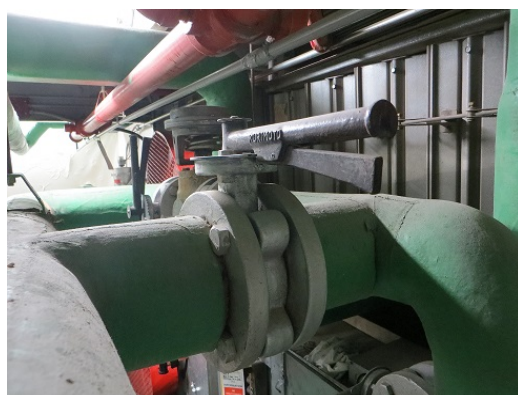
We have assessed the boiler room and found that the insulation applied to the mechanical systems is in fair to good condition. However, there are some instances where pumps, valves and piping have no insulation applied and therefore, an opportunity to receive some savings is available.

The workmanship of the existing insulation is in fair to good condition but some bad practices were followed when these materials were installed. During the course of this inspection we counted at least (30+) valves, (6+) strainers, (30) pumps and a number of flanges and couplings as well as and other areas which have not been insulated. We also found areas where the mechanical insulation is damaged, missing and worn out from mechanical abuse. There isn't a good reason to not insulate valves, piping and or fittings but to achieve cost savings at the time of construction or a specification which allowed these practices to take place. We can now show that not insulating pipes hot or cold will cost money for the operation of the building and or repairs to equipment or piping. The report contains visual inspection of these systems utilizing thermographic analysis and conventional digital photographs for reference.

The energy wasted in the boiler room in the Leduc facility as a result of the poor performance of the insulation systems is approximately 1,242 GJ per year.

Looking at the work done in the boiler room, the existing work was well done judging by the condition of the materials applied. However, there are many areas that will need to be insulated to ensure that each type of system is covered appropriately. The heating and steam system is missing substantial amounts of insulation from the valves, strainers, pumps and equipment. This is typically throughout the plant and will provide the most savings when insulated. The domestic hot and cold are missing insulation materials also due mostly to maintenance work at which time reapplication never happened.

Upon consideration of all observed conditions and the information gathered from the 3EPlus program, we recommend that all areas identified within this report be insulated or repaired. We also recommend that **Best Practices** be followed when applying insulation to these items as any deviation from applying insulation will reduce any potential savings. For example, we know that the elimination of canvas can shorten the lifespan of fiberglass with an ASJ finish because of the lack of a protective cladding system. We also recommend using removable insulating pads where necessary or feasible. This will allow maintenance to take place by removing the insulation pad whenever maintenance needs to take place.

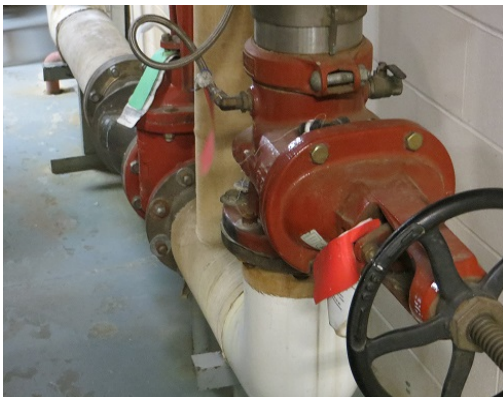
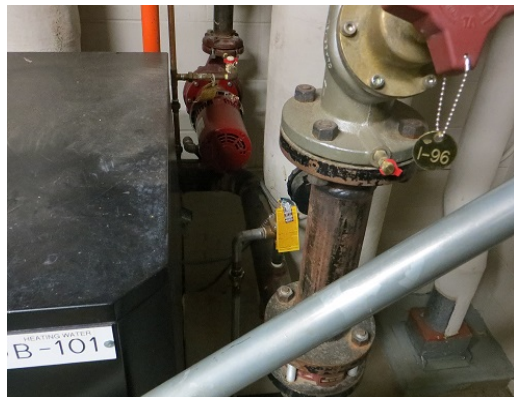
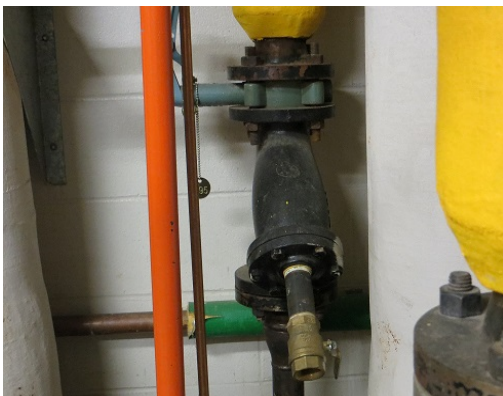
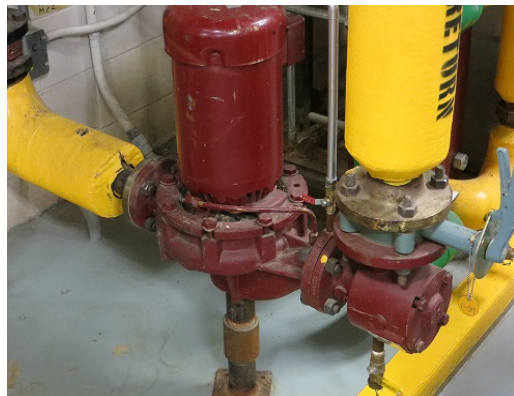
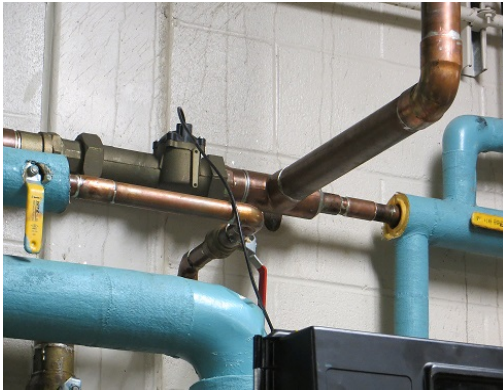
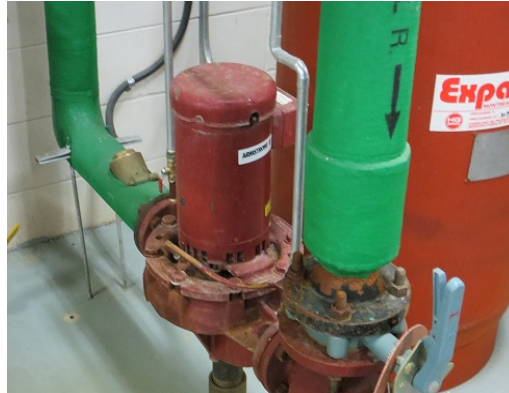
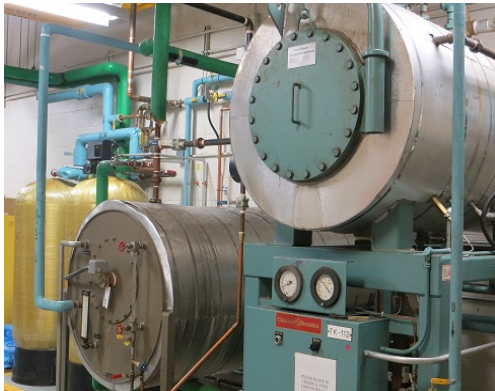
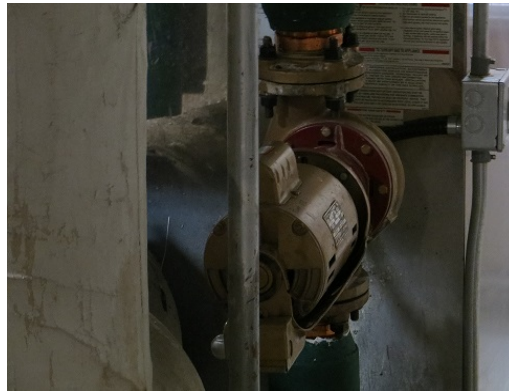
Mechanical Room 2nd floor

We have walked through and inspected the mechanical room on the second floor and found numerous areas which will require insulation to be applied to achieve thermal efficiency. The overall workmanship is good but as seen in other areas insulation has not been applied to any valves, strainers, pumps or heat exchangers. There are areas where pipe covering has been removed for maintenance work, this material should have been replaced at the time when work was done. There are many areas which have no insulation applied which is the main reason why this area is so warm at 30C.

Deficiencies in the insulation systems for the mechanical room on the 2nd floor result in a loss of approximately 1,217 GJ per year.

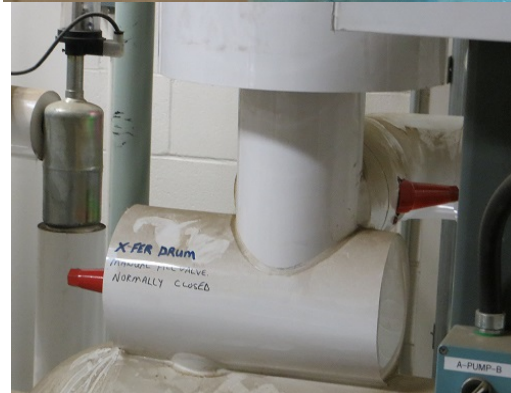
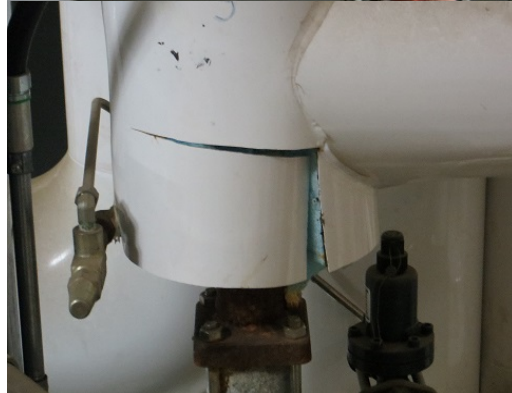
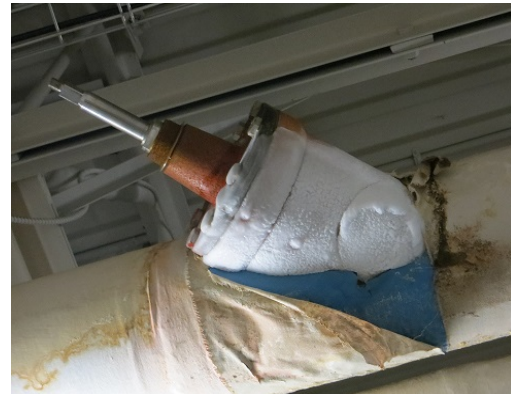
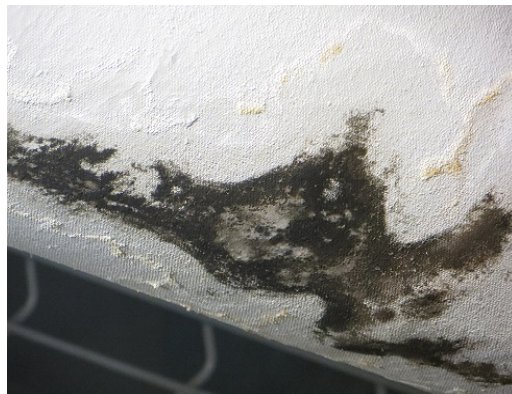
2nd Floor Mechanical Room Ammonia System

We have inspected the ammonia system piping in the 2nd floor mechanical room and found that the work and the condition of materials is excellent. We found a few minor areas where materials had been removed and the ice that has formed in those areas is the evidence that the vapor barrier was compromised. We observed a few areas where there was what appeared to be black mold formed on the canvas jacketing this is probably because of a failure of the vapor barrier.

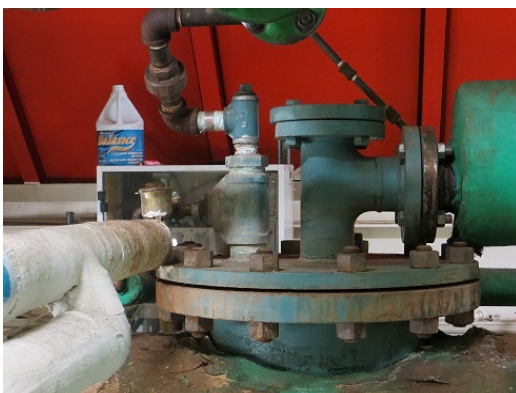
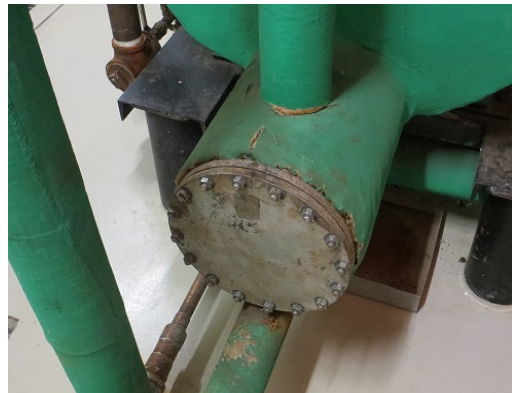
We also would like to address the hazards that the hot exposed items present to personnel. The boiler rooms and fan rooms generally are tightly packed with equipment and piping systems operating up to 121°C, the systems and equipment which are not insulated leave many opportunities for employees and maintenance personnel to come in contact with these surfaces which can burn skin. Properly insulated systems and equipment eliminate the possibility of individuals coming into contact with these hot surfaces and will prevent accidental burns which will add value by individuals not having claims and or lost time incidents.
