Mechanical Insulation Energy Audits

Energy Audit

For Reynolds Museum
6246 – 40 Avenue
Wetaskiwin, Alberta

April 12, 2016

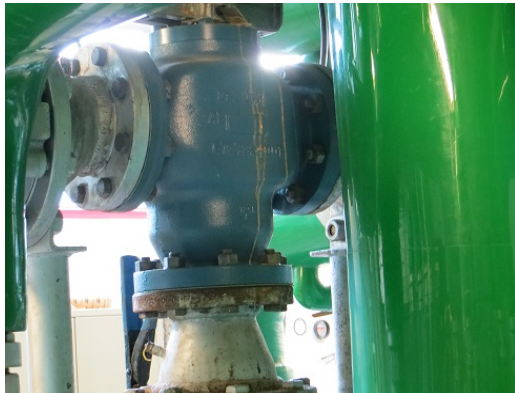
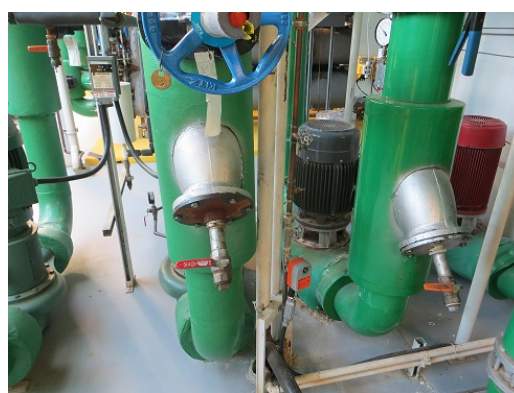
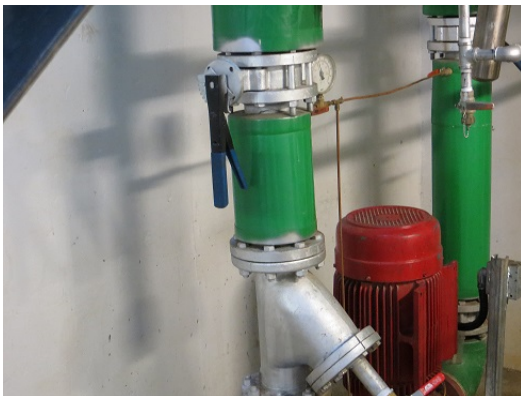
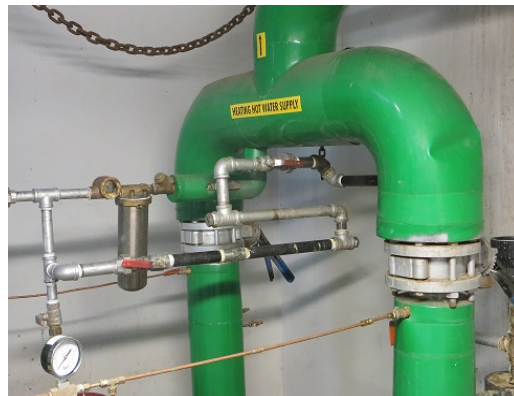
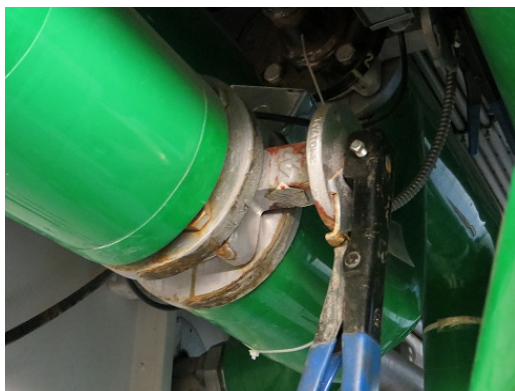
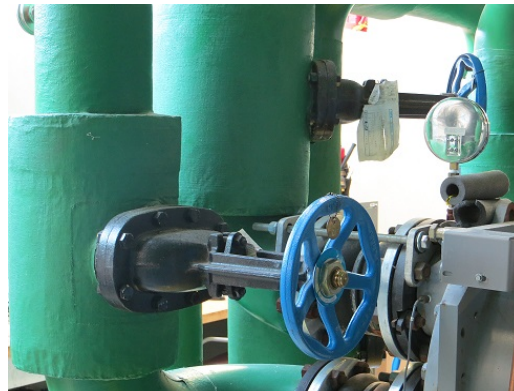
Fan Room

We have inspected the mechanical fan room and found the same experience of missing insulation on the valves, pumps and poorly insulated piping that was not insulated with respect to the original specification. The picture below shows clearly that there is no insulation under the PVC elbow and the elbow is melting from the heat. The copper from the hot water tanks also requires insulation and in its current state poses a possible burning hazard.

Upon consideration of all observed conditions and the information gathered from the 3EPlus program, we recommend that all areas identified within this report be insulated or repaired. We also recommend that **Best Practices** be followed when applying insulation to these items as any deviation from applying insulation will reduce any potential savings. For example, we know that the elimination of canvas can shorten the lifespan of fiberglass with an ASJ finish because of the lack of a protective cladding system. We also recommend using removable insulating pads where necessary or feasible. This will allow maintenance to take place by removing the insulation pad whenever maintenance needs to take place.
