# SALAMANDER INSPECTIONS LTD

## Energy Audit

For Royal Tyrell Museum  
1500 – Dinosaur Trail  
Drumheller, Alberta

April 14, 2016

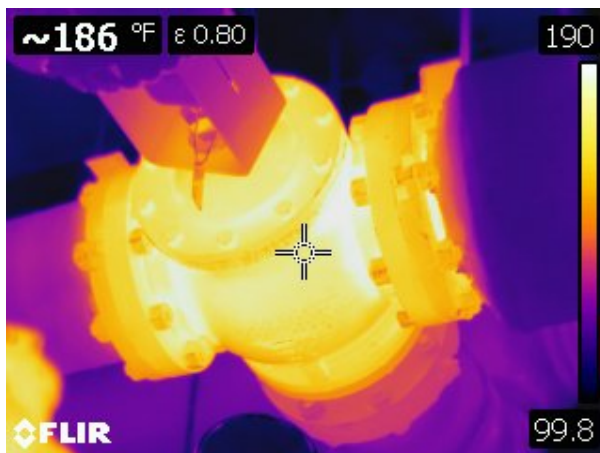
There are some areas where pumps, valves, heat exchanger and piping remain without insulation applied.

**We are pleased to tell you that if all areas within this report are addressed Royal Tyrell Museum will save 759 GJ per year saving \$3,039.52. The cost associated with the insulation of items contained within this report is \$7,104.46 with a ROI of approximately 2.33 years. *The insulation costs do not include the finish ie: PVC elbows or PVC finish. The ROI is determined by dividing the costs by the savings.***
