PAVEMENT MANAGEMENT PILOT

UPWP Task 5.32
June 30, 2020

North Florida TPO Pavement Management Pilot

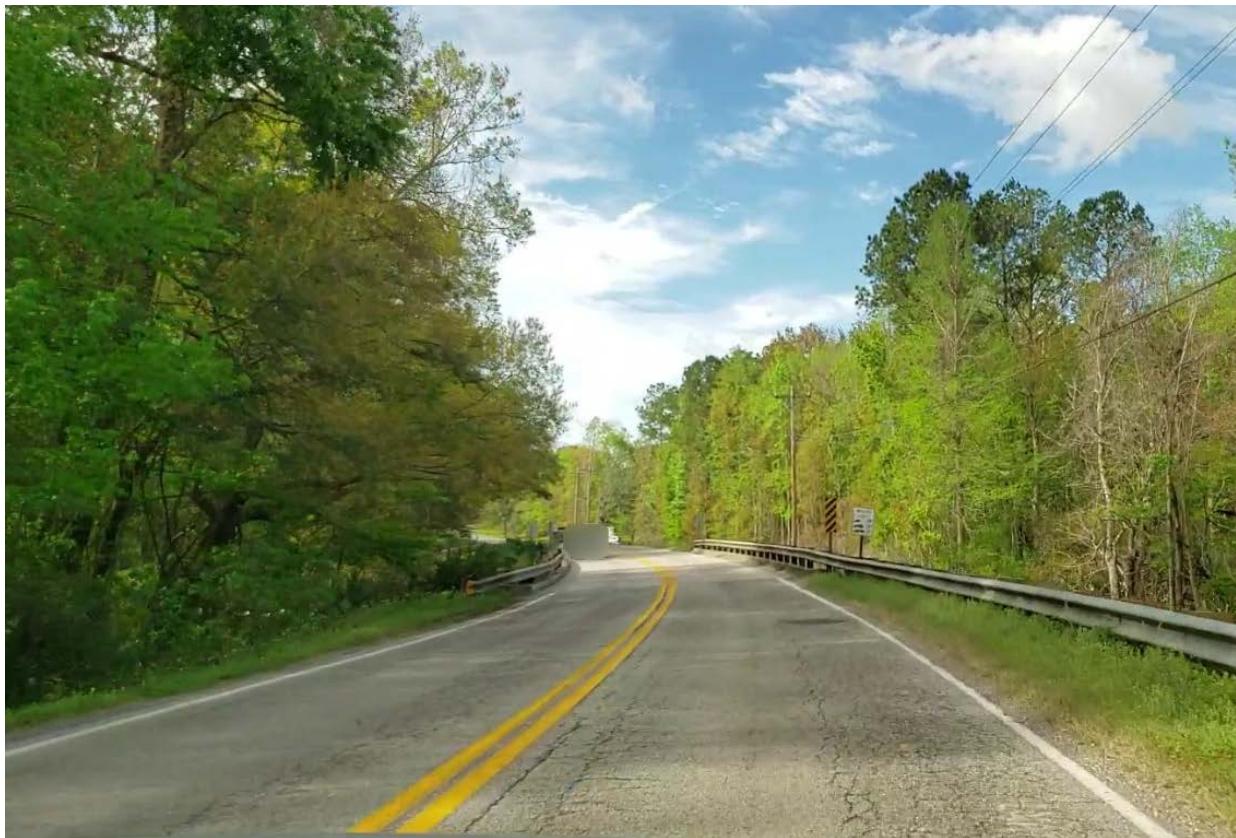
Figure 2. Cracking

Cracking and patching are intuitive terms. Raveling occurs when the mix of materials in the pavement does not stick together and the materials separate.

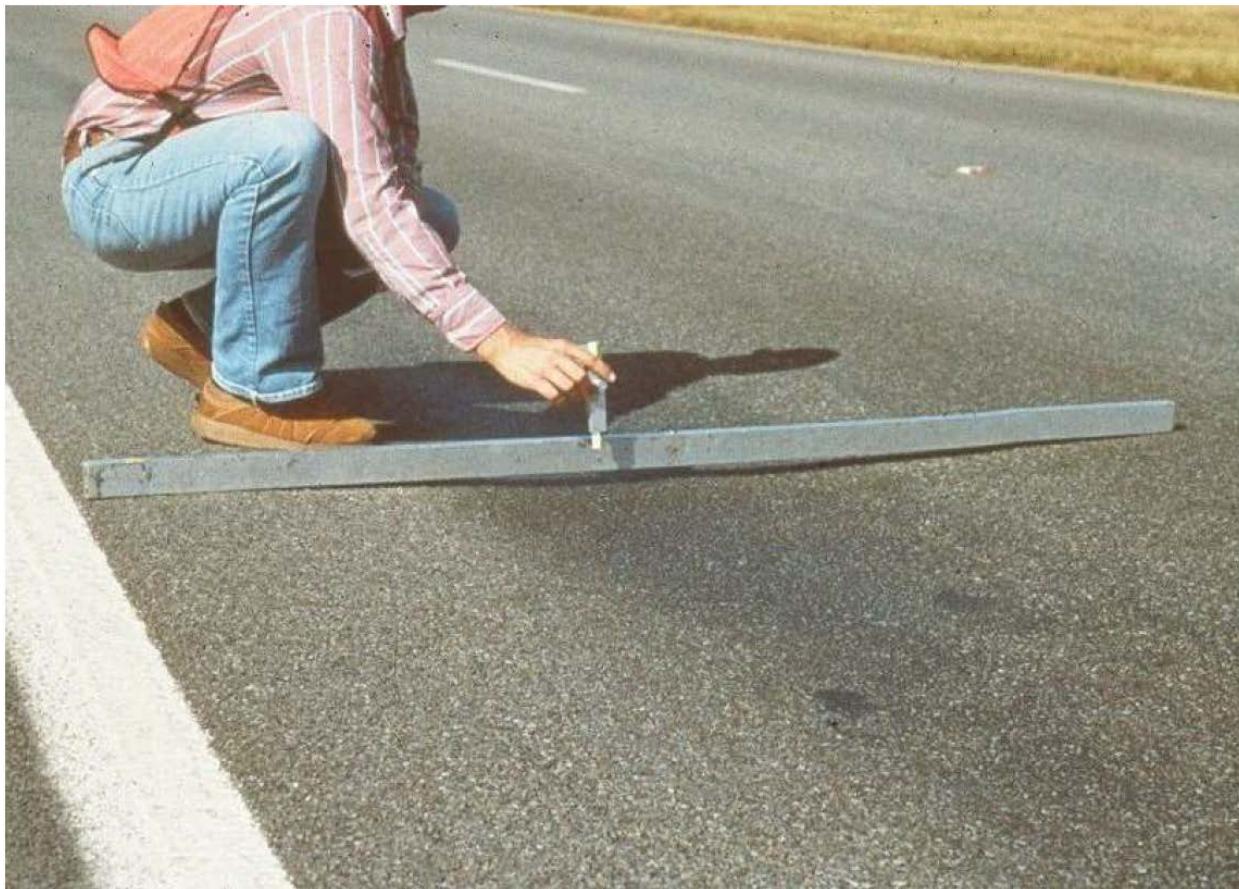
Figure 4. Rutting

Rut depths are collected using a profiler mounted on a pavement survey vehicle or by hand measurement. Rutting is the permanent deformity of paving creating depressions in the pavement.

Rutting causes the pavement to not drain correctly and ponding can occur resulting in a higher potential for hydroplaning and other vehicle collisions.

When rutting occurs, reconstruction of the pavement and base may be required.

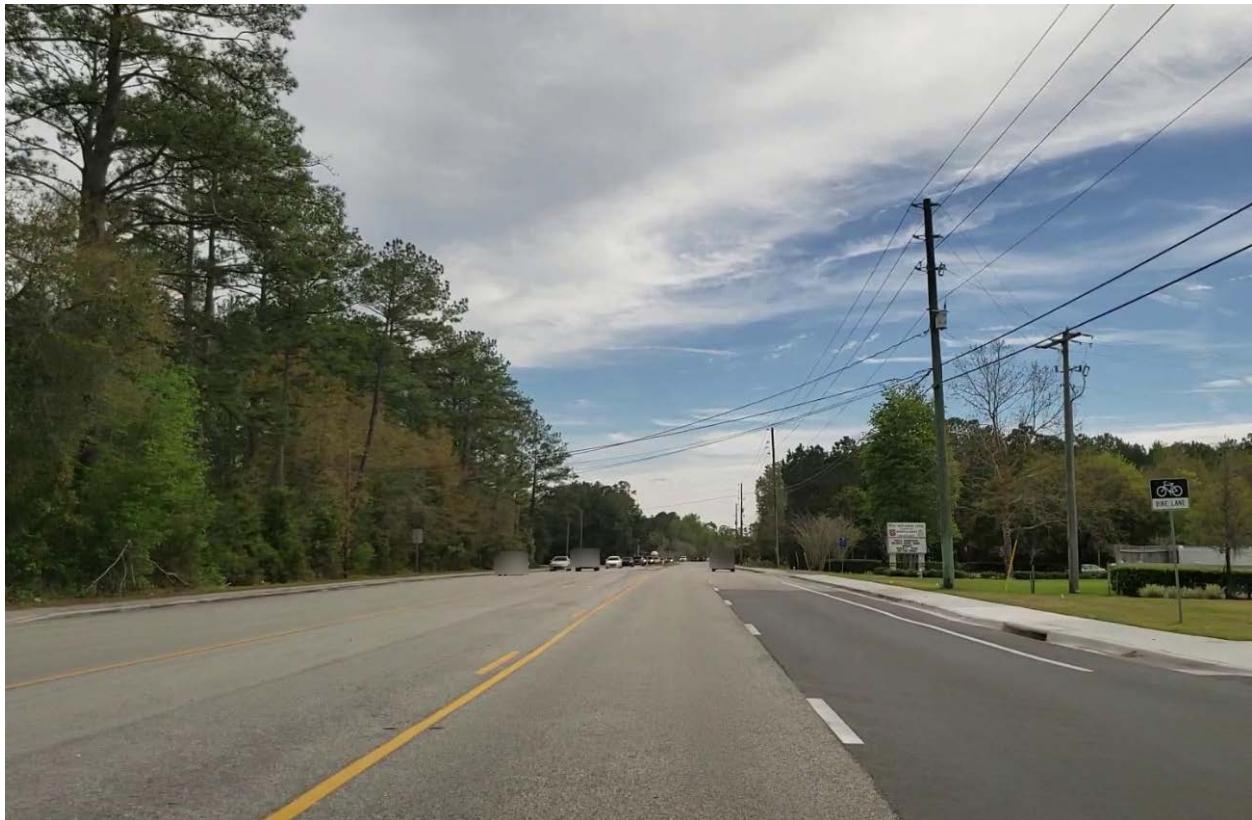
Figure 5. Oxidation

In Florida's hot climate, oxidation occurs when molecules bond which causes asphalt pavement to become brittle (asphalt pavement is flexible allowing the pavement to respond and recover to vehicle loading). This process reduces the strength of the pavement and can be seen when the color lightens to a grey hue. Cracking and subsequent failure occurs. It is the most common cause of pavement failures for low volume or local roads and can be used as a predictor of future failure as this process occurs over several years.

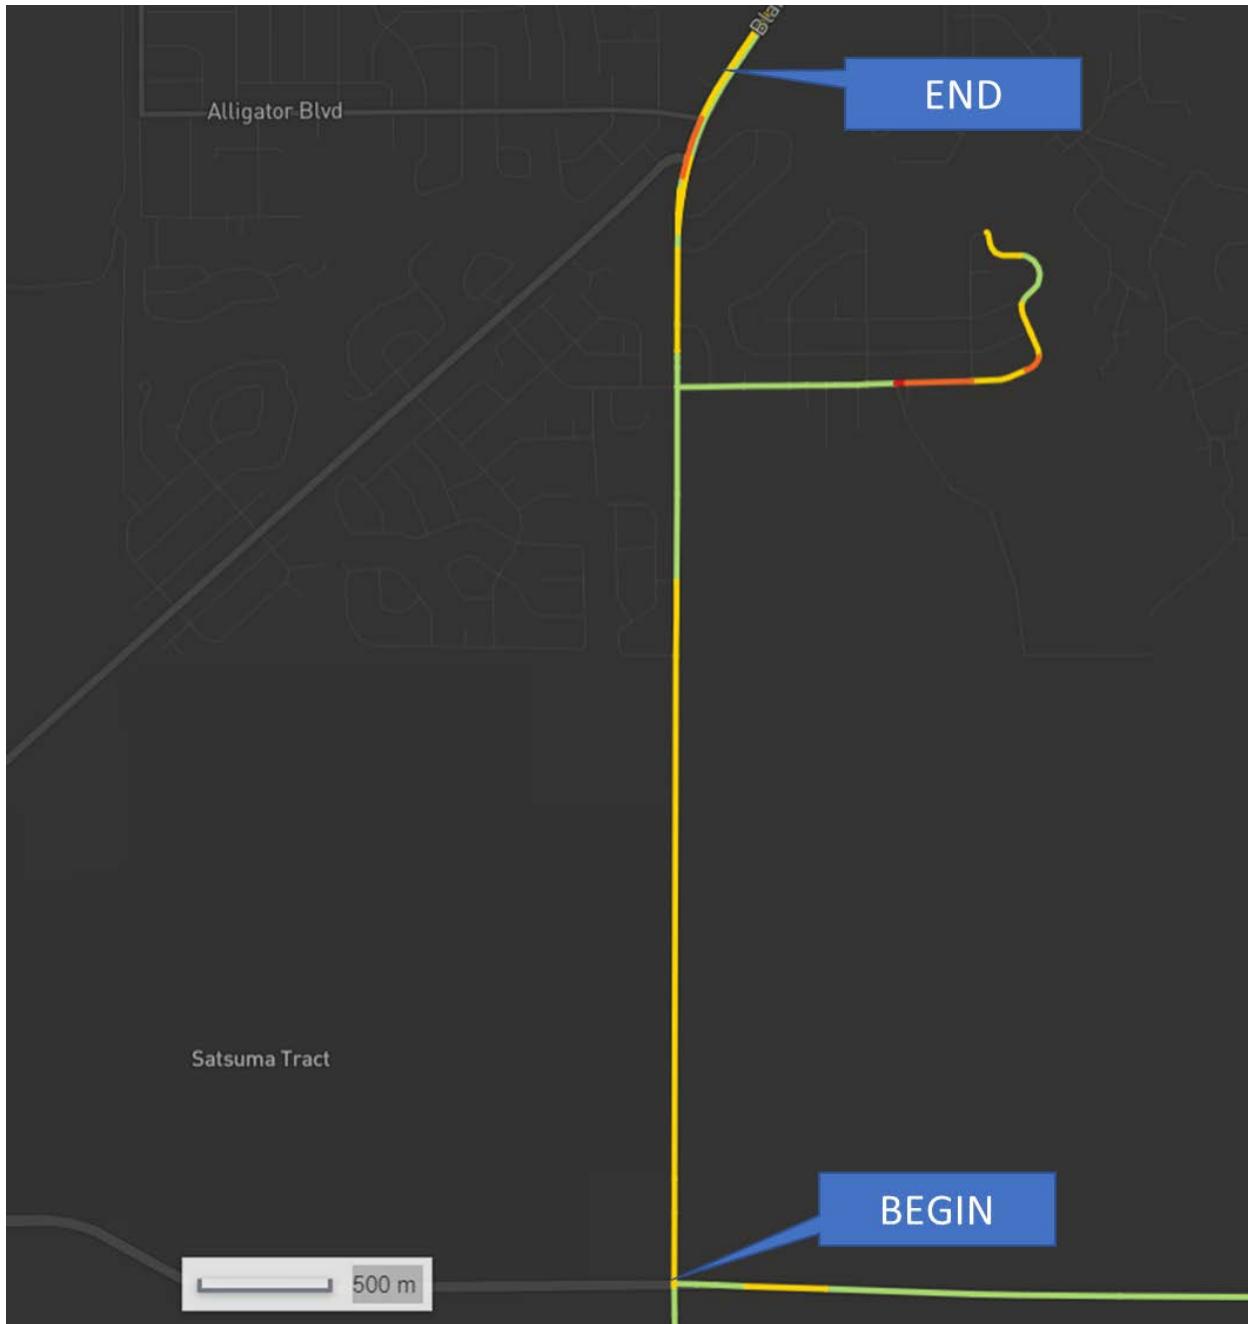
Figure 10. SR 21 from SR 16 to the End of Section 7111000

There were two areas where pavement distress was rated as significant in the left (southbound lanes). The segment where the distress occurs is shown in Figure 11. A photo taken during the data collection located between Peppergrass Street and Halpern Street as shown in Figure 13.

For the two segments where RoadBotics rated sections of SR 21 deficient and FDOT did not, there was significant distress to the pavement to justify preventative maintenance and resurfacing as demonstrated by the photos included in this report. They were likely not sufficiently long to impact the overall FDOT rating because of the length of the segment vs. the length of the areas with severe distress was observed.
