Major Power Plant in Turkey Protects Stack and Facility Equipment with ChemLine® Coatings

ChemLINE®
CASE STUDY

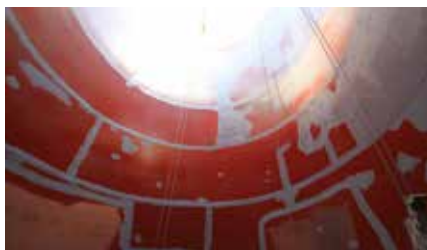
APC now sprayed the base red ChemLine® 784/32 coating (as shown in photos above). This was followed by a mostly roller stripe coat (above), especially covering the corroded steel surfaces. The ChemLine® 784/32 grey topcoat was then applied by spray (as shown top right).

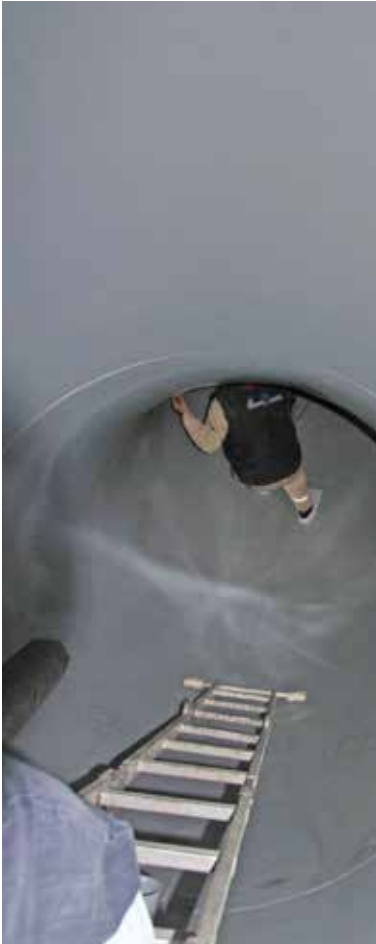
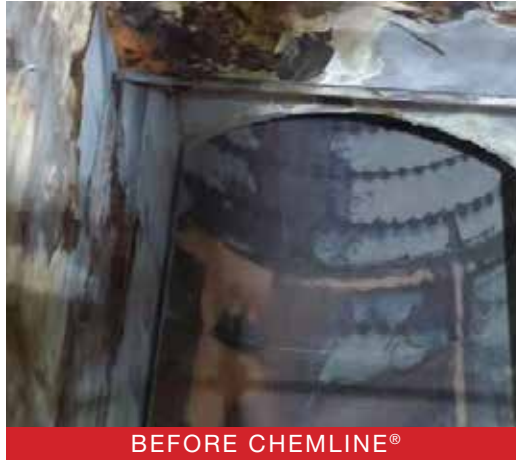
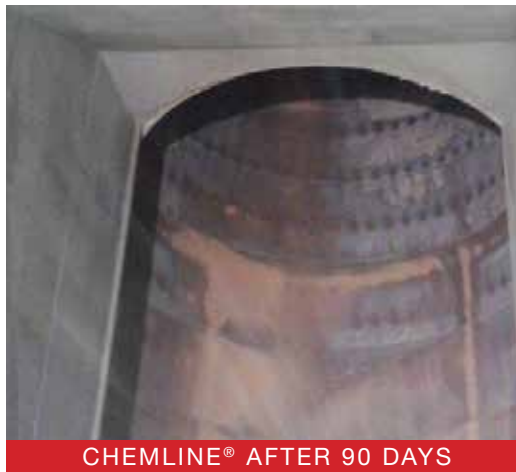
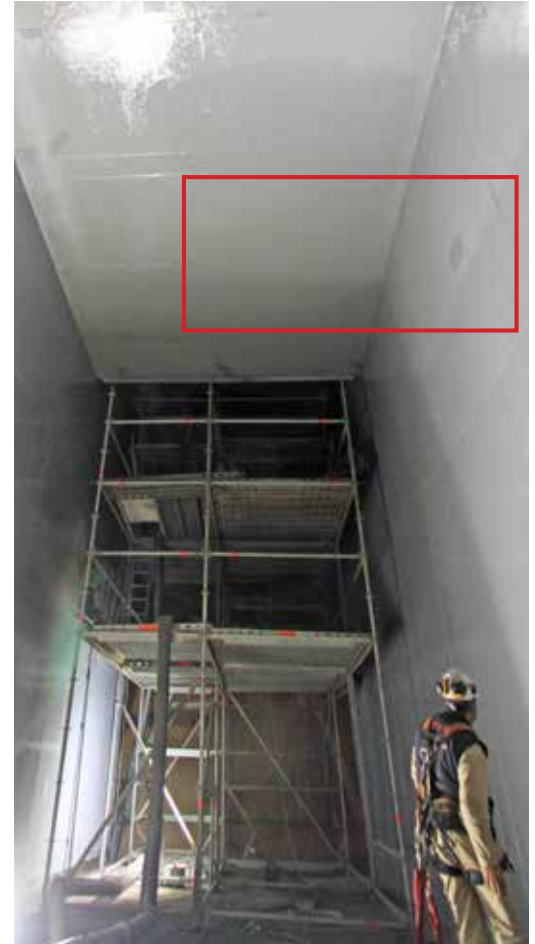
- 500 square meters of stack tunnels (above).
- 35 meter length x 1.80 meter diameter condenser lines/sea water lines (above).
- Concrete neutralization pits.
- Two process water tanks; one for 37% HCL, and the other for 45% sodium hydroxide (shown right).
- Some outer areas of the stack.
